Final report

6-02/1-23

Fatal man overboard from fishing trawler VARITA on August 28, 2022

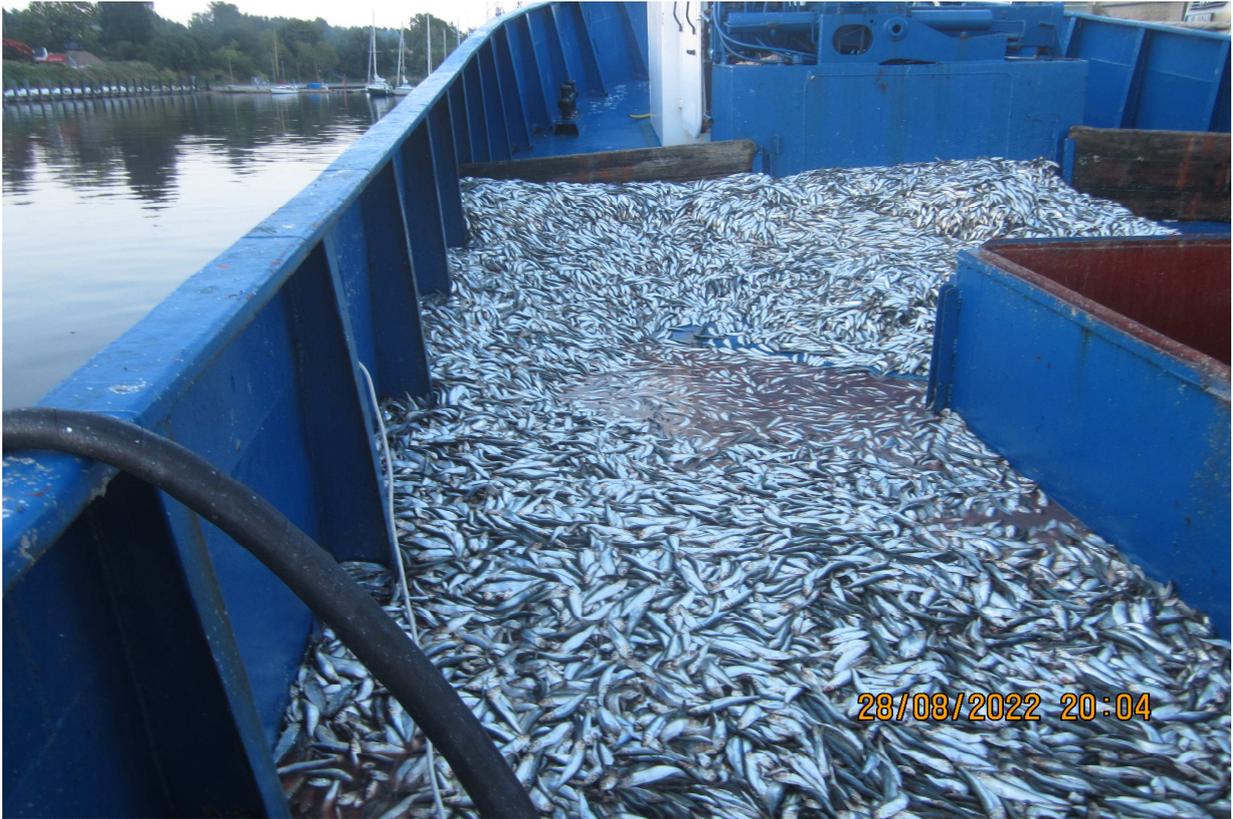
Figure 1. Fish released on deck

The engine was stopped and the crew prepared to release the fish from the trawl on deck. This is done in segments. Part of the trawl 2-3 tons of fish is hoisted by crane on deck and the fish is released (Figure 1). Then the empty segment of the trawl is disconnected from the cranes hook and released again into the sea, to prepare to hoist next segment. The rope connected to the cod end of the trawl is on the deck when the segment is on deck where the buoy remains in the water.

In this situation the rope was under the fish. Taking empty segment from the hook and releasing it to the water the trawl was going down fast under the weight of fish. The rope appeared between the lags of fisherman pressing his one leg to the railing and pooled him into the water. He just shouted “STOP” and was pooled out into the sea. Crewmembers tried to rescue him, but no one saw him on surface. As from testimonies of the crewmembers, it happened within one second.

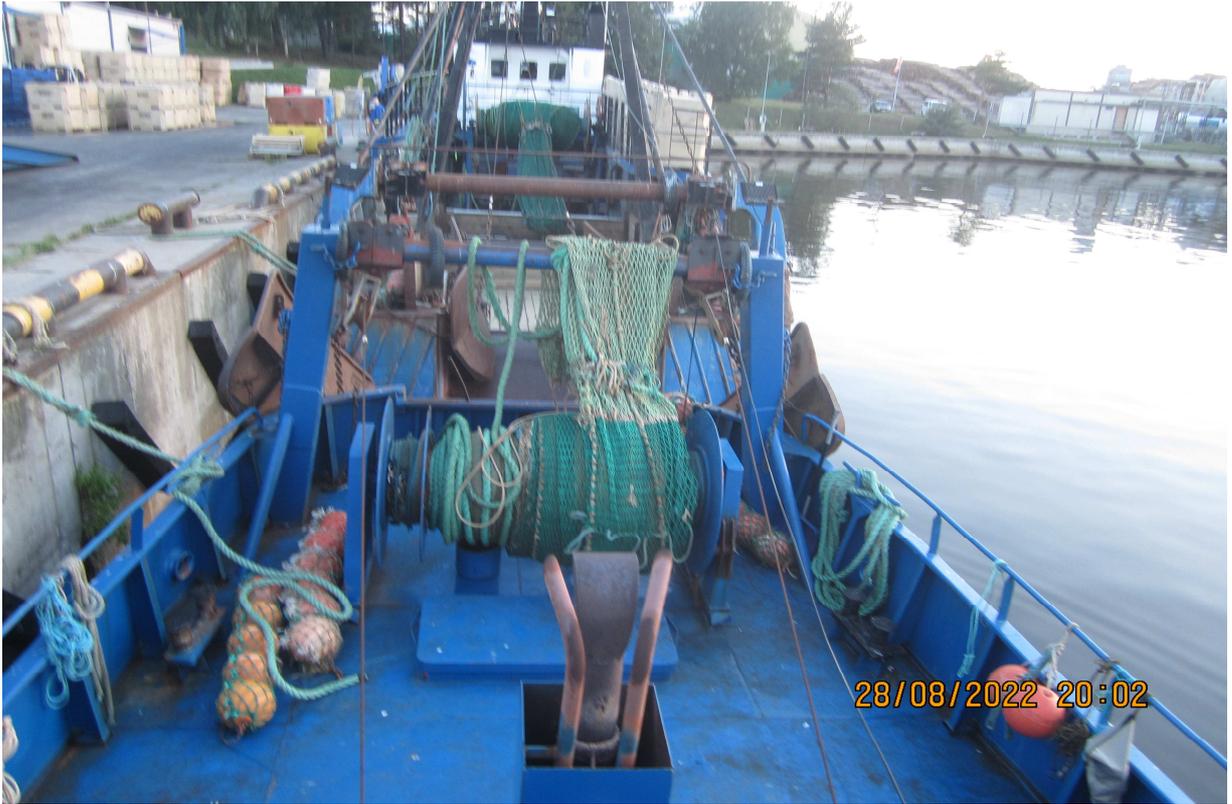
Figure 3. Trawl winch

At 11:20 the crew began hauling the net (Figure 3), which was controlled from the stern deck. The crew donned their oilskin long trousers, fisherman's boots and went onto deck. None of the crew were wearing PFDs or safety harness. Soon later, the trawl doors were recovered and secured, and the sweeps and bridles were (Figure 2) then disconnected and the trawl was connected onto the forward (Figure 4) crane, in the front of wheelhouse, where the trawl was in the water on starboard side. The construction of the trawl contains rope 8-10 meters, connected to the end of trawl with the floating buoy at the end of the rope, which marks the end of the trawl when trawling.
