FINAL REPORT No 4-02/1-23(1-24)

on the serious incident to the aircraft Airbus A220-300 (CS300) registered YL-AAP operated by airBaltic runway excursion at the Riga International Airport (RIX), on March 8, 2023

Investigation No 4-02/1-23	Aircraft Registration: YL-AAP
Aircraft: Airbus A220-300 (Bombardier/BD-500-1A11(CS300))	Type of flight: Scheduled (BT 694), IFR
Engines: Pratt & Whitney PW1521G-3	Flight: BT1-4HE
Crew: 6	Passengers: 89
Place: Riga, Latvia	Date and Time: 2023.03.08/21.18 UTC

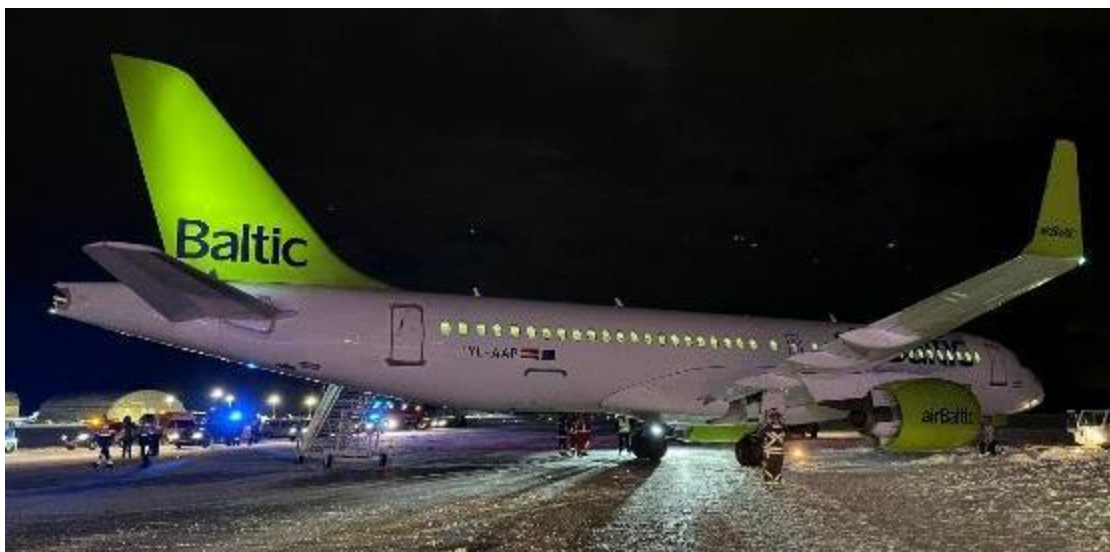
Figure 1: The aircraft at the serious incident site

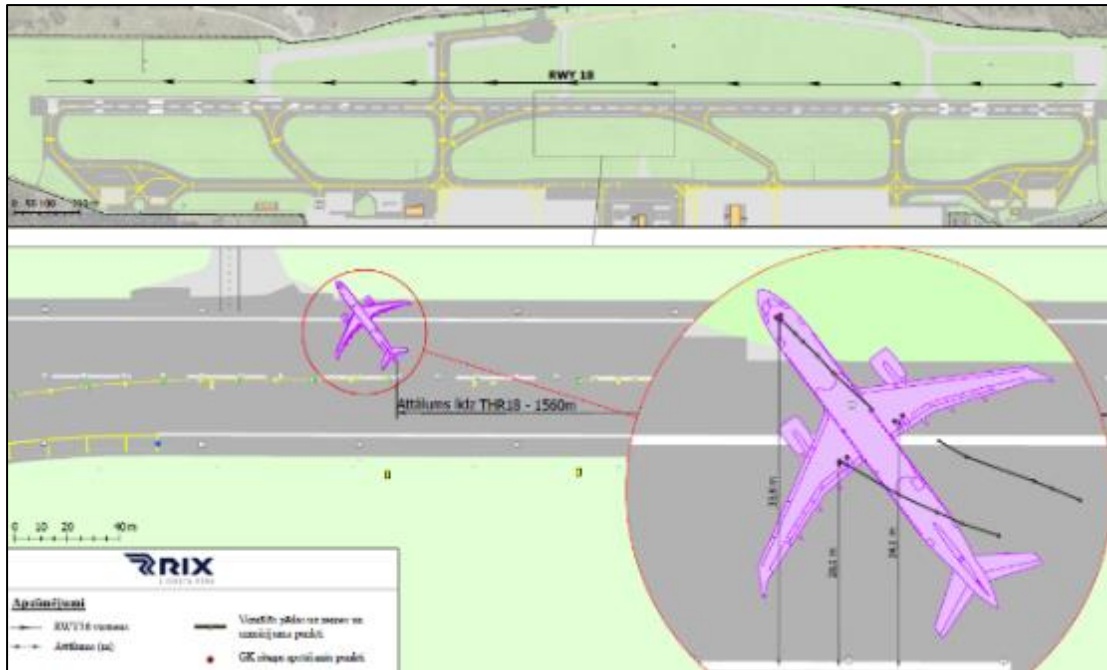
Figure 2: Location of the aircraft after the occurrence (source: RIX scheme on 08.03.2023)

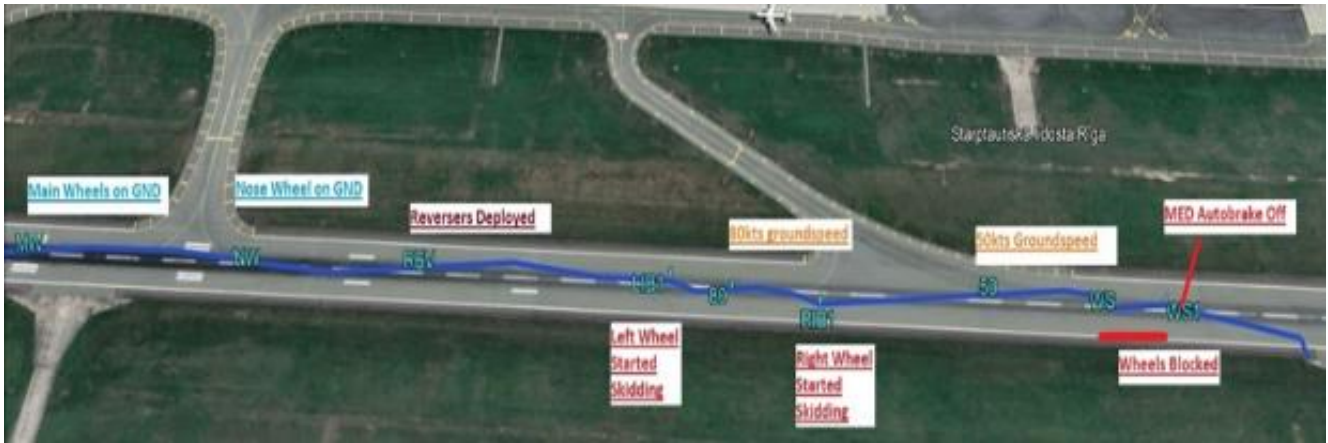
At **21.17.53**, the right MLG wheels were skidding the aircraft started to yaw left (Yaw rate was approximately -1.9 deg./sec) with the ground speed **63** kts; the aircraft pilot reduced its right rudder pedal input to correct the yaw (see Figure 6).

Figure 6: Computer simulated scheme of the aircraft deflection after landing on the RWY18

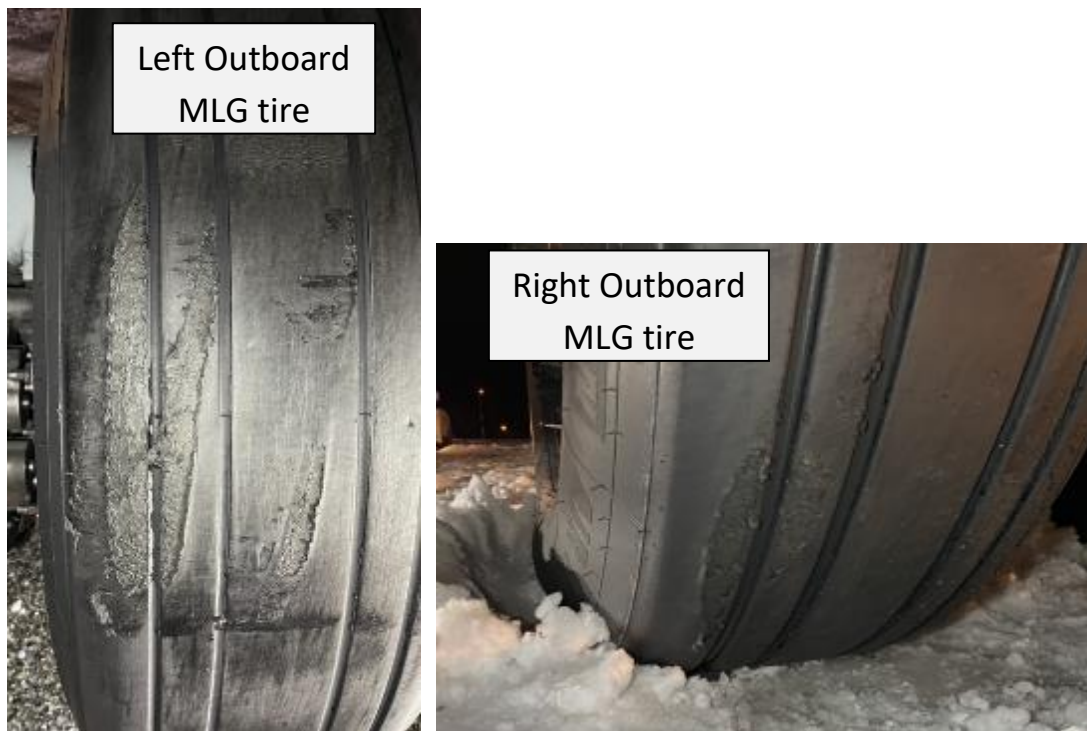
Performing a visual inspection of the aircraft at the incident site the MLG wheels outboard tires damages were detected: skid abrasion marks were found on the MLG wheels tires (see Figure 7a and 7b).

Figure 7a, 7b: The MLG tires abrasions marks

Note: The visible tires wear marks on the MLG wheels tires may be due to the wheels locking when the aircraft was on the runway, and/or sideslip moment of the aircraft when the nose landing gear left the runway surface.

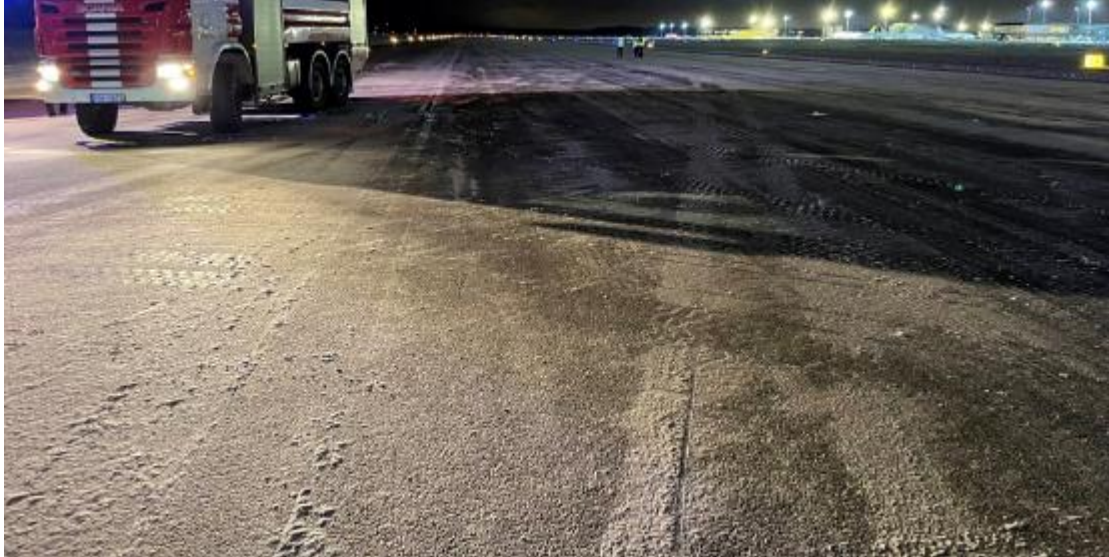
According to the information provided by the aerodrome services, at the time of the occurrence at **21.18.18** the runway surface was covered with “Dry Snow” about 5 mm thick, which corresponds to the runway condition code RWYCC “3” (see Figure 11).

Figure 11: Visual surface condition of the RWY18 approximately an hour after the occurrence

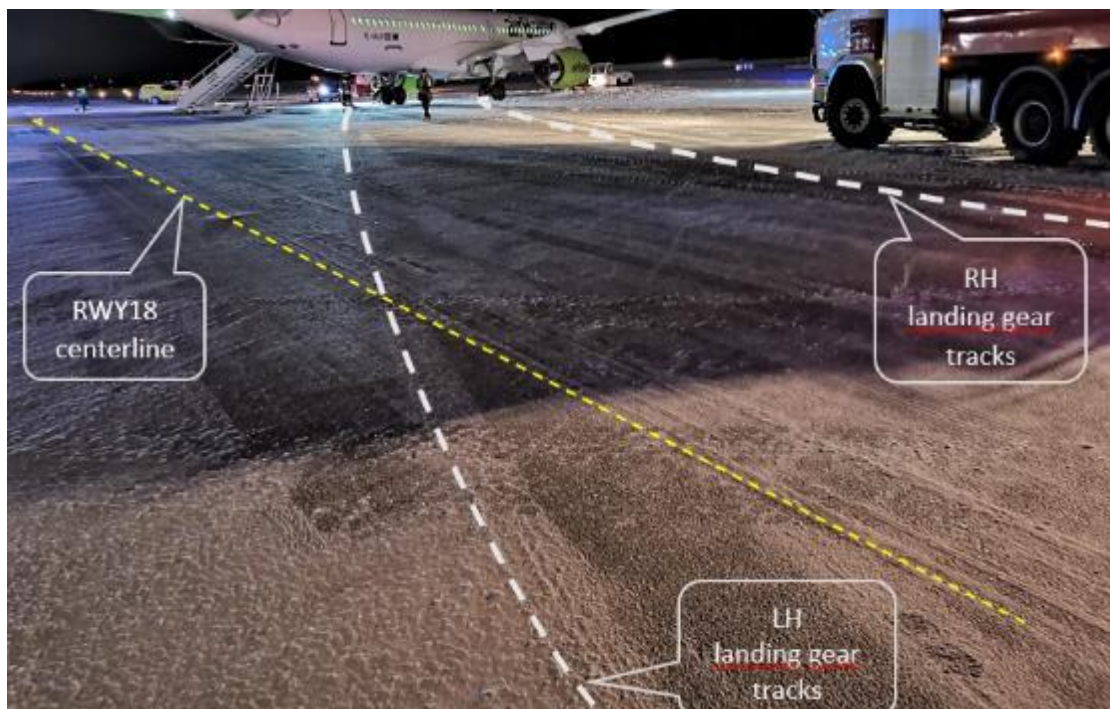
At the incident site the aircraft's tire sliding track was visible for a length of 97.2 m, in the direction to the right from the runway centerline, until the aircraft left the paved surface of the runway and stopped (see Figure 13a and 13b).

Figure 13a: Visible tracks of the aircraft tires on the runway

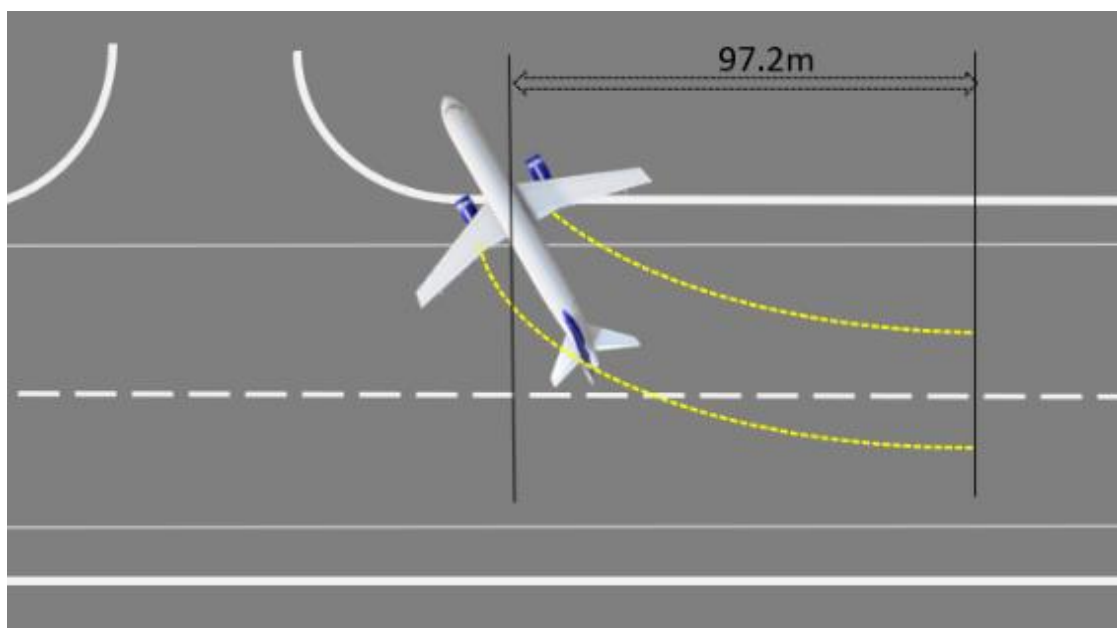
Figure 13b: Scheme of the aircraft runway sliding distance

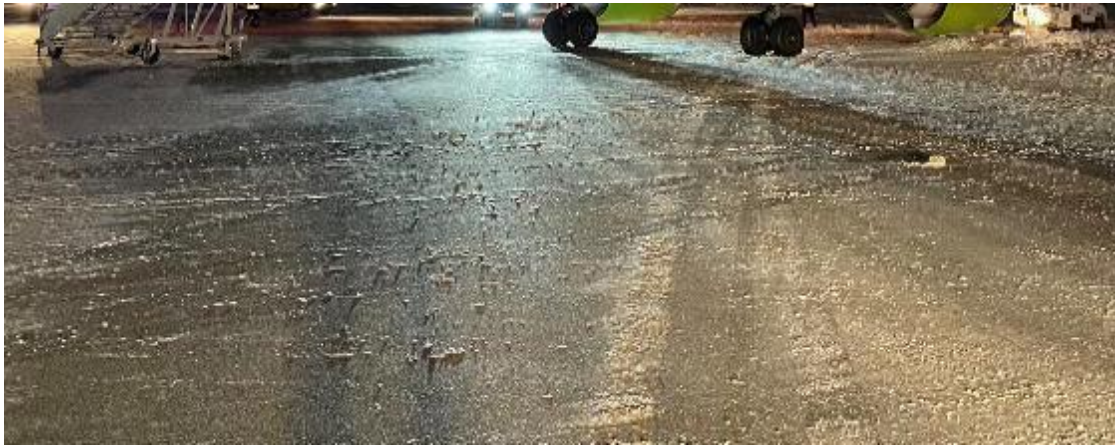
According to the Section 1.12 of the TAIIB investigation report, snow tracks of the main landing gear tires found on the runway surface 97.2 meters long from the runway centerline, could have been caused by sliding of the blocked wheels of the main landing gear (see Figure 14).

Figure 14: The aircraft MLG tires sliding traces

Possibly the main landing gear wheels were completely blocked after the pilot had rapidly pressed the brakes of the aircraft, subsequently the aircraft began to slide uncontrollably to the right from the RWY centerline.

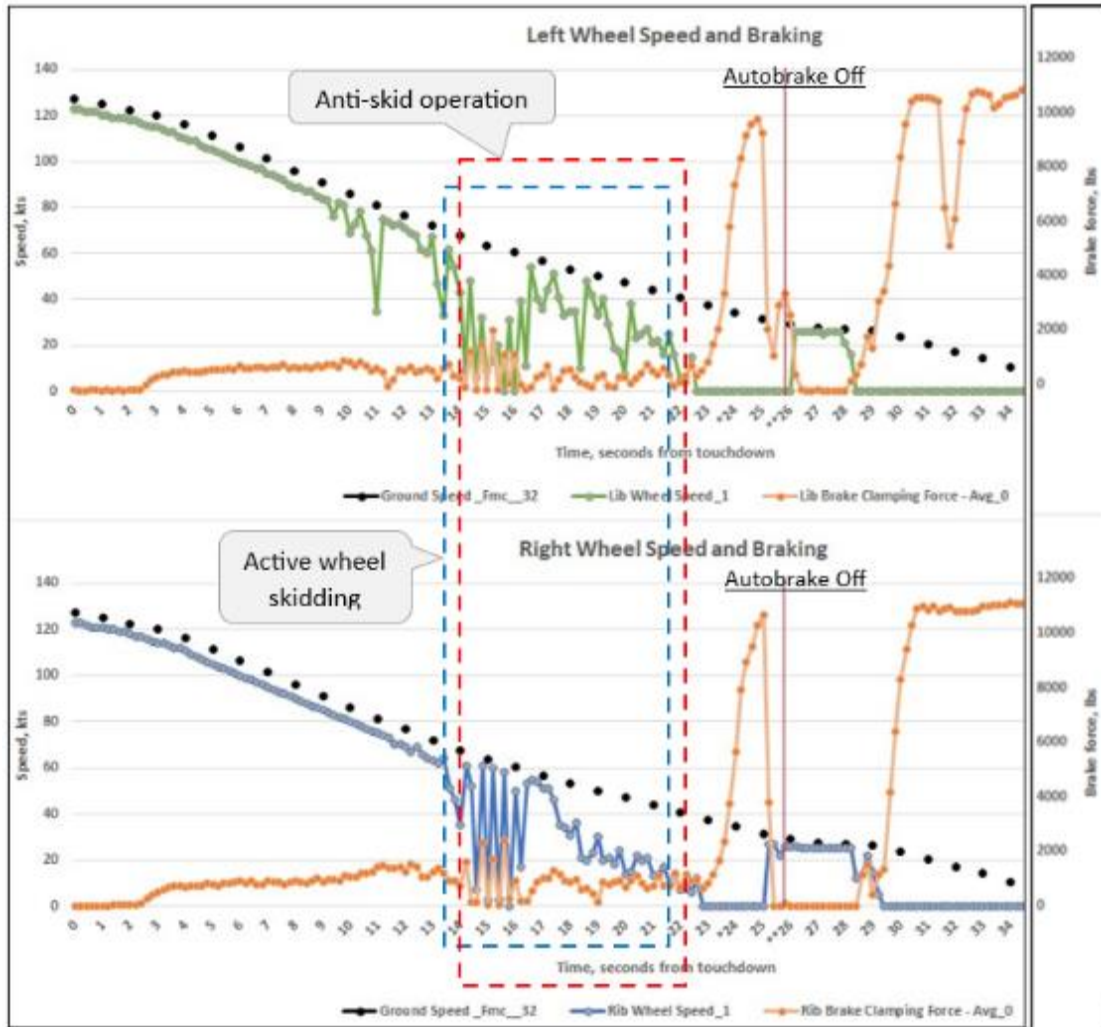
- the active operation phase of the anti-skid protection ranges from 11 sec to 23 sec after the aircraft touchdown and at a ground speed of about 60 kts;
- the skidding of the main landing gears wheels is from 14 sec to 23 sec after the aircraft touchdown, until the MLG wheels lock at 23 sec at a ground speed of about 30 kts.

Figure 15: Areas of the aircraft wheels skidding and anti-skid protection operation according to the FDR data

Thus, it can be assumed that after the active operation of the anti-skid protection due to wheels skidding, the decreased wheels rotation speed could be a cause of the divergence of the wheel speed vs aircraft speed and early inhibition of the locked wheel protection and anti-skid function, and the subsequent MLG non-symmetrical wheels blocking, was probably a contributing factor for the pilot loss of control of the aircraft landing ground roll and the aircraft began to veer uncontrollably to the right.

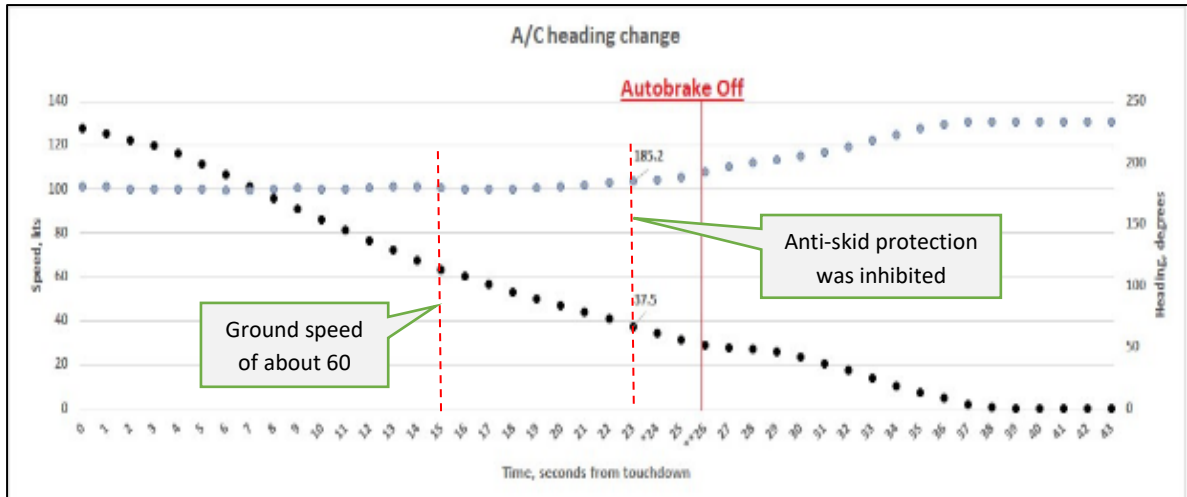
During the 23 seconds of the aircraft landing ground roll to approximately half up the RWY18 the A220 aircraft remained close to the centerline of the runway until the anti-skid protection turned off and the aircraft began to deviate to the right from the runway centerline. According to the FDR data and the displayed aircraft heading change plot the aircraft deviation from centerline at a ground speed of about 60 kts was also minimal, approximately +1.5° from the RWY18 true direction (see Figure 16).

Figure 16: The aircraft heading change

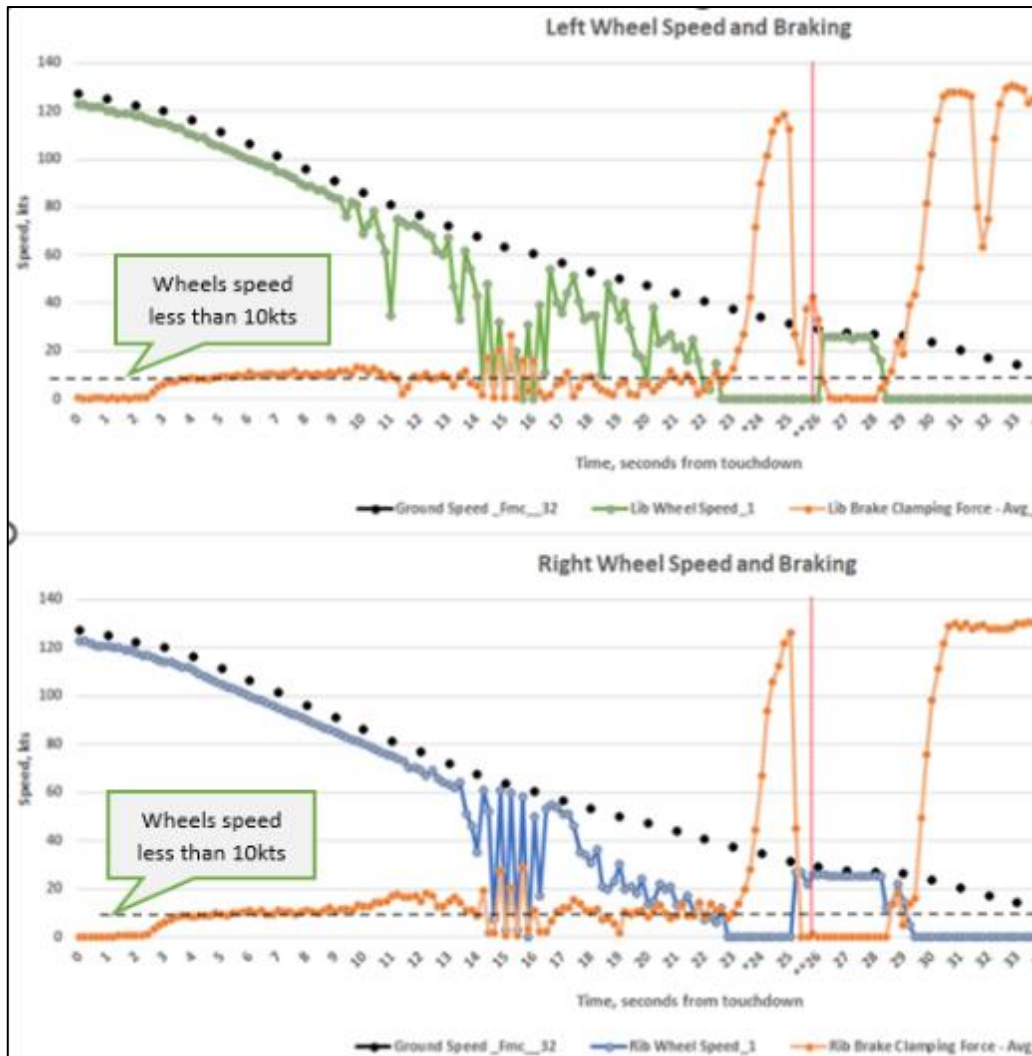
As the wheels rotation signals from wheel speed transducers (WST) reduced below 10 kts, the anti-skid protection was de-activated and therefore the aircraft's automatic braking system activated full braking force (increased to ~10400lbs), the wheels blocked completely, and the aircraft began to drift towards the right side of the runway at a ground speed **34** kts (see Figure 17).

Figure 17: Display of the decrease in the wheels speed rotation of the aircraft
