Transporta nelaimes
gadījumu un incidentu
izmeklēšanas birojs

Simplified report Nr. 1-2024

Serious injury of crew member on board of Maltese flagged vessel KAILI on 02 May 2024 in Bay of Riga

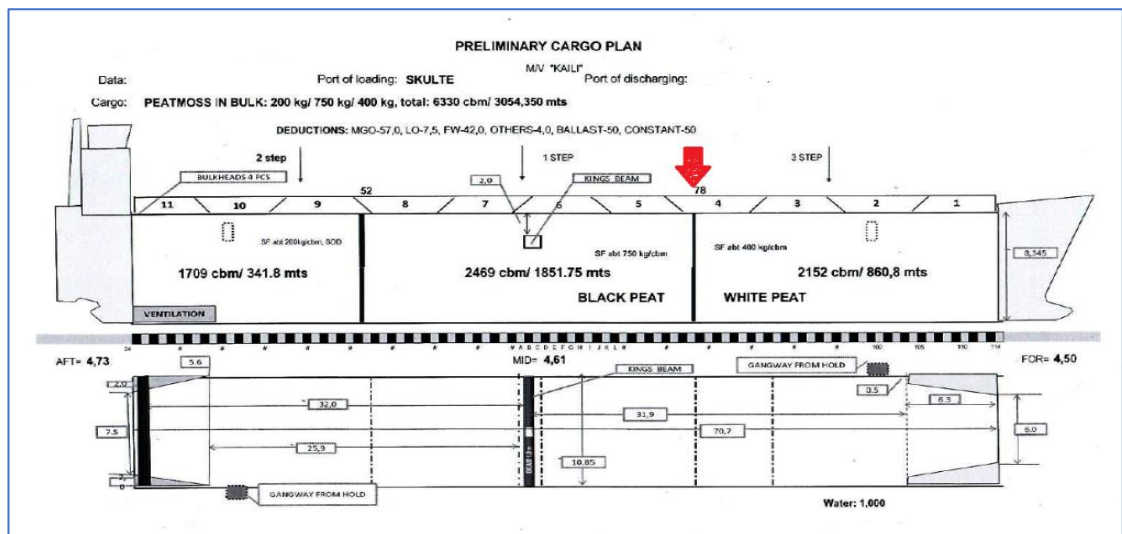
Image 2. Bulkhead location within cargo hold (on 78 frame), shown by red arrow as planned to be installed, in accordance with the cargo loading plan

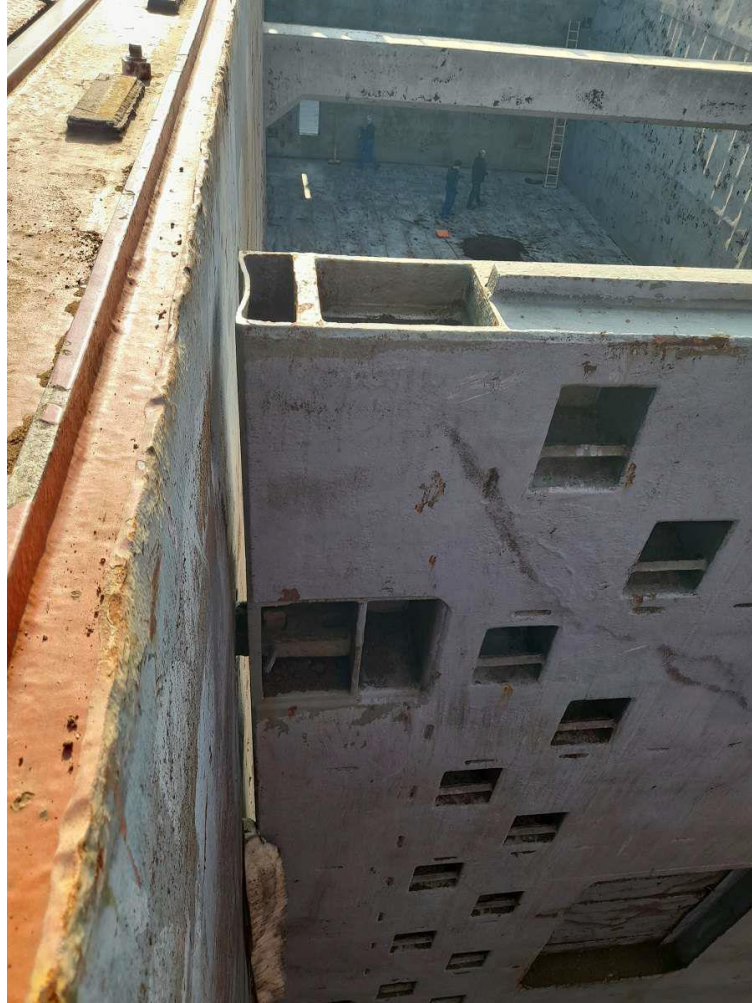
Image 3. Moveable bulkhead installed in cargo hold with transverse fastening pins

3.1.3. Event 3: Bulkhead installation. By 20.00, the lower part of the bulkhead had been successfully installed. However, during the installation of the upper part of the moveable bulkhead, the crew members observed misalignments of the bulkhead fixing pins. To rectify the matter, the crew members fastened the port side pins and made attempts to align the same level of upper slots and upper pins by slight adjustments of the bulkhead, using the gantry crane (see image 3, for illustrative purposes).

3.1.4. Casualty Event (Accident). The Able Seafarer, staying on a portable ladder inside the cargo hold, tried to align the pins and slots for fastening, verbally guiding the crane operator, to put all the elements correctly. During the process, the AB put his left arm between the cargo hold side shell and the unsecured movable bulkhead. At one point, the vessel rolled slightly (possibly due to the wake generated by a passing vessel), causing the bulkhead to shift transversally. Consequently, the AB's left arm was trapped between the cargo hold side shell and the bulkhead, inflicting a serious injury. The AB shouted to the gantry crane operator, prompting him to shift the gantry crane, so that he could release his arm. After releasing his arm, two crew members assisted and walked the injured crew member out of the cargo hold to the bridge.

- 1.1. Review the moveable bulkhead installation instructions manuals (covering also all aspects of gantry crane operations) IAW requirements, as defined by IMO Circular MSC.1/Circ.1663 GUIDELINES FOR LIFTING APPLIANCES, (issued 28 June 2023) where *inter alia* it is stated in Para 3.6.1.2 : *All personnel involved in a lifting operation should understand their role during the operation and, in particular, the signals that may be required to commence, coordinate or stop the operation.*
- 1.2. Review the Company's SMS documentation in order to bridge gaps in the language used and spoken.
- 1.3. Review vessel's working-rest hours policy and procedures IAW the Maritime Labour Convention, 2006 requirements, in order to mitigate potential fatigue issues.

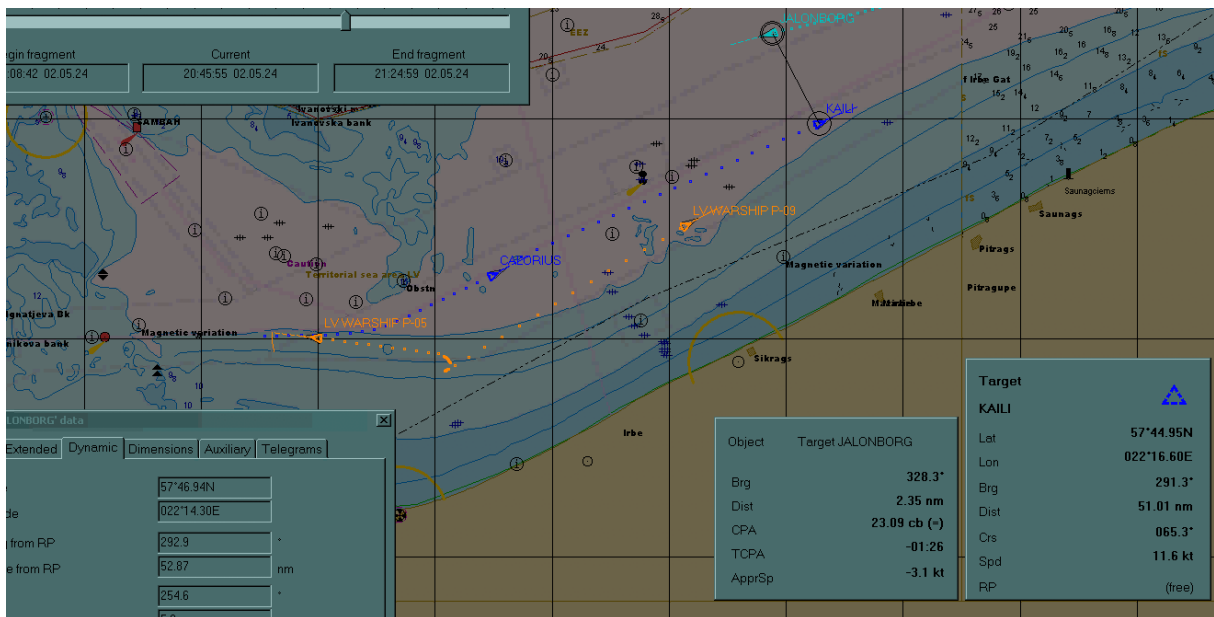
Image 4. Snapshot of AIS data on movement of KAILI in Irben straight at the moment of CPA (closest point of approach) to vessel JALONBORG

The analysis of the available AIS data, indicated that the only vessel passing in vicinity of KAILI was mv JALONBORG. The closest distance between the two vessels was 2.35 nautical miles, at 20.45. This time almost correlates with the bulkhead installation works on board KAILI and the approximate time of the accident. Therefore, the possibility of the wake from JALONBORG causing KAILI to roll slightly during bulkhead operation was not excluded.
