Transporta nelaiemes gadījumu un incidentu izmeklēšanas birojs

*Transport Accident and Incident Investigation Bureau of the Republic of Latvia*

## **FINAL REPORT No. 4-02/2-18(2-19)**

### **ON AIRCRAFT SERIOUS INCIDENT INVOLVING AIRCRAFT PIPER PA 28-140, REGISTRATION No. YL-JKV AT AERODROME SPILVE ON 5 JULY 2018**

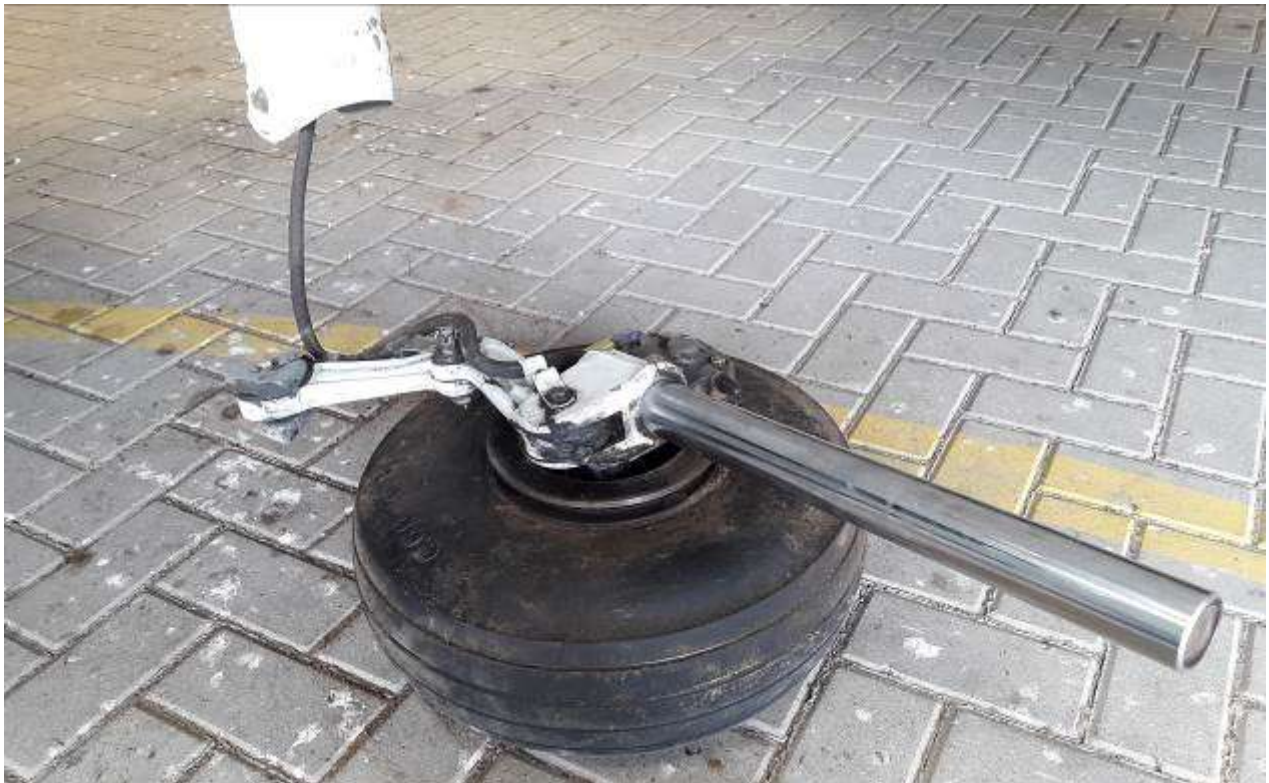
After successful emergency landing at aerodrome Ādaži, visual inspection of the right-hand landing gear strut and wheel was performed detecting that the wheel was holding on to the landing gear strut only by the brake system hose.

Figure 2. Right-hand landing gear strut

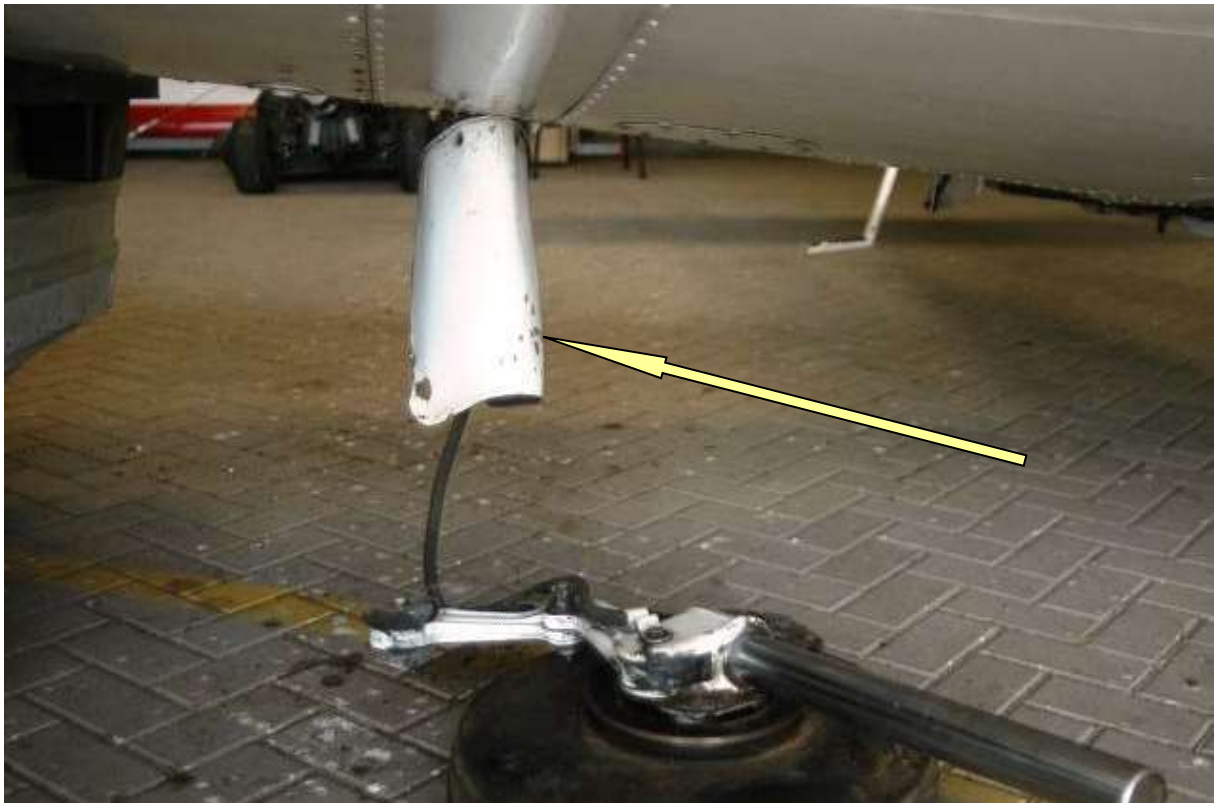
- protective shield of the right-hand landing gear has been bent forward;

Figure 3. Protective shield of the right-hand landing gear strut cylinder

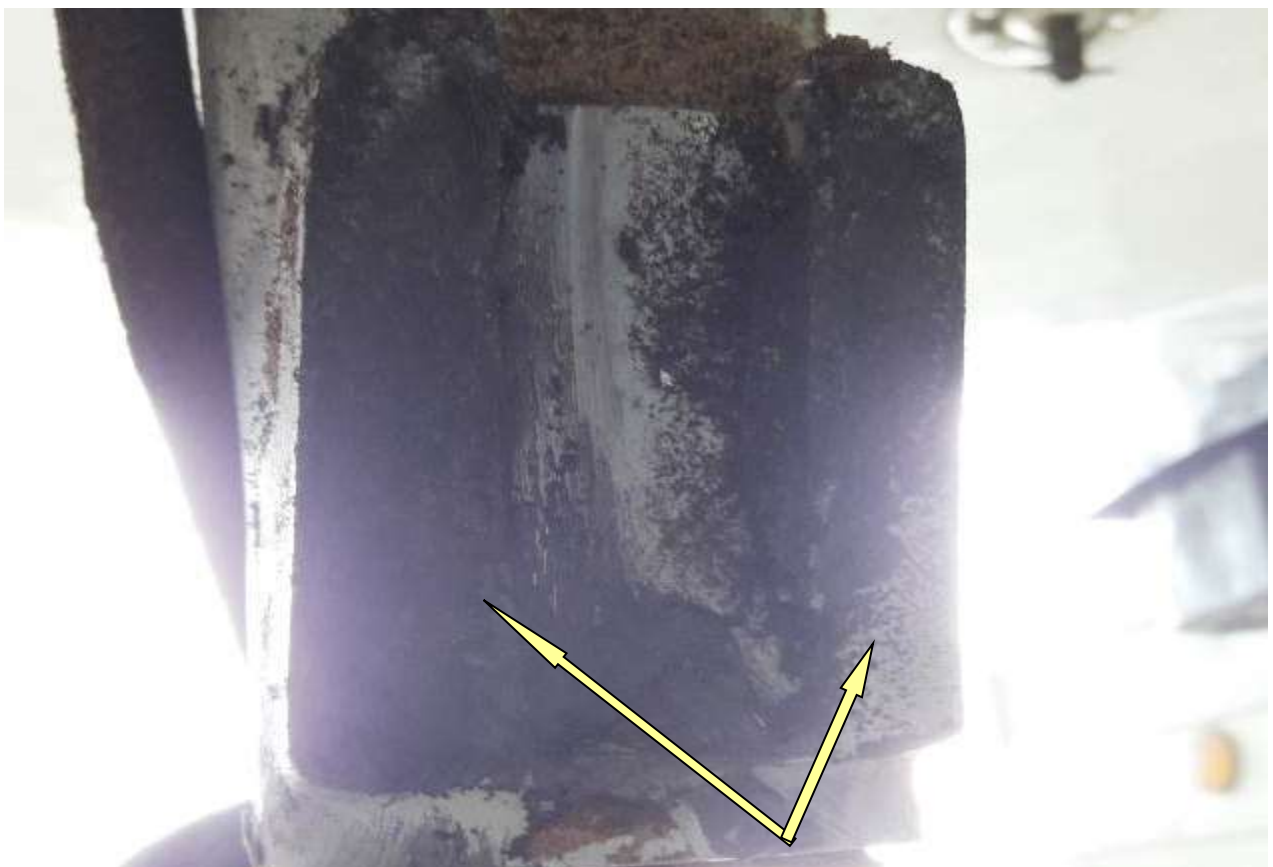
- torque link lugs (ear) at oleo cylinder of right-hand landing gear have been broken off;

Figure 4. Breaking points of the torque link lugs (ear) at oleo cylinder of right-side landing gear

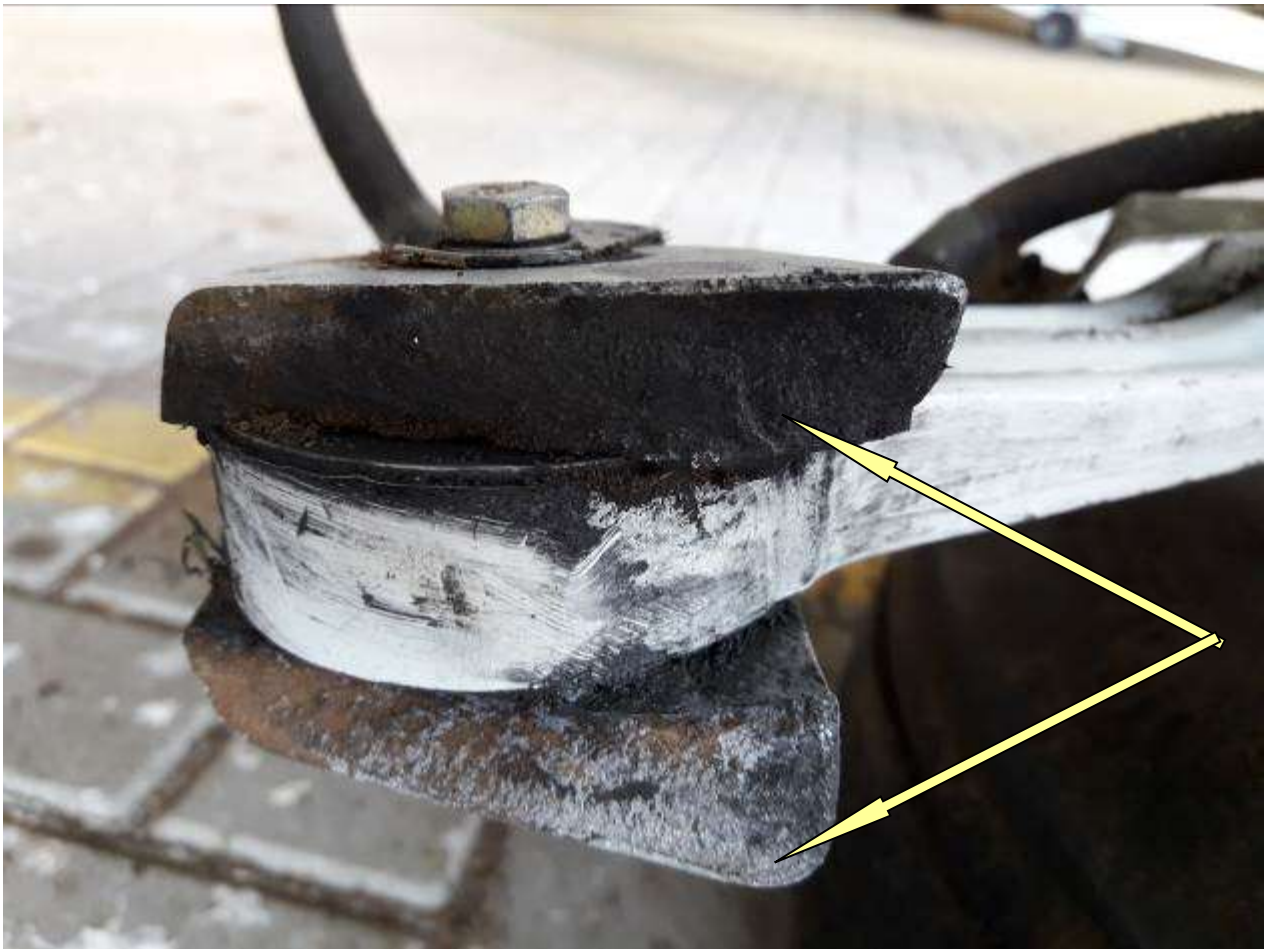
Figure 5. Broken-off torque link lugs (ear)

After dismantling of the right-hand landing gear strut of the aircraft its visual inspection was performed, checking in detail fractures in the right-hand landing gear strut lugs at strut housing; fatigue fractures of lugs were detected.

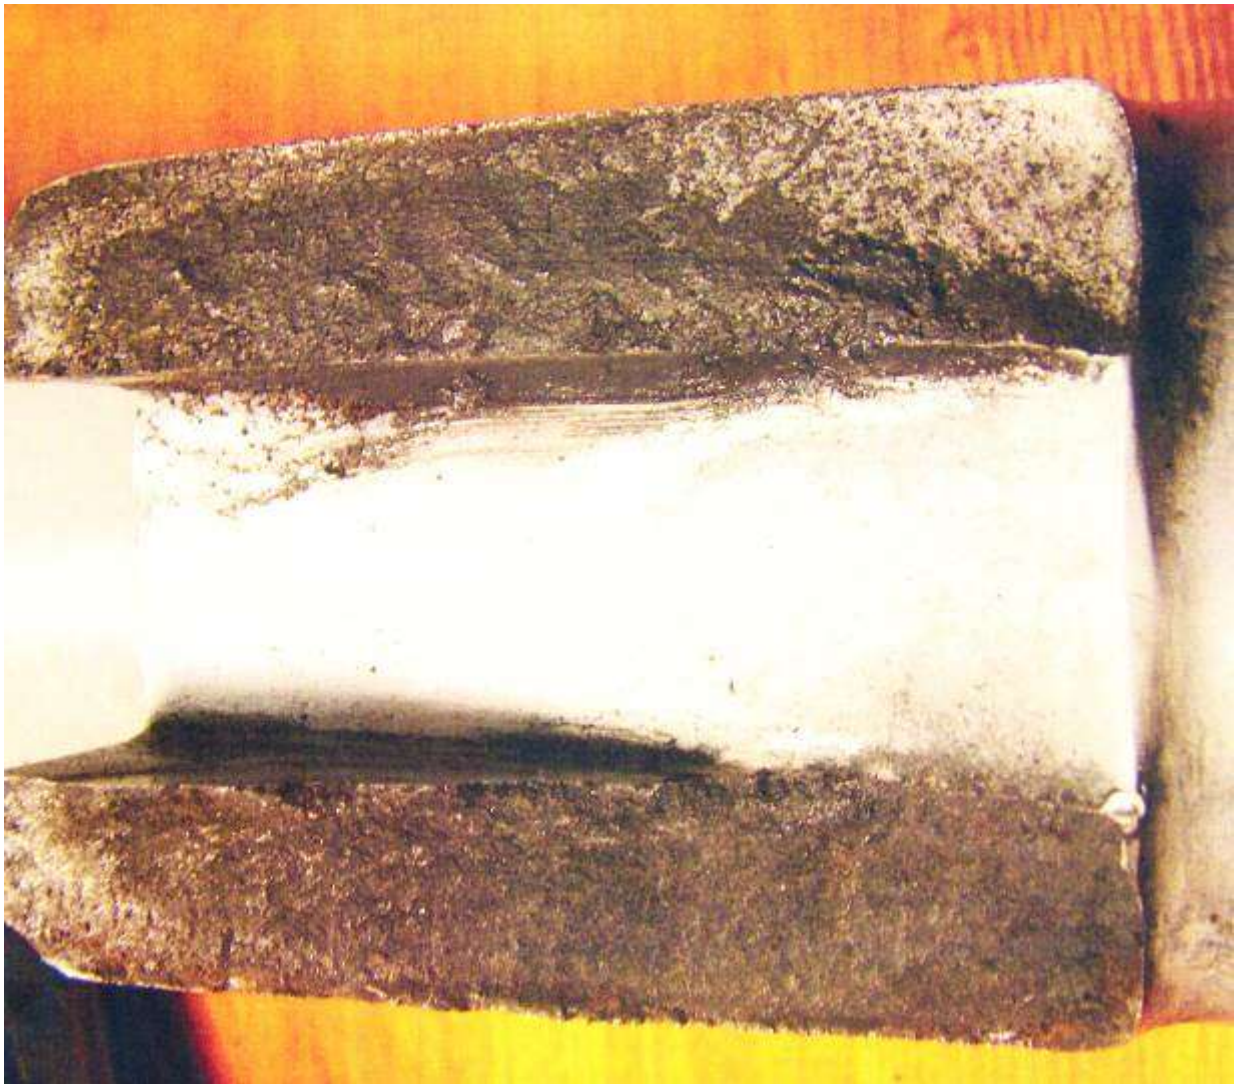
Figure 8. Fracture overview magnified twice

It was detected during technical analysis that the fracture of the landing gear strut had occurred upon the aircraft performing multiple takeoffs and landings during the period of use. The material of strut torque link lugs (ear) was obtained, using casting method in a metallic mould, therefore, fine-grained layer had formed in the upper layer. Analysis of the fracture surface shows that the fracture bears the nature of low-cycle fatigue having occurred due to varying loads during the use. It is visible in Figure 8 that the fracture had started in the lower part of torque link lugs. The surface of the fracture has adjusted and become lighter there. After a low-cycle (change in load) number the cross-section of the surface decreased and the load caused the ultimate fracture throughout the cross-section. Upon placing the broken-off torque link lug to the site of fracture, a crack was detected (Figure 9).

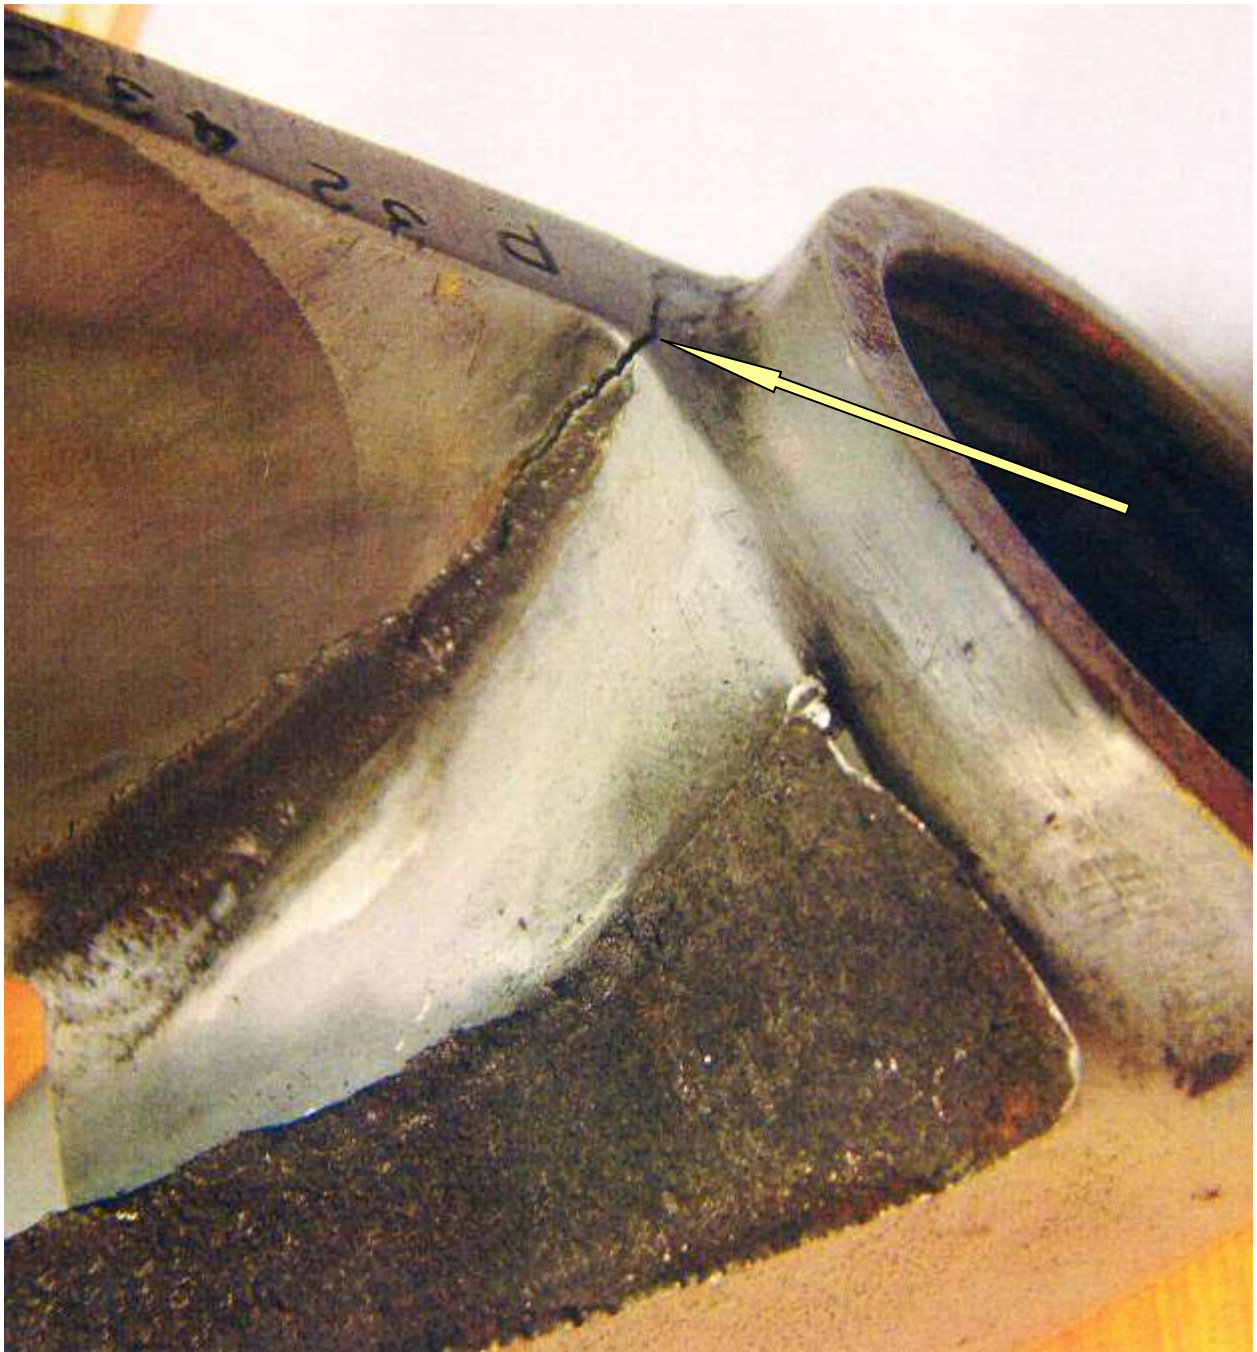
Figure 9.

The crack occurred during the use and was not noticed during recurrent inspections. The surface of the fracture is grainy in nature, the fine-grained layer of casting is visible on the external edge, forming a shiny surface of fracture which could be the initial cause for the fatigue fracture (Figure 10).

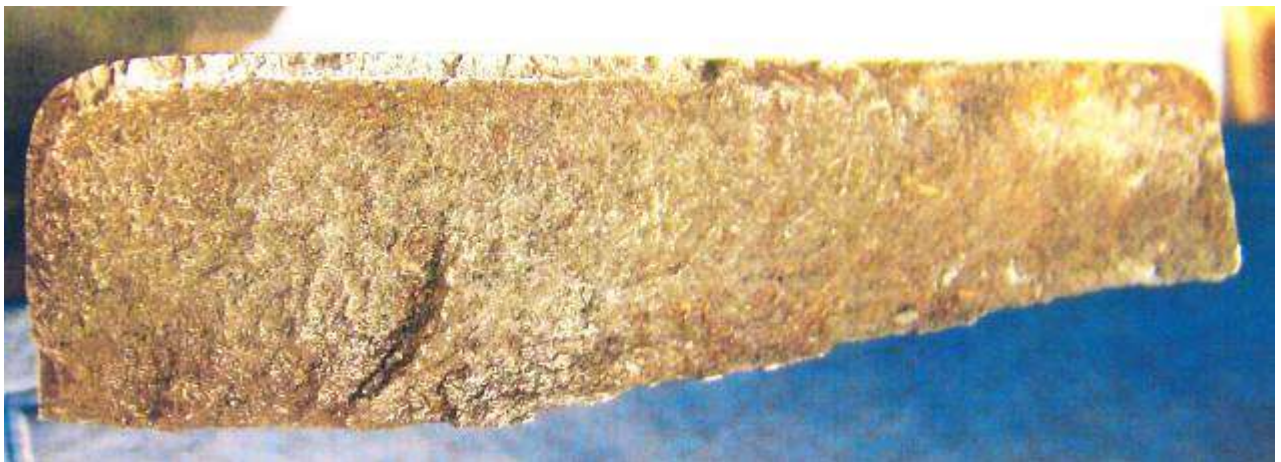
Figure 11.

After one side of the lug broke off the load on the other side increased, and due to the increased load it also broke off. The surface of the fracture (Figure 11) has the structure of grainy casting without the signs of plastic deformation. When the wheel of the landing gear hits the ground, compressive stress occurs in the upper part of the torque link lug, changing the nature of the fracture surface.

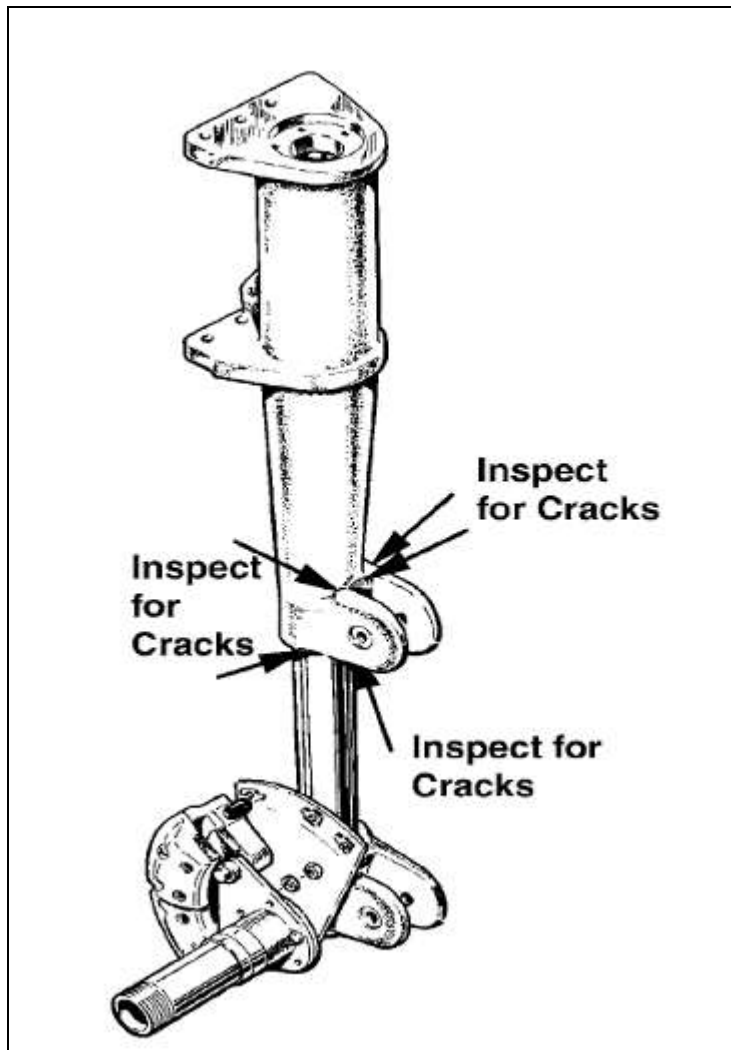
In accordance with the Service Bulletin No. 1131 torque link lugs on the “cast” main landing gear strut cylinders should be especially inspected for cracks and damages, using a 10X power magnifying glass and inspecting the top and bottom connections (Figure 12).

Figure 12. Technical maintenance scheme in accordance with SB 1131

If fractures or cracks were not found after visual inspection, the paint method must be used. If cracks are detected, the landing gear strut cylinder must be changed.

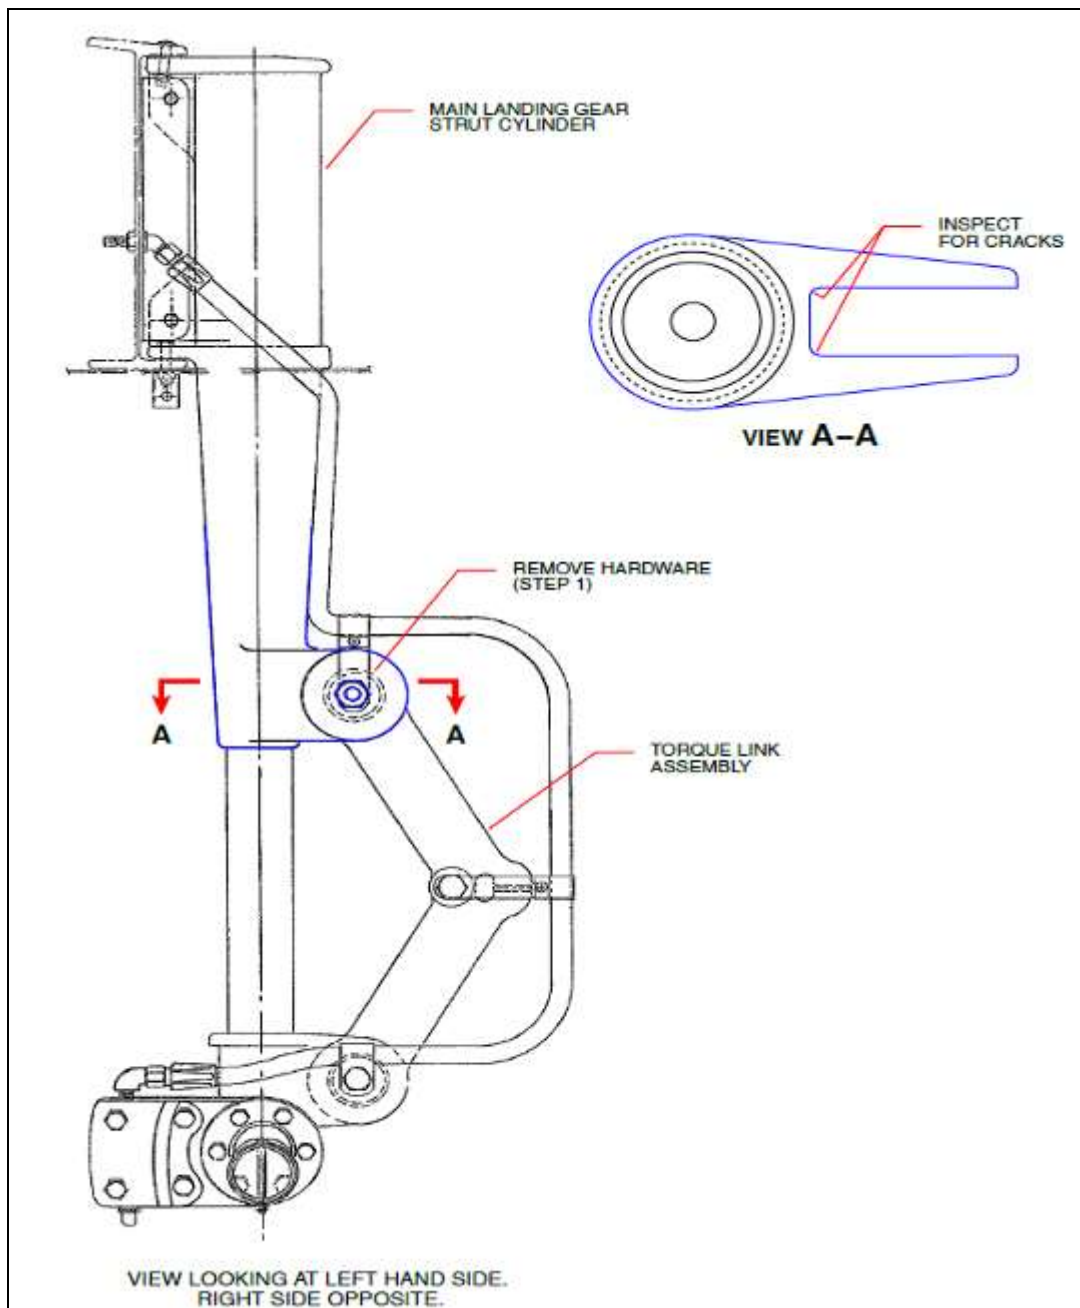
The Service Bulletin SB 1131A developed by the aircraft manufacturer Piper Aircraft Inc. supersedes the Bulletin SB 1131 in its entirety and must be introduced by operators from 18 January 2016. Paragraphs 1 and 6 of the Service Bulletin SB 1131A describe and illustrate the additional activities for maintenance (Figure 13) which allow the performance of inspection procedures of torque link lugs (ear) on the main landing gear strut cylinders of the aircraft Piper-28 from the inside after dismantling of the swivel joint of the strut.

Figure 13. Illustration of the Service Bulletin SB 1131A

Improve the maintenance procedure of the aircraft PA-28-140, registration No YL-JKV, with additional activities in accordance with the Service Bulletin **SB 1131A** of the aircraft manufacturer Piper Aircraft Inc.

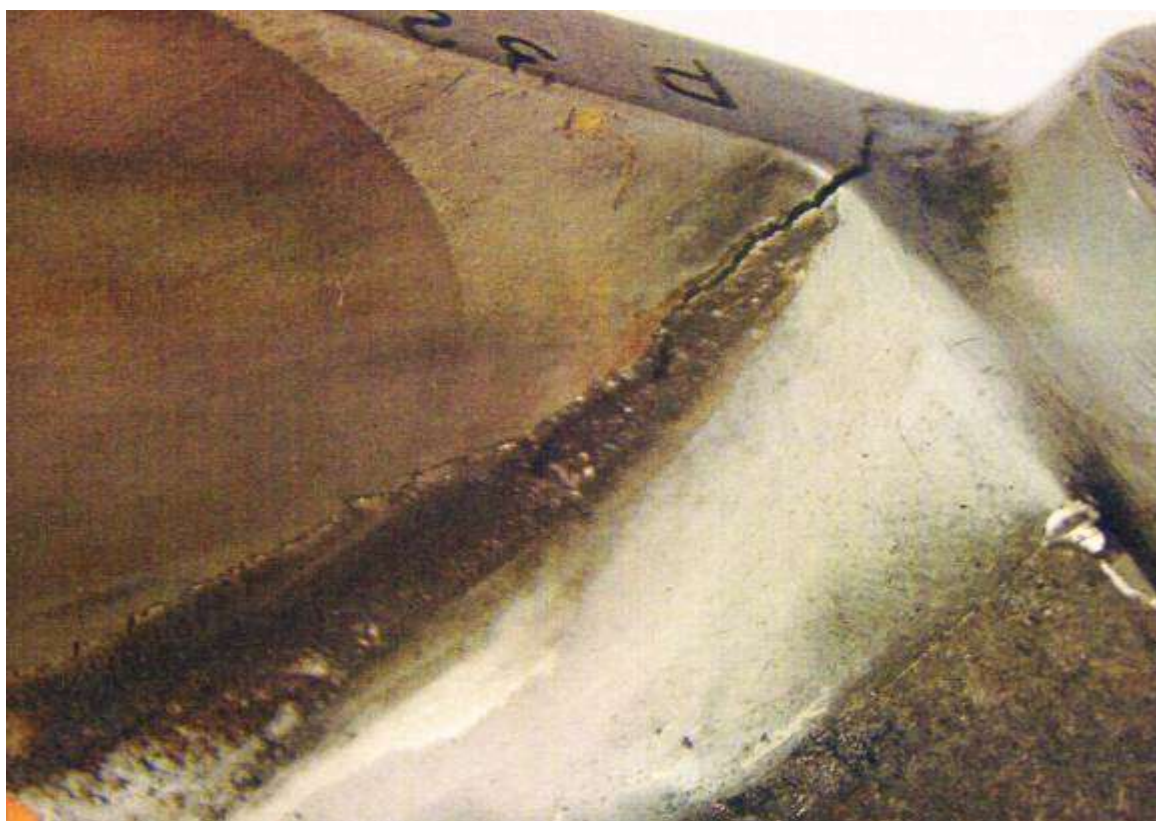
Figure 14.

Fatigue fracture in the “cast” landing gear strut cylinder started in the lower part of torque link lugs (ear) of the swivel joint where a micro-crack had emerged during the use, later transforming into a fatigue fracture. According to the detected signs of formation of a crack it is possible that the site of occurrence of the fracture was inside the torque link lugs (ear) (Figure 14).

Therefore it is possible that the technician could not have noticed the micro-crack in the “cast” cylinder without dismantling of the swivel joint during the aircraft maintenance (as provided for in the Service Bulletin SB1131A developed by the aircraft manufacturer in 2016) and had not actually noticed it.
