SAFETY INVESTIGATION REPORT

REPORT NO.: 15/2017

MT *GIANNUTRI* **Crew member fatality following a fall into an empty cargo oil tank at a shipyard in Riga, Latvia** **21 June 2016**

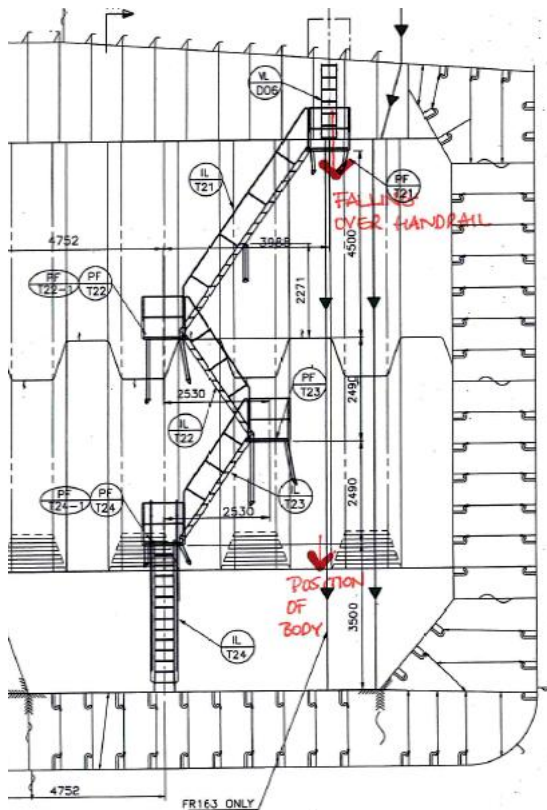
By now, heavy rain was pouring. Rather than making their way to COT no. 2 port, the OS and the 1200 - 1600 AB proceeded to take shelter in the starboard deck store, forward of the manifold. After a few minutes, at approximately 1603, with the rain having subsided slightly, the OS quickly made his way across the deck towards COT no. 2 port and hurriedly disappeared down, behind the tank coaming (Figure 1).

Figure 1: Transverse section and access to the COT

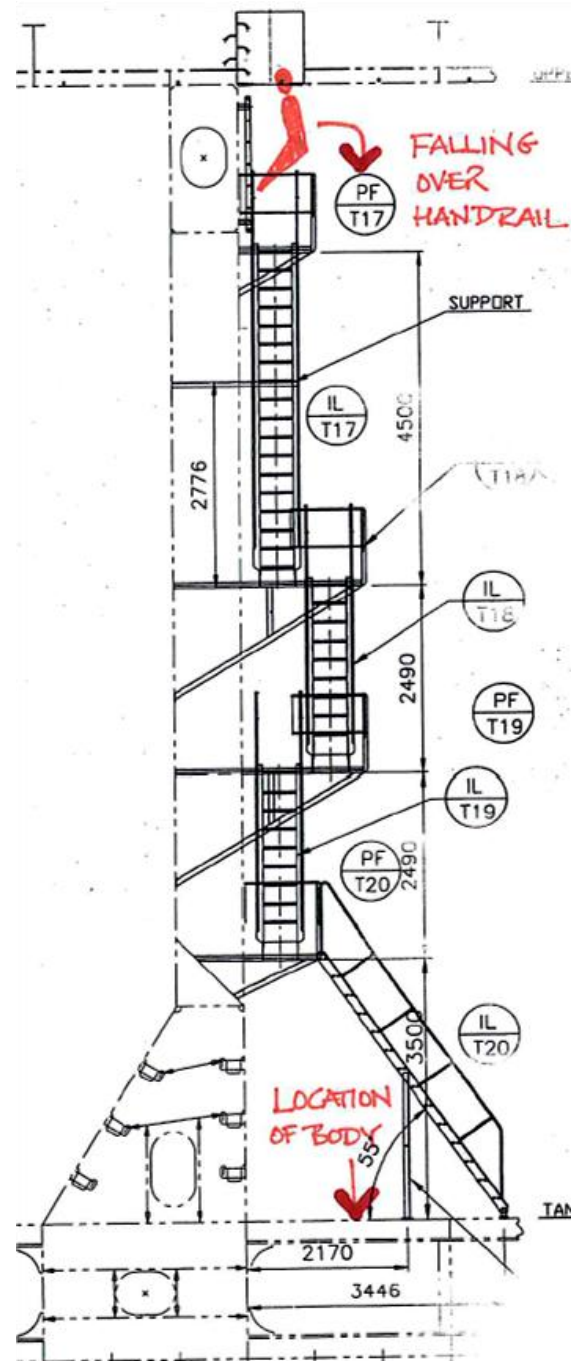
The AB followed the OS just a few moments later. By the time he looked down the coaming, he could just make out what appeared to be the OS falling over the handrail (Figure 2).

Figure 2: Sketch of the accident

Indeed, the OS had fallen from a height of about 14 m, down to the bottom of COT no. 2 port. The AB raised the alarm, and while one of the painters exited the COT

- Toolbox meetings are to be attended by senior ranks and personnel / crew members assigned to carry out the actual work;
- Forecast changes in the conditions which affect risk, need to be addressed during toolbox meetings.

15/2017_R1 carry out regular observations on board as part of their proactive safety management in order to analyse, understand and address how crew members carry out tasks on board.
