Final Report RS 2014:01e

Serious accident at sea on 15 October 2012 involving the vessel Liva Greta at Nockeby Bridge in the County of Stockholm, Sweden.

Diary No: S-165/12
2014-03-12

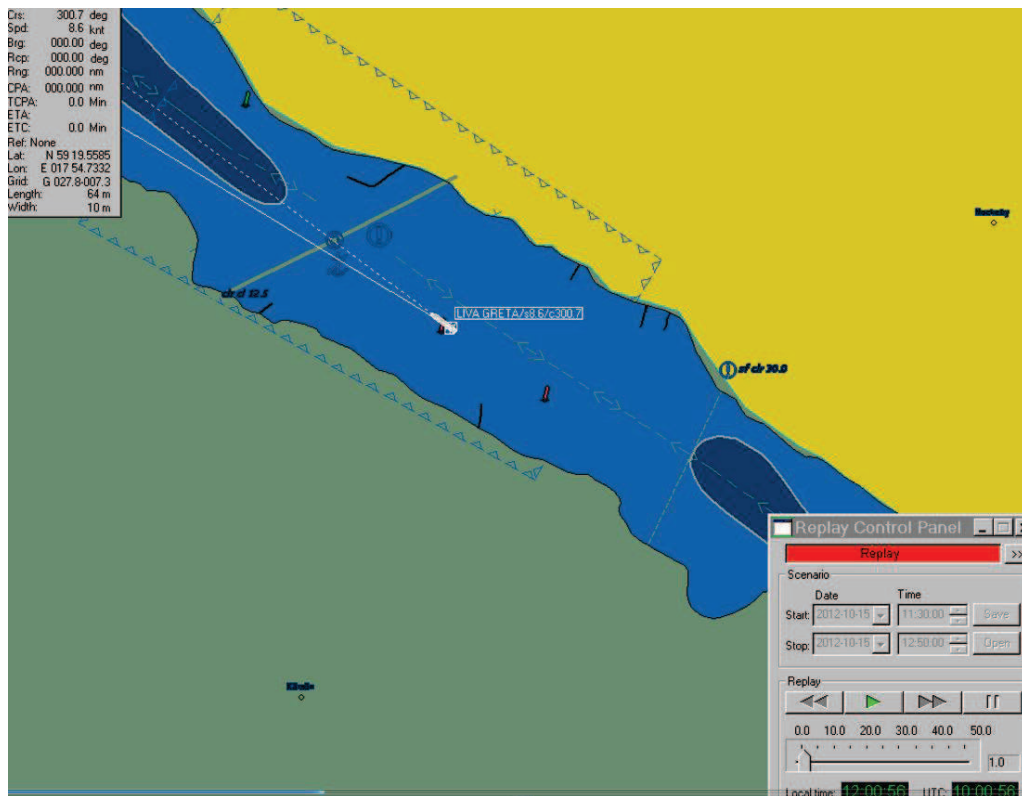
Fig. 3. AIS recorded when passing the second red spar buoy.
 © Sjöfartsverket No: 10-01518.

A general speed limit of 5 knots begins to apply at a distance of some 4 cable lengths (about 750 m) from the bridge. M/S Liva Greta held a steady course of 301° and a speed of 8.6 knots until the second buoy had been passed about 1 cable length from the bridge, when the vessel began to reduce speed and change course to starboard (see Fig 3).

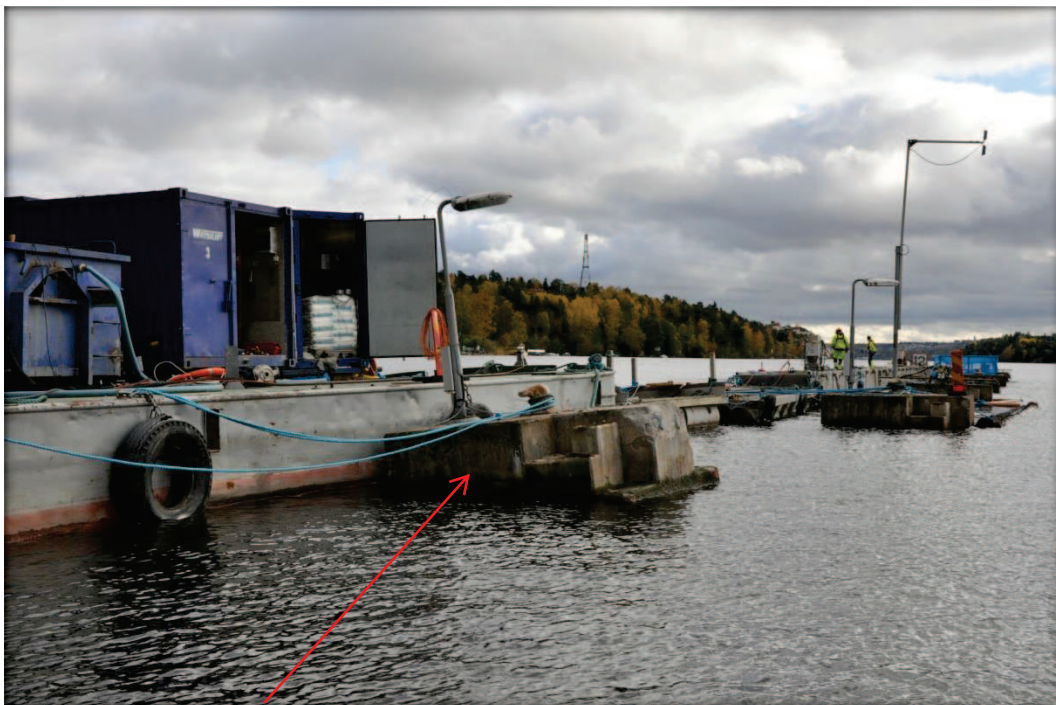
Fig. 4. Fouled dolphin, which was shifted approximately 1.5 m out of position.

Damage to two dolphins, one of which had to be replaced by a new structure, whereas the other one was only cracked and could be repaired.

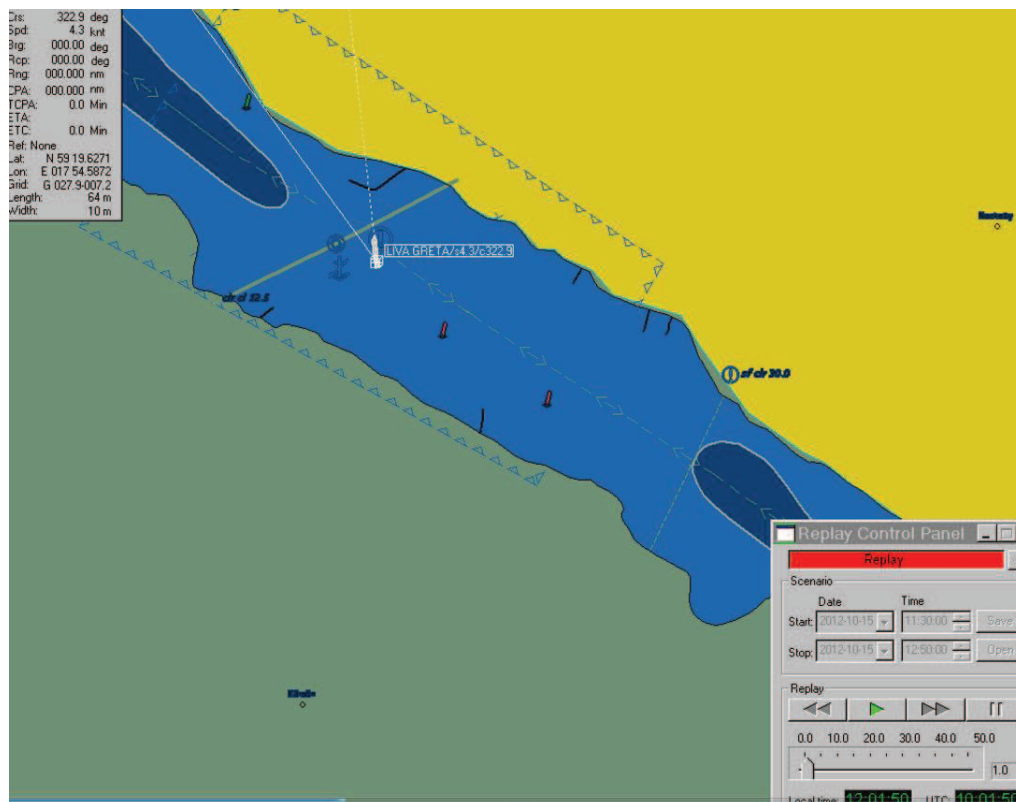
The vessel continued to reduce speed and change course to starboard until the collision occurred. The stern of the vessel collided first with a dolphin on one side of the channel, after which she continued over to the other side of the channel where she collided bow-on with another dolphin (see Fig. 4). The speed of the vessel at the time of the collision was just over 4 knots, which meant that it was a serious collision (see Fig. 5).

Fig. 5. AIS recording at the time of the collision.

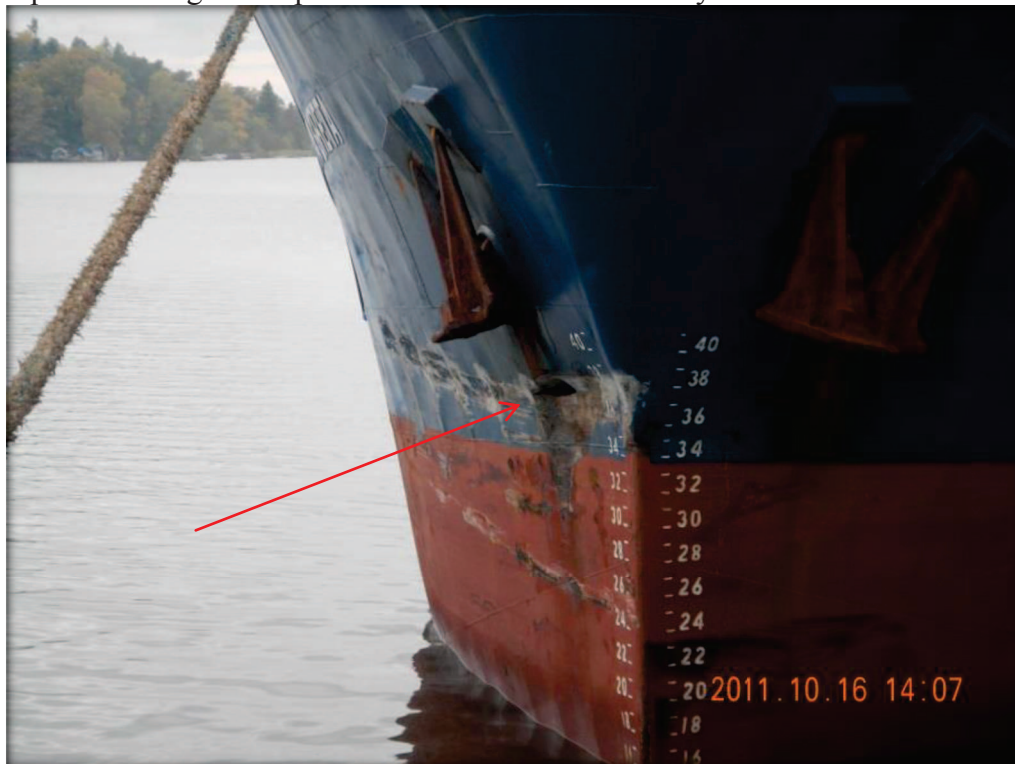
The damage to the vessel was limited to a hole in the forepeak above the water line immediately beneath the starboard anchor (see Fig. 6). The damage was repaired during the stopover at the harbour in Hässelby.

Fig. 6. Damage to the Liva Greta.

When the required turning speed was not obtained, the engine were thrown into full astern in order to avoid colliding with the dolphin bow on. In similar situations, when the engine is running full astern, the turn is accelerated and takes place in a partially uncontrolled manner – in this case to starboard owing to the direction of propeller rotation. In this case, the stern section turned and collided with the southern dolphin, which caused cracking in the dolphin structure. After this, the vessel continued towards the northern dolphin where the starboard bow hit the dolphin and the vessel was holed just below the starboard anchor.

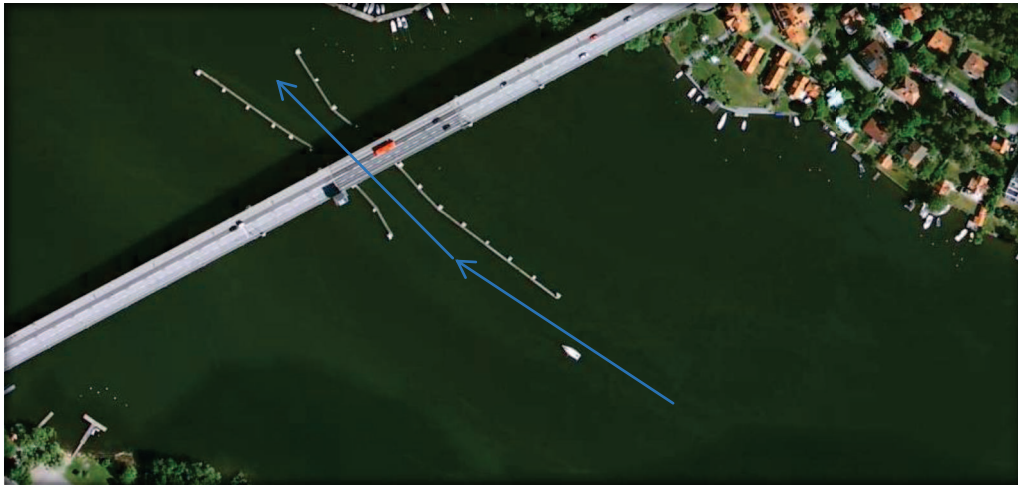
On those occasions when, for example, an adjustment in course needs to be made before entering a narrow section of channel, such as under a bridge, where the fairway and the bridge crossing require different courses, it is an advantage if the vessel has finished turning and is on a steady course in as good time as possible before the beginning of the narrow section. This technique can be referred to as “opening the bridge hole” (see Fig. 7).

Fig.7. Nockeby Bridge viewed from above. The arrows on the photo illustrate the required change in course for the purpose of “opening the bridge hole” and thereby acquiring the largest width of channel or fairway for the vessel as it crosses under the bridge. Photo: © Lantmäteriet Diary No. R61749_130002.
