TRANSPORT ACCIDENT AND INCIDENT INVESTIGATION BUREAU

FINAL REPORT Nr.5/2012(3-2014)

**of HELICOPTER MD 369E, REGISTRATION OH-HJR ON JULY 12,
2012 AT KASTIRE**

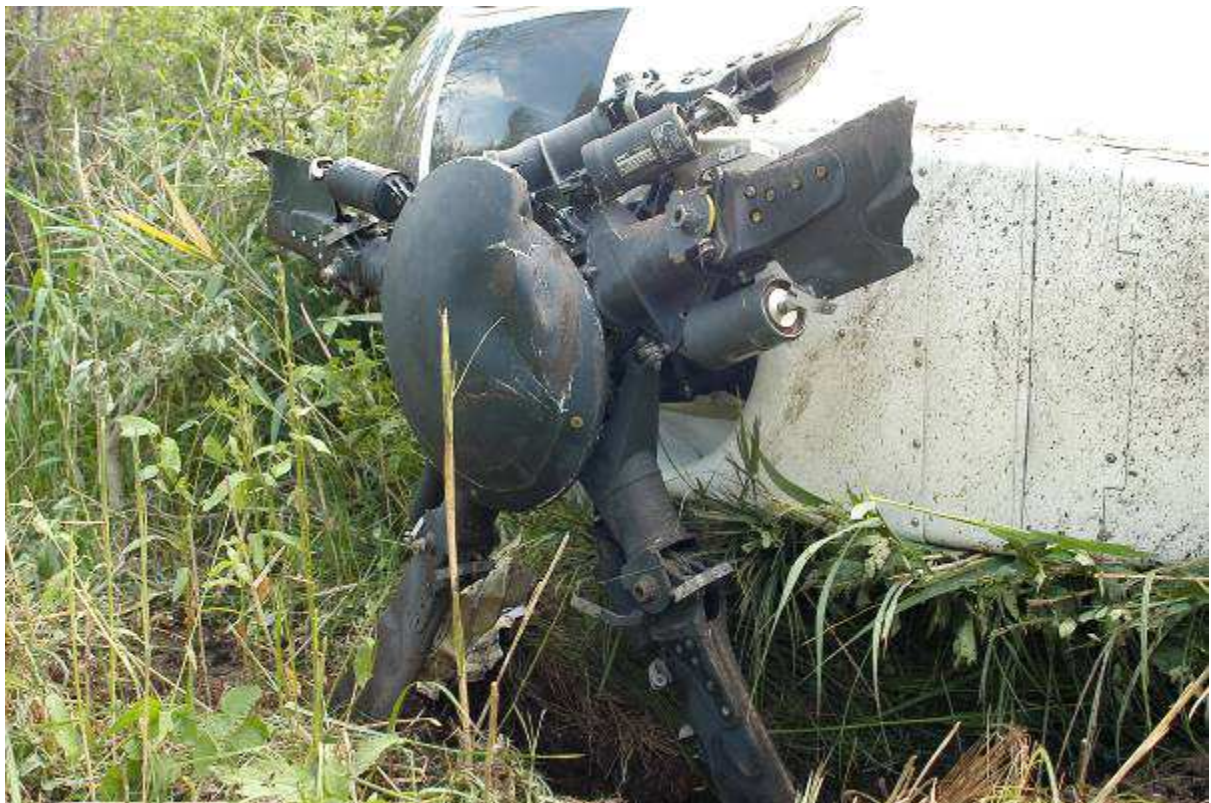
Figure 4

- left side landing skid front strut and rear strut broken;

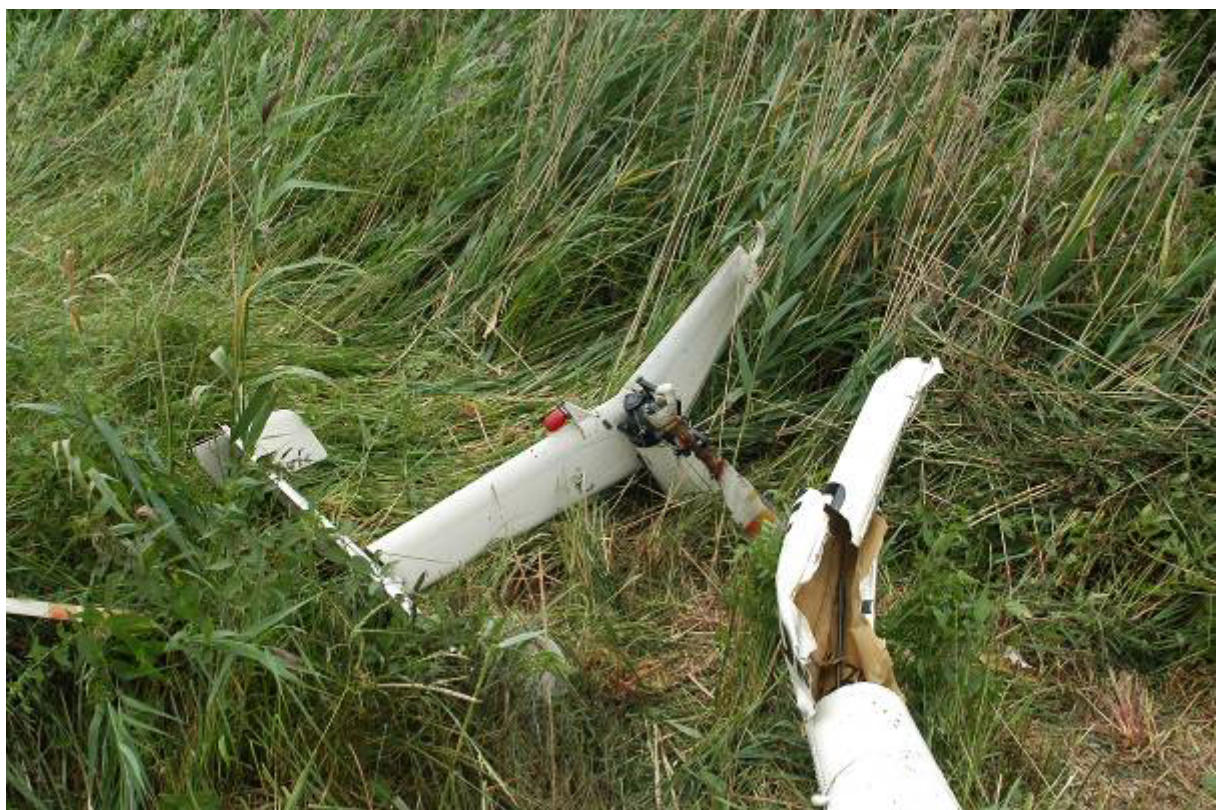
- tail boom broke in two - synchronized elevator, vertical stabilizer and transmissions separated from tail boom, tail rotor drive shaft teared (**Figure 5**);

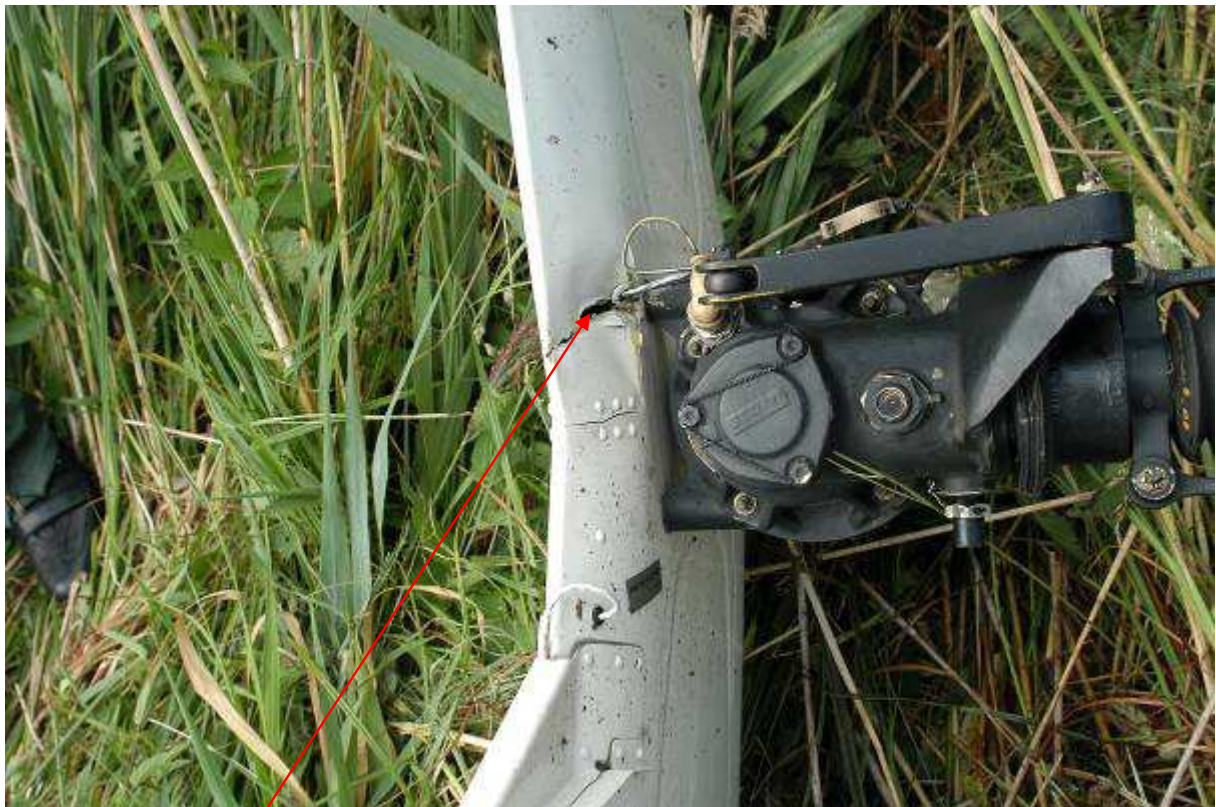
- vertical stabilizer broke (**Figure 7**);
- different failed components were thrown from the helicopter;

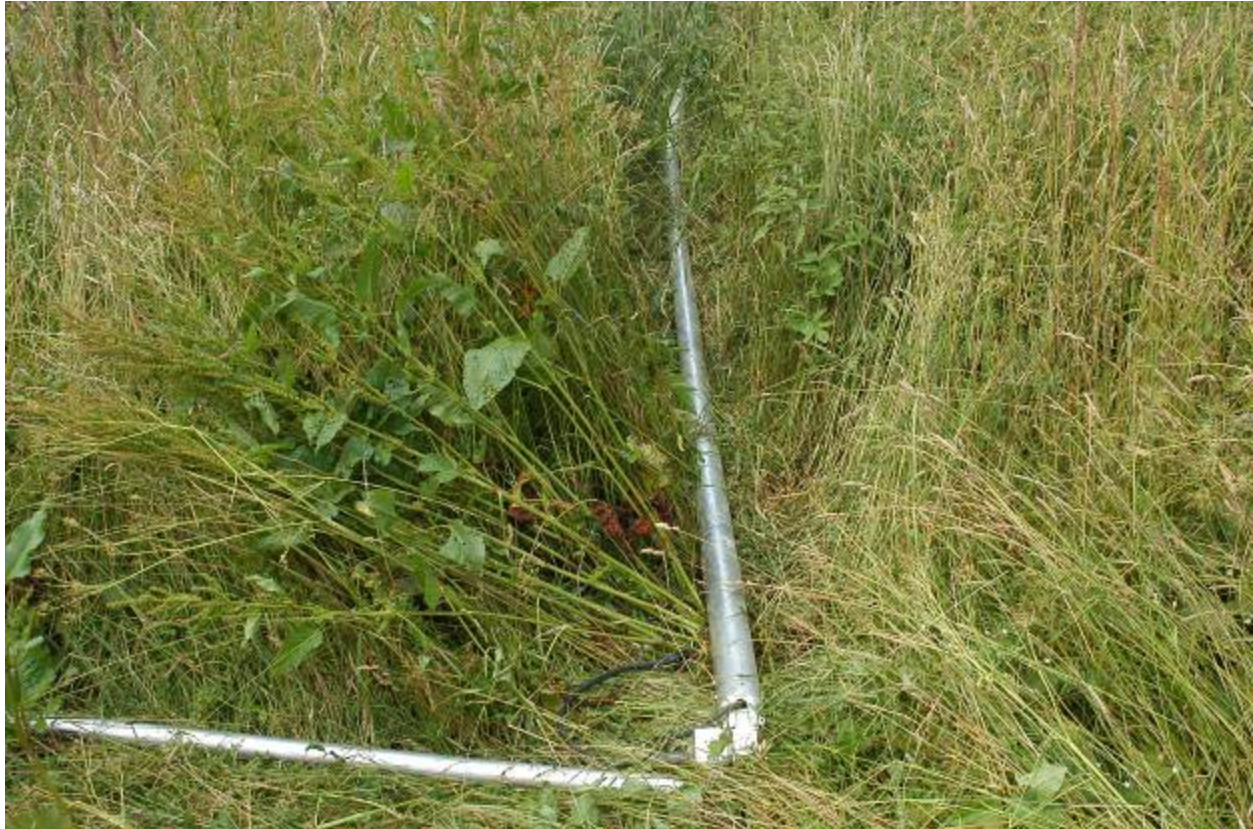
Figure 14. The dropped saw

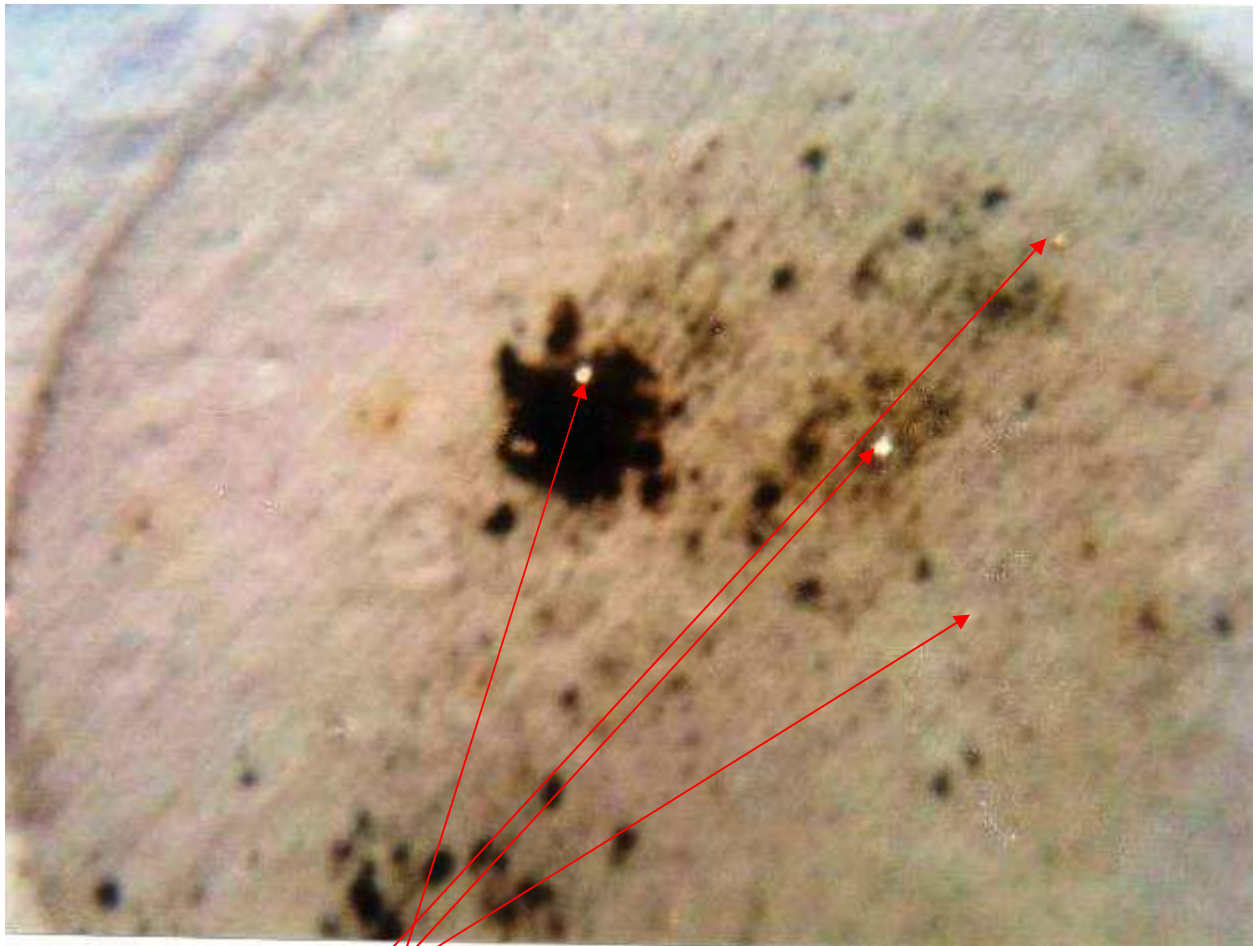
- The engine oil has high content of metals –Fe and Al;
- On both filter elements (rough and fine) are metallic chips – ferromagnetic and nonmagnetic that could witness about engine bearings or other mechanical component failure;
- Oil filter not damaged and is in good working condition.

Figure 18. Microscope image of metallic chips

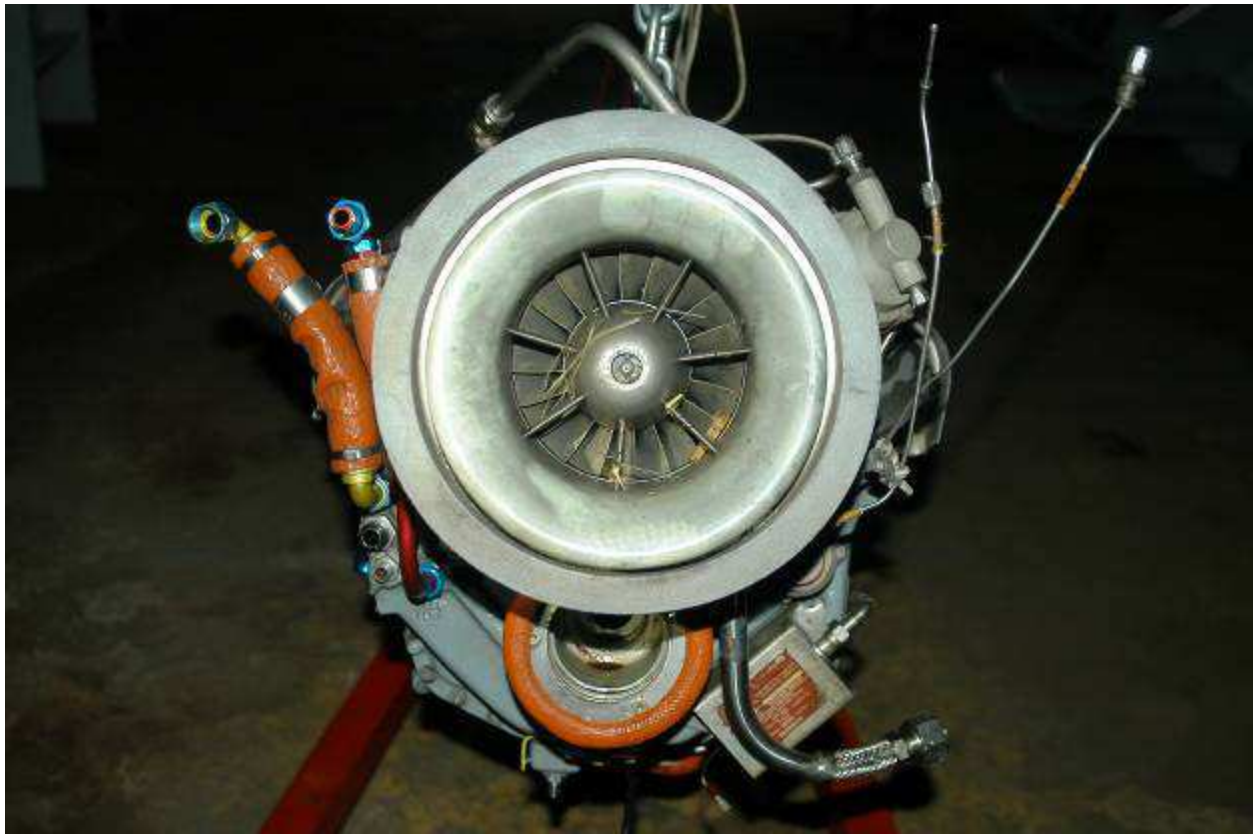
Figure 21 Compressor section

In intake of compressor section were some debris noted as well as traces of oil leakage.

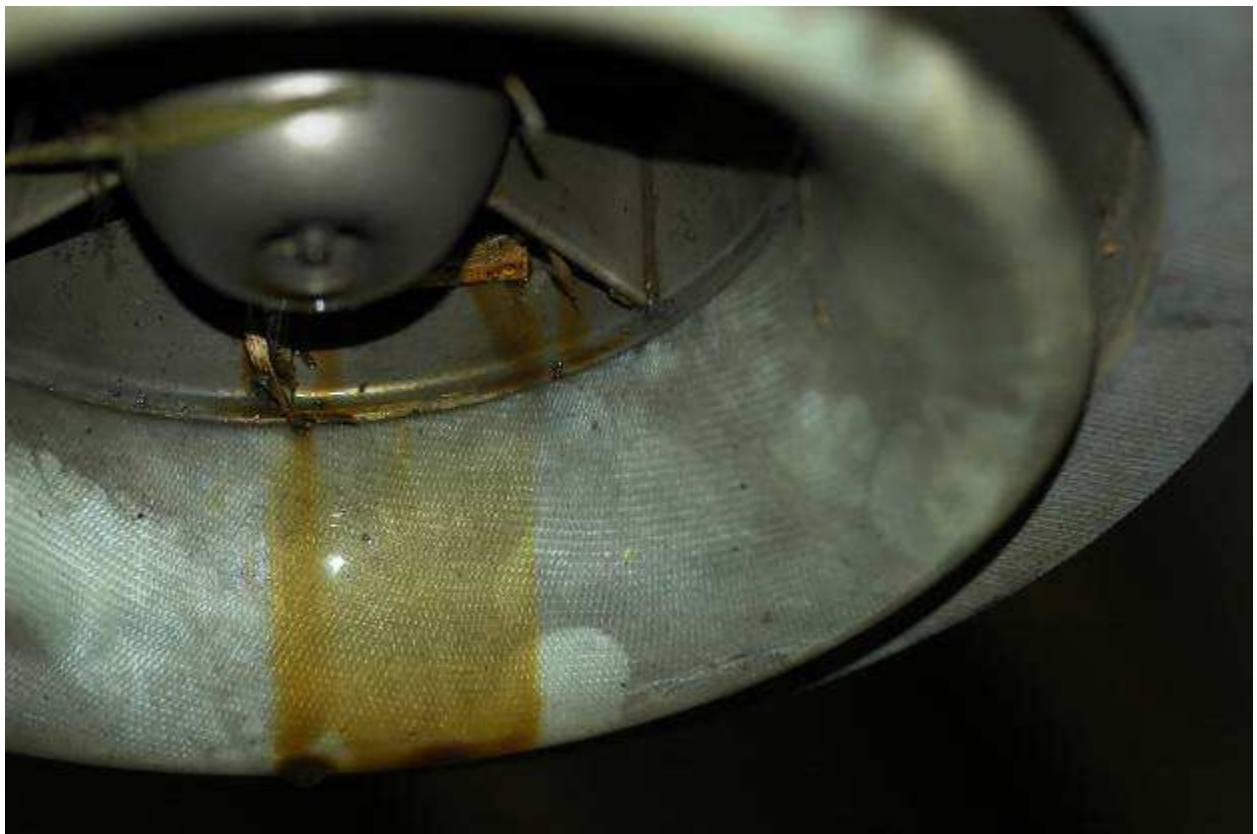
Figure 21. Traces of oil leakage

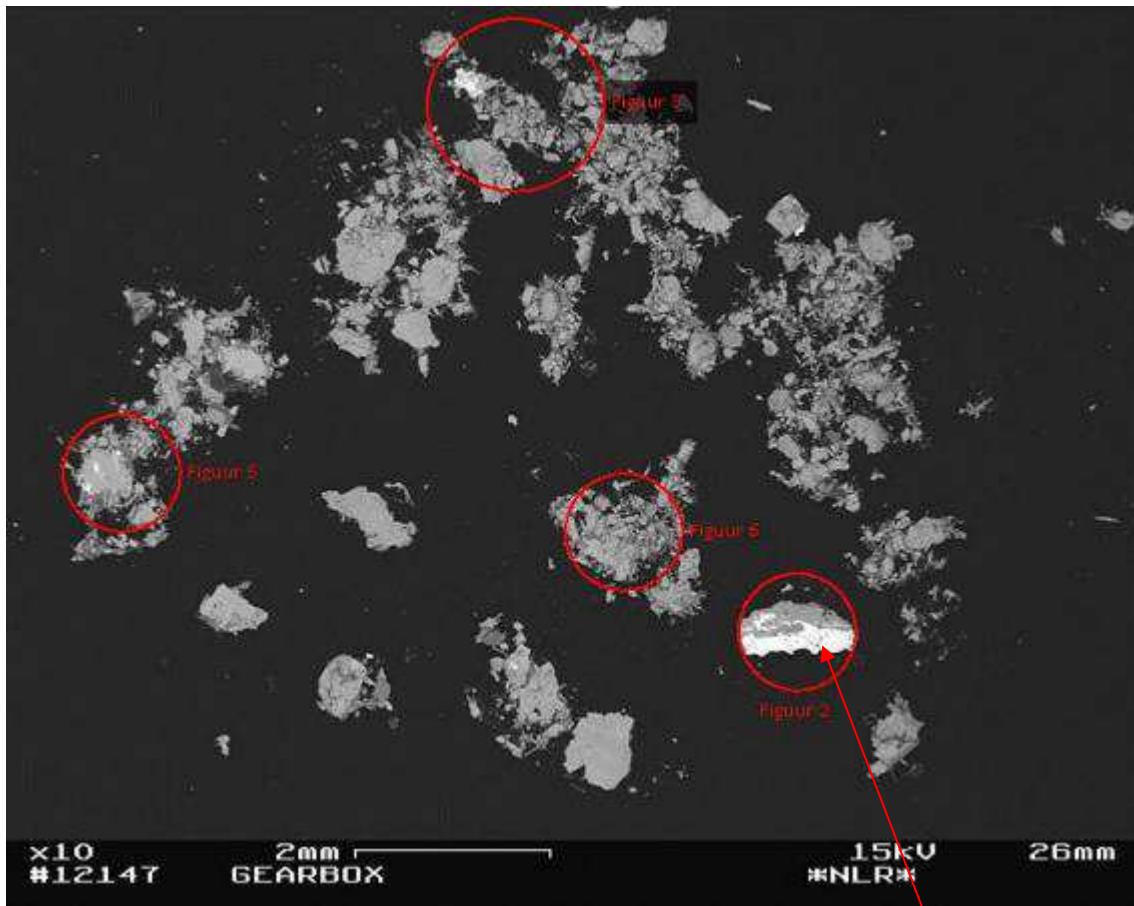
Figure29. Overview of the particles found on the Upper chip detector (after cleaning)

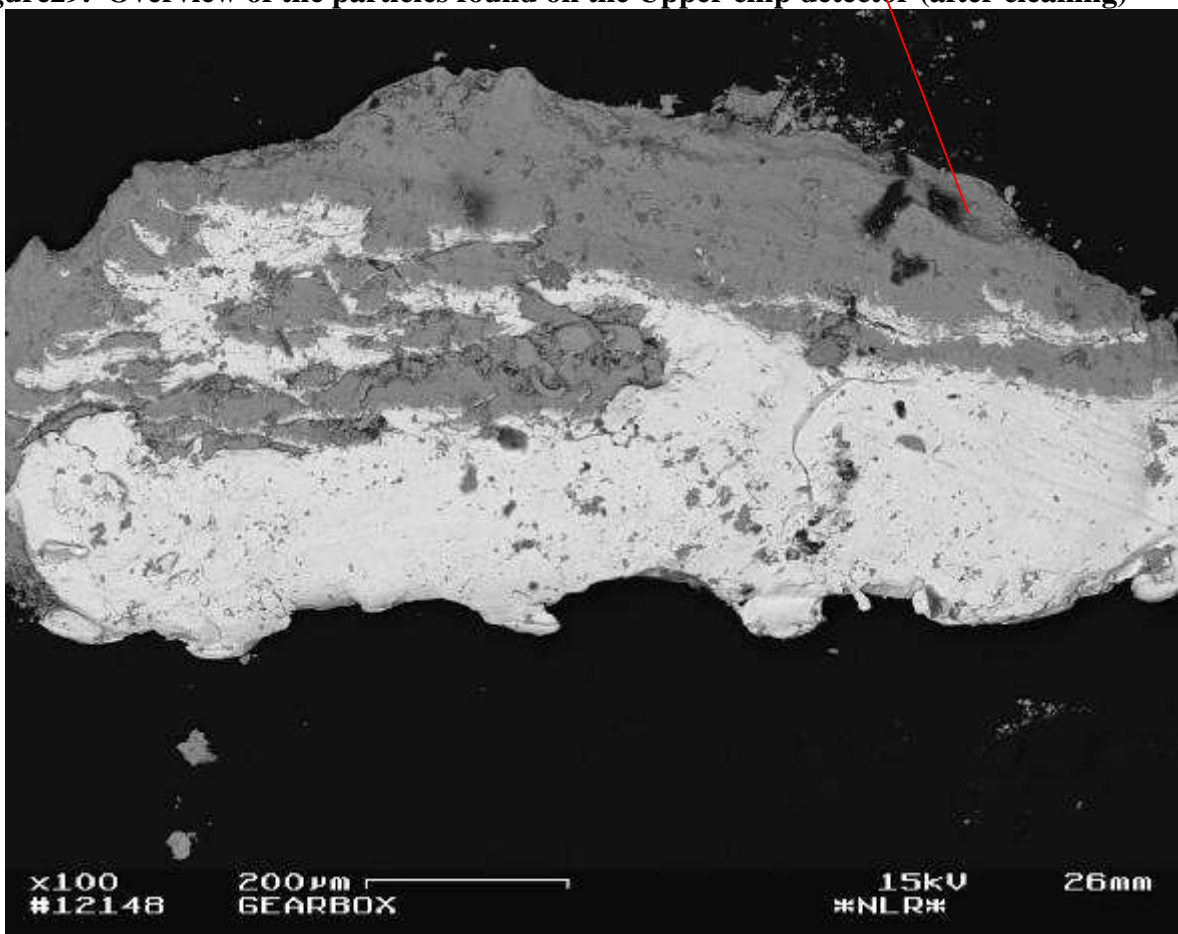
Figure 30. Image higher magnification. The white material is 100 % silver

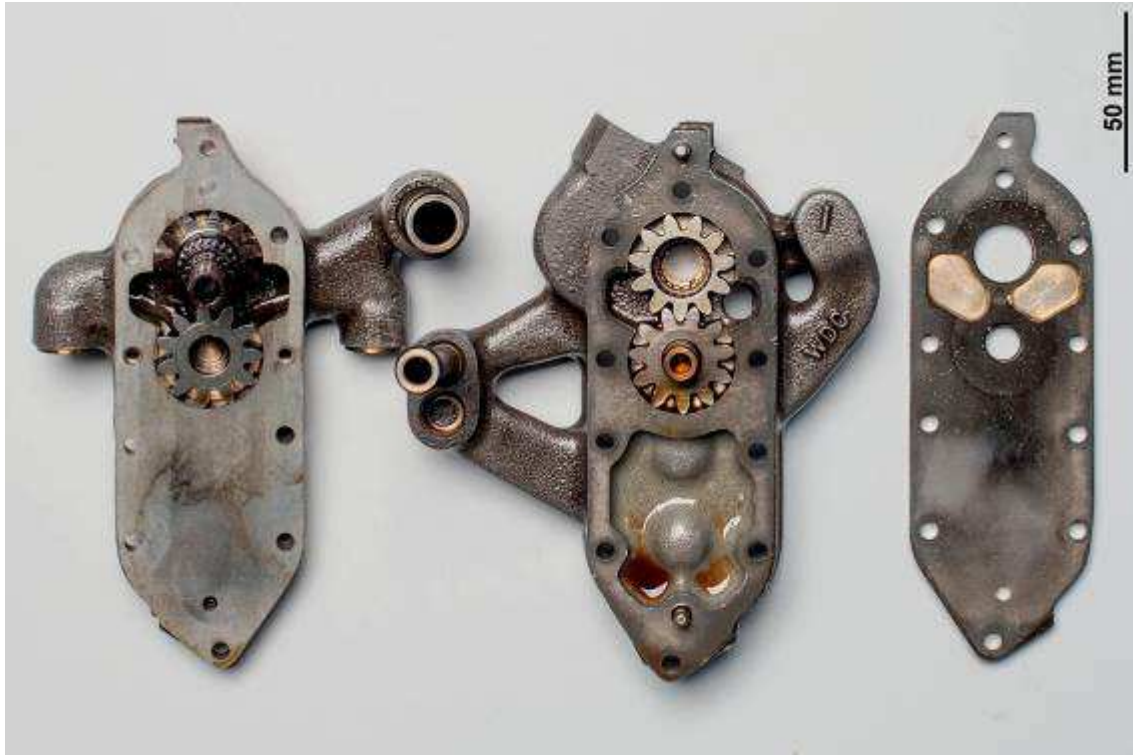
Figure 34. Gearbox oil pump (disassembled) and cogwheels

The gearbox oil pump was disassembled and there not found any metal particles or damage to the teeth of the cogwheels of the oil pump.

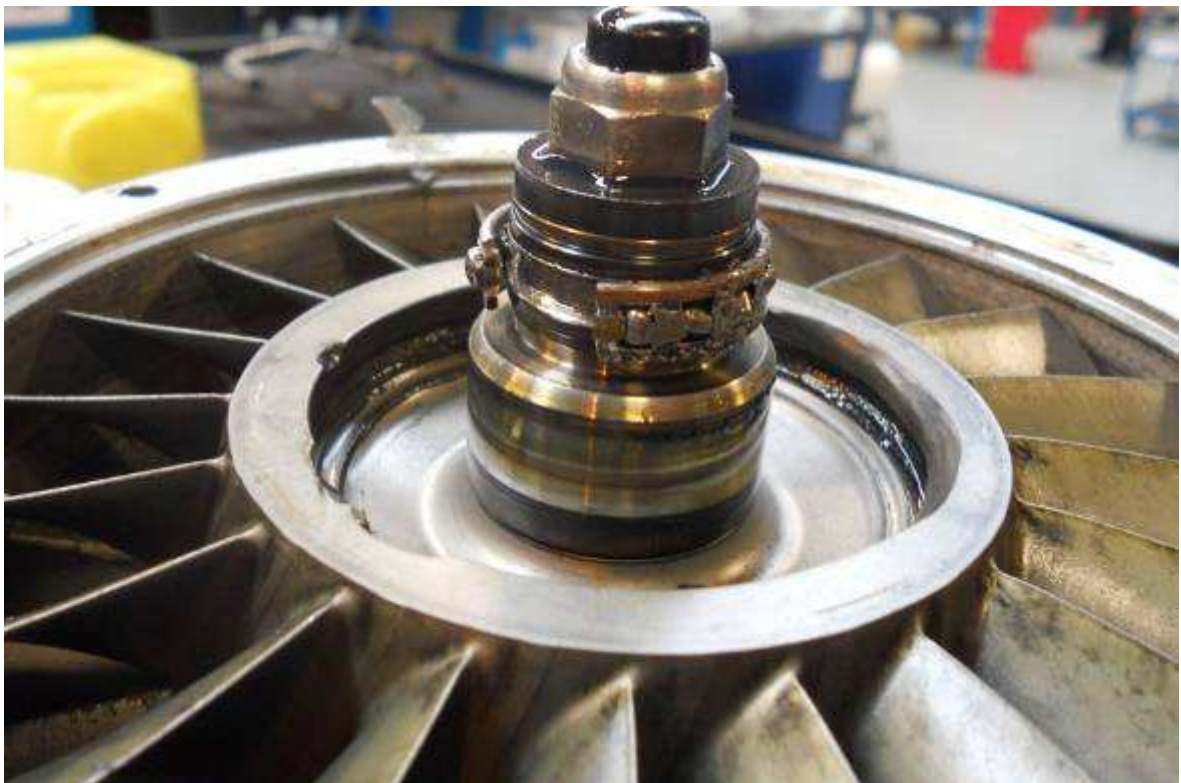
- When front support was removed No1 bearing found damaged;(Figure)
- With all contents of the front support still intact (front housing, bearing outer race and carbon seal) an air supply was attached to the oil feed to check if clear. The air flow was good with no debris exiting the feed;

Figure 35. Damaged No1 bearing.

The bearing was found during inspection was found that a three (3) roller wide section of the separator was fractured. The remaining section was intact but showed damage from roller contact inside the individual pockets (windows). The damage was predominately to the top and bottom of the pockets but was also noted to the sides. The majority of the rollers retained within the remaining section of separator show signs of size reduction, flattening and end wear.

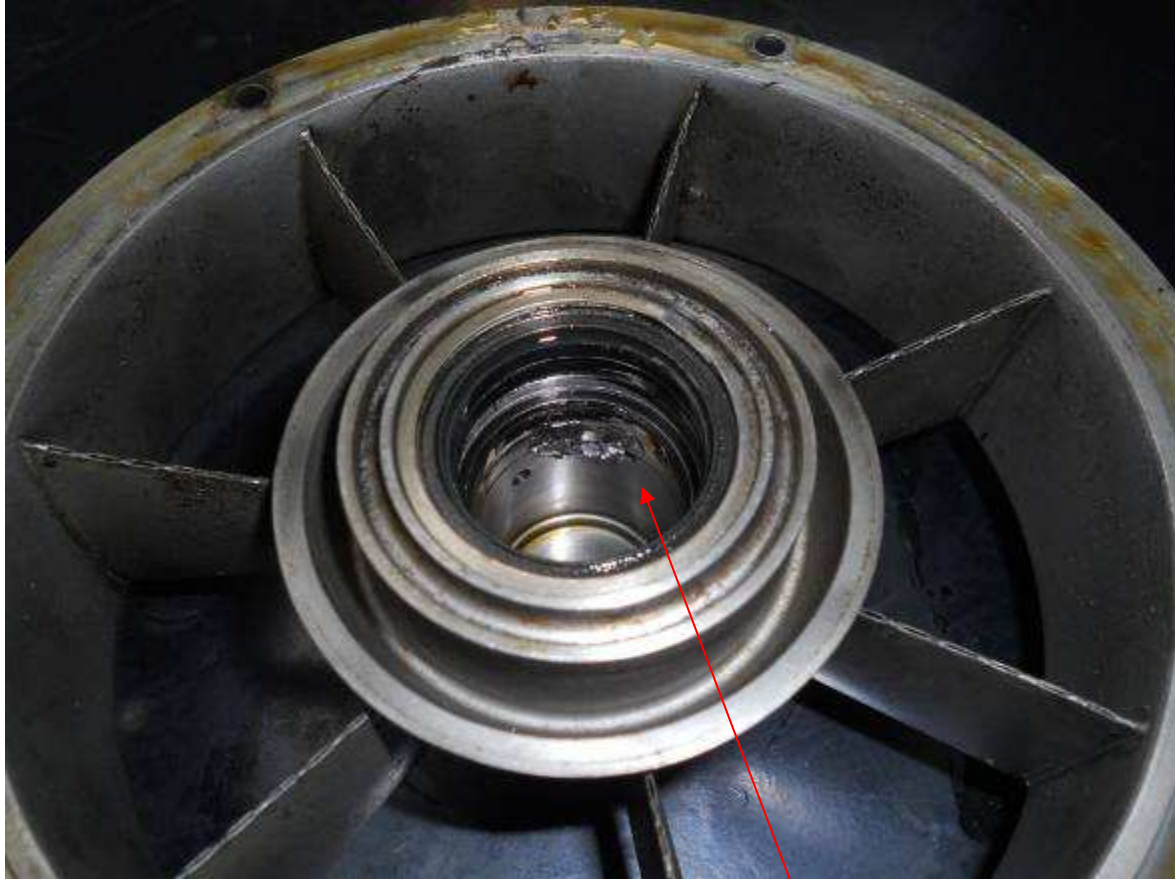
Figure 36

Two (2) of the remaining three (3) rollers were found inside the housing as was a localized area of debris which was believed to be missing separator and/or roller material. This material was wiped with a clean paper towel and placed in a bag. The aft end (shoulder) of the bearing journal shows impact 360 degrees;

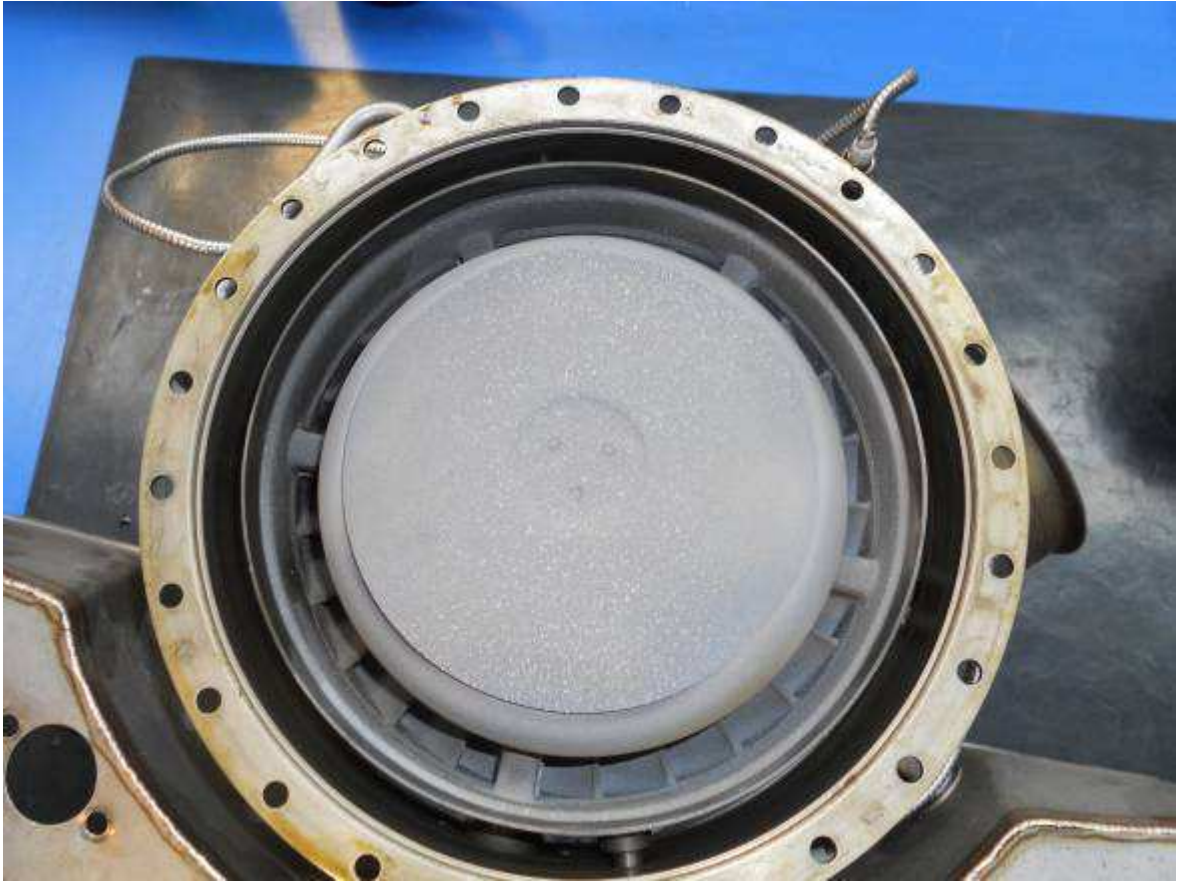
- Rotation was checked, both rotors found to rotate satisfactory;
- The first stage turbine nozzle shield and flow path shows heavy concentration of diffused material covering the shield OD as well as the pressure side of the first stage nozzle and downstream components; (Figure)
- Turbine disassembled to remove both rotors to view, further deposits found throughout the gas path;

Figure 37 The first stage turbine nozzle shield and flow path shows heavy concentration of diffused material

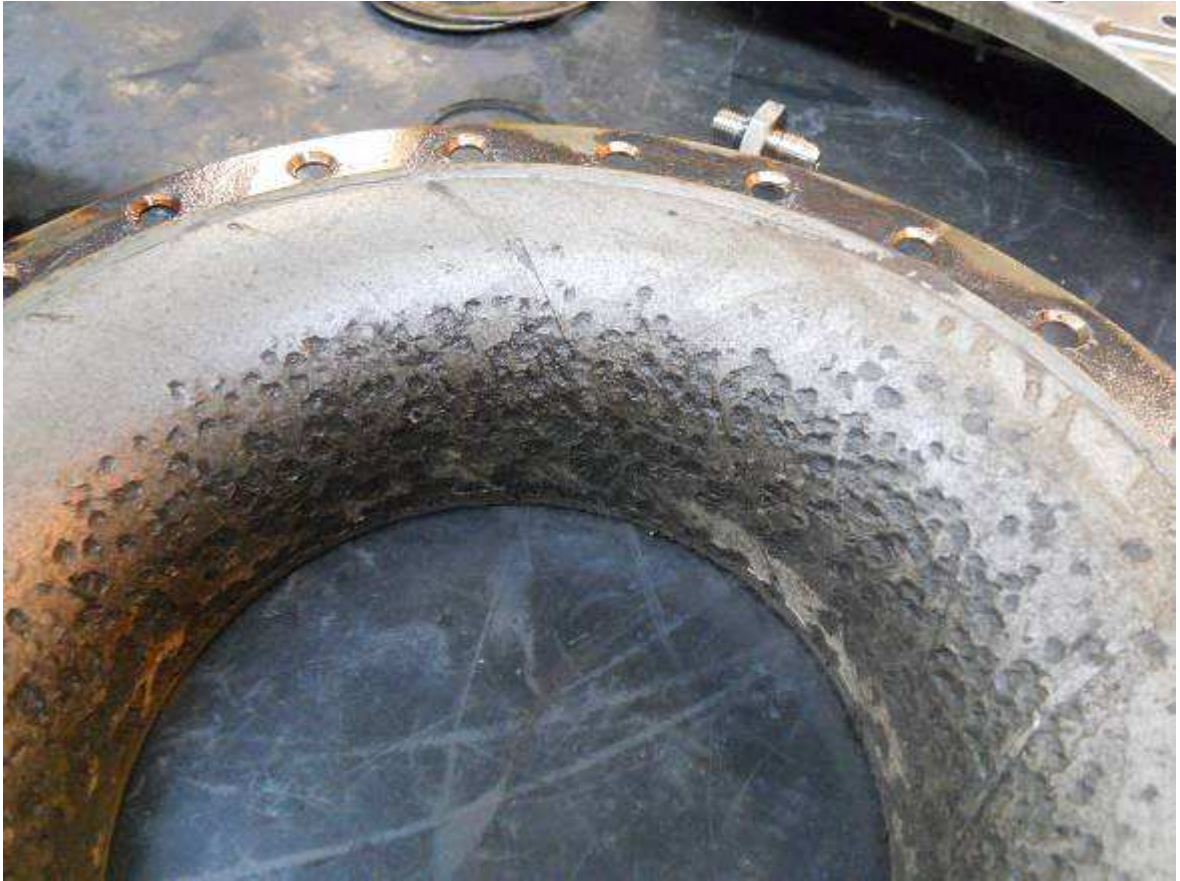
- Compressor case blade tracks found to have heavy scoring due to blade contact as a result of the No1 bearing failure; (Figure)
- Front shroud found to have damage to coating, does not appear to be contact damage. (Figure)

Figure 41 Front shroud damage to coating

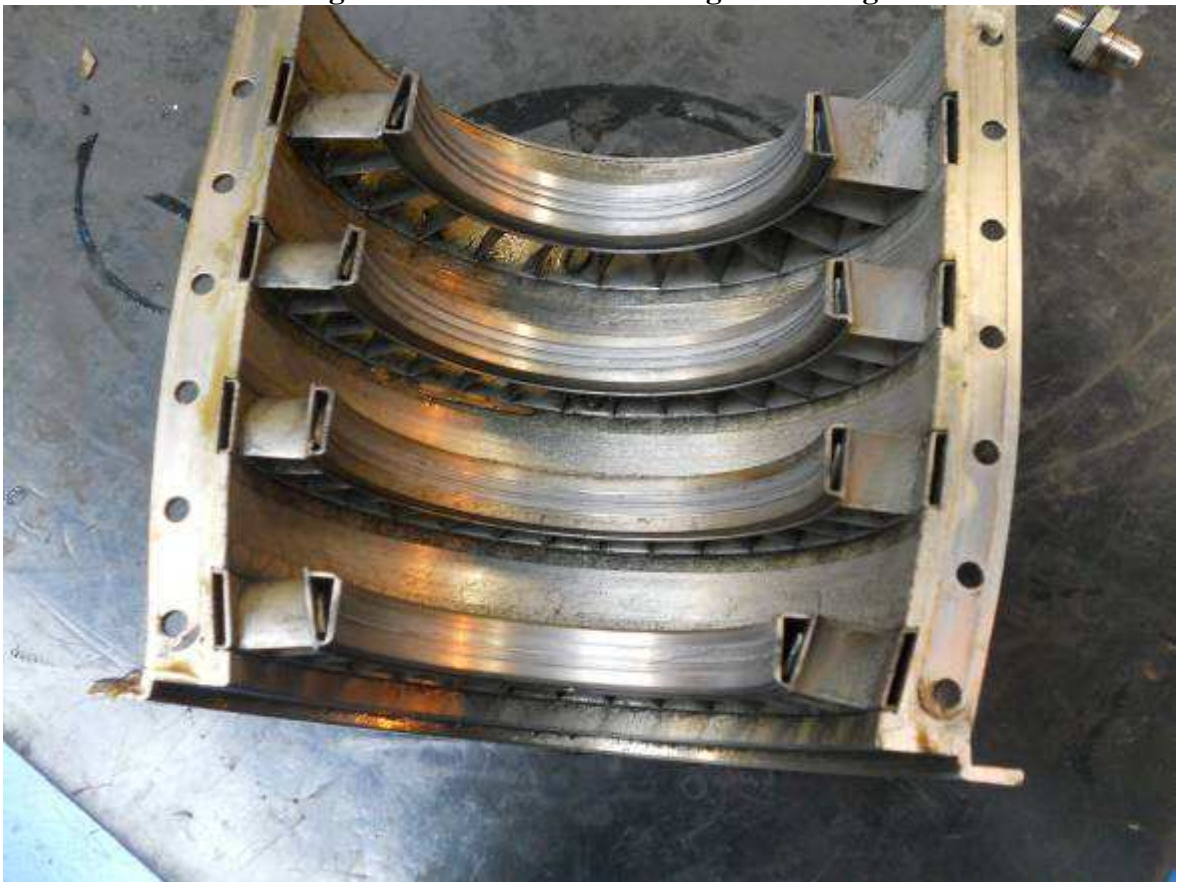
Figure 42 Compressor case blade tracks have heavy scoring due to blade contact

The findings during inspection reflect the cause of occurred accident - the resulting loss of power due to the unsupported rotor having heavy contact with the compressor cases. The magnetic chip indication was from the breakup of the No1 bearing resulting in the case material passing through the engine and depositing on the first stage nozzle and gas rotor.

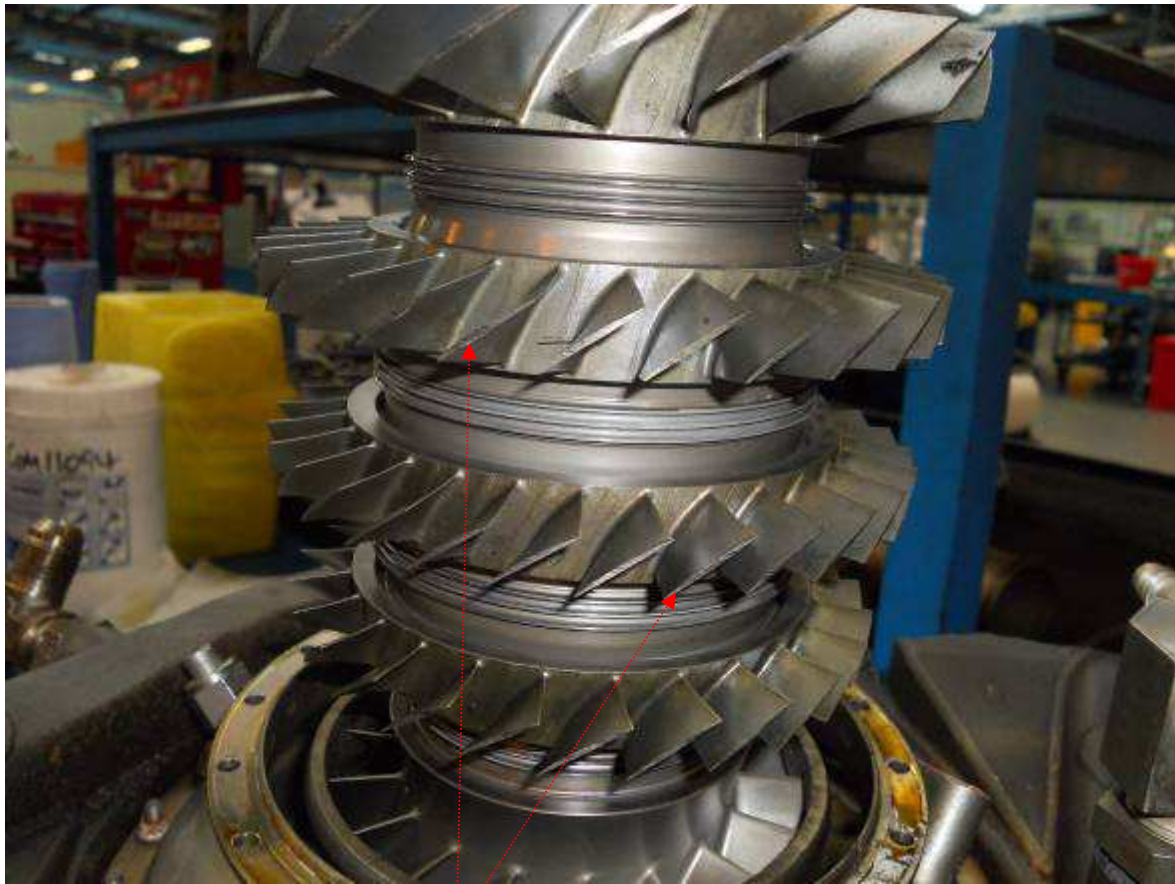
Figure 43. Blades tip rub on the stage 1 compressor wheel contact

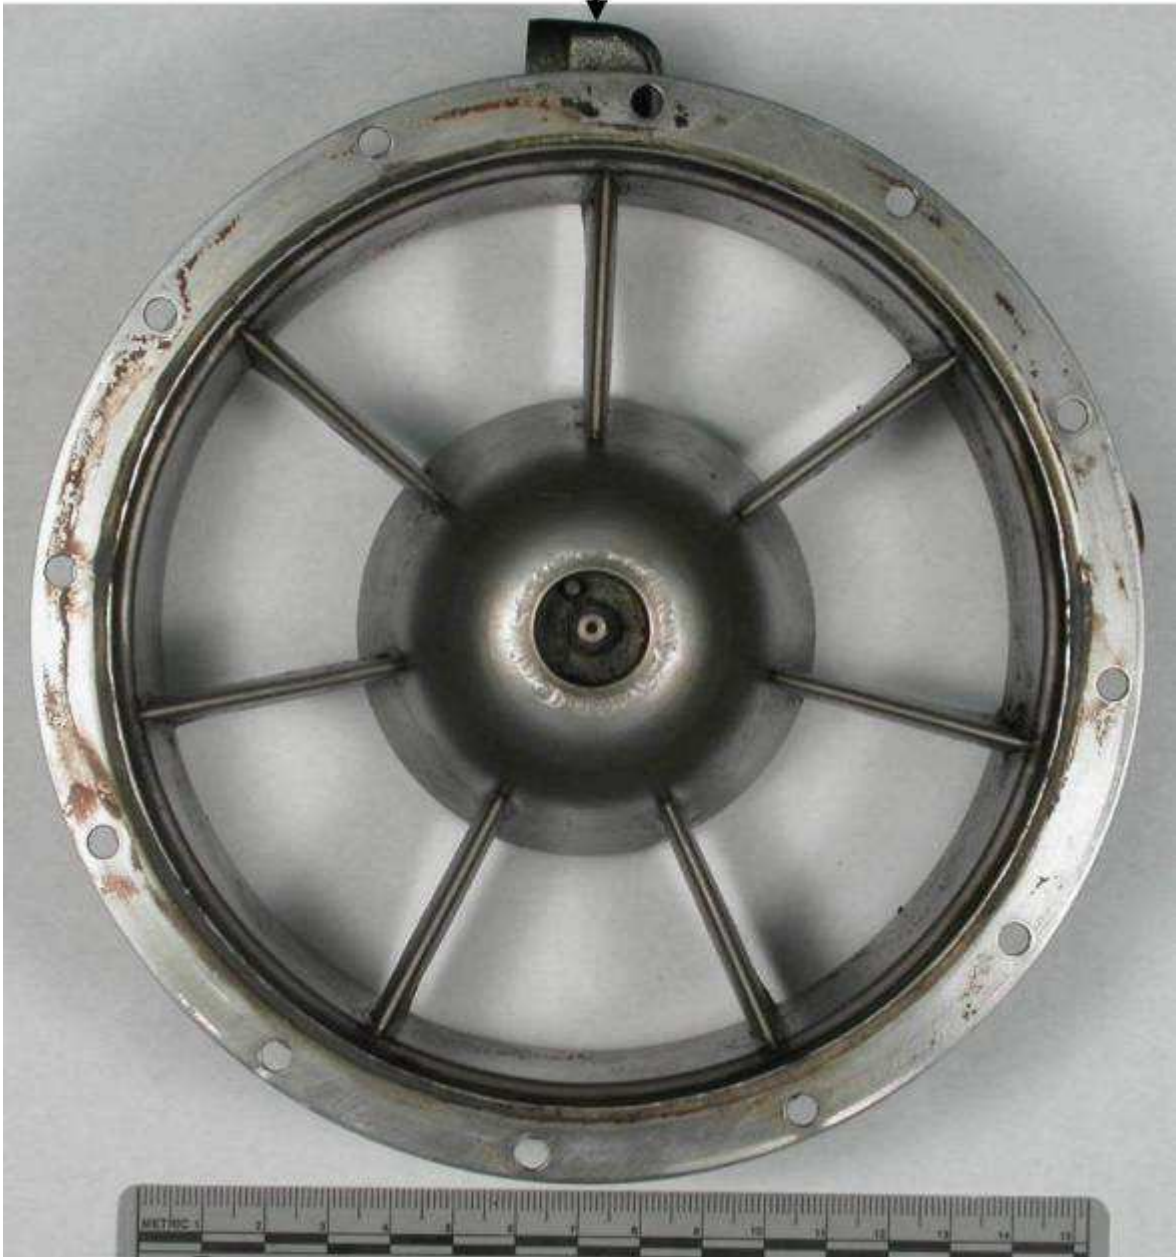
The condition of the front compressor support assembly documented in *Figures 44* and *45*. *Figure 45* shows witness marks on the aft flange indicating the orientation of the compressor case as it was installed. The radial witness marks are from the compressor case split lines. The support assembly was generally oily but exhibited no obvious damage or impact marks on the struts.

Figure 44. The front compressor support assembly viewed from the front side

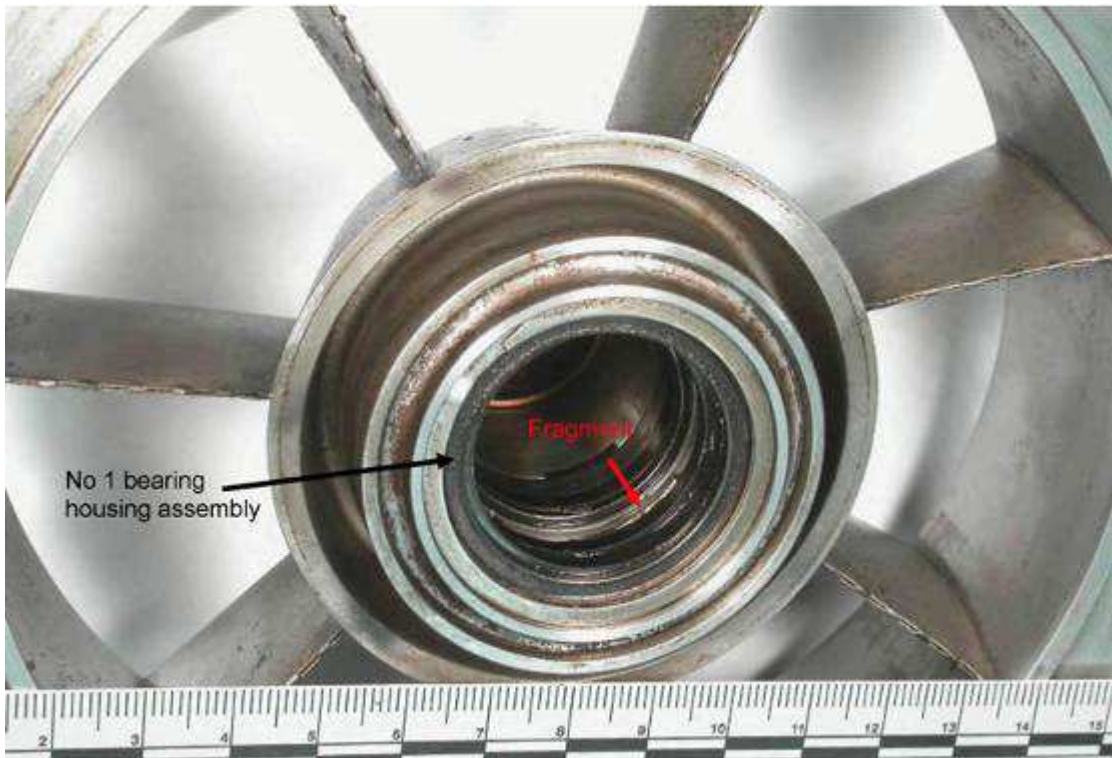
Figure 46. The aft side of the No1 bearing sump area

The No 1 bearing housing was still installed in the hub area, and bearing fragments and/or debris was noted within the housing as shown in *Figure 46*. Additional debris was noted between the bearing housing and the front support hub wall after the bearing housing was removed. *Figure 47* shows the debris fragment in the front support cavity

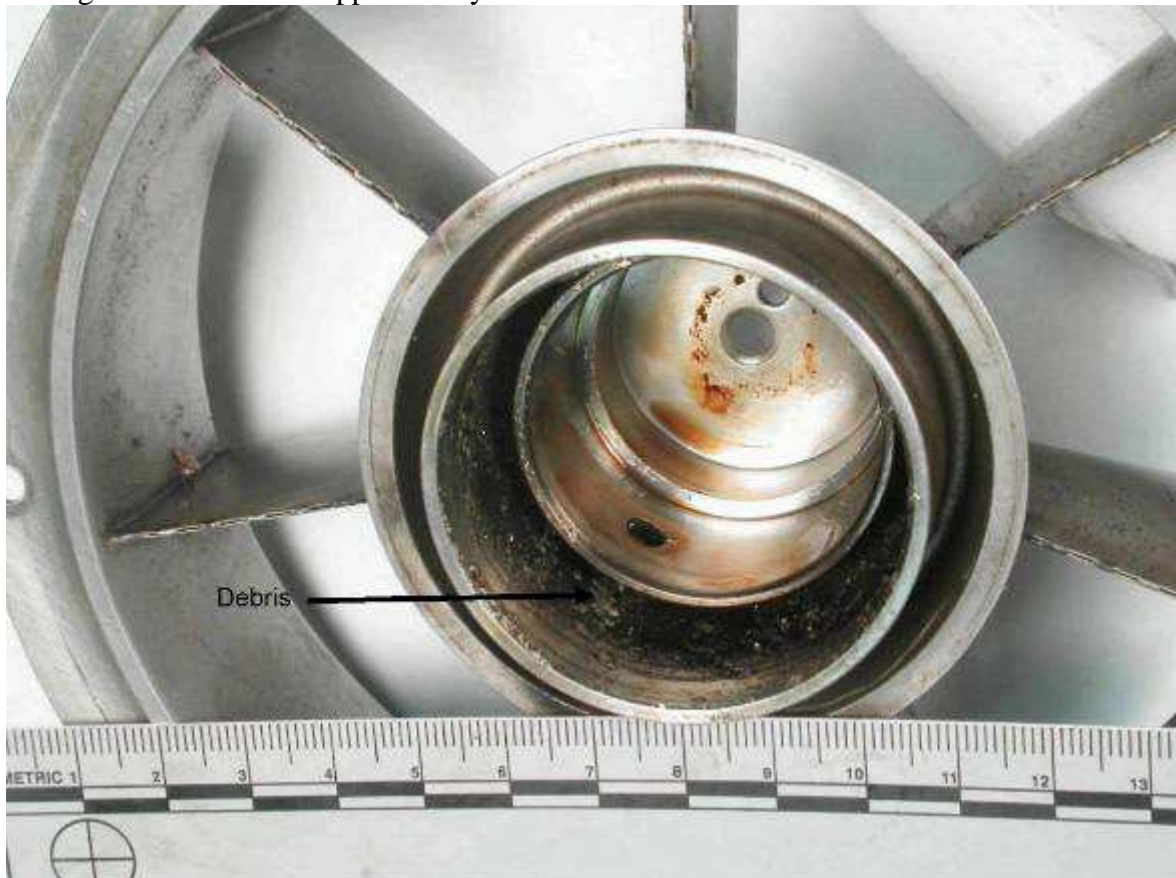
Figure 47. After the bearing housing assembly had been removed.

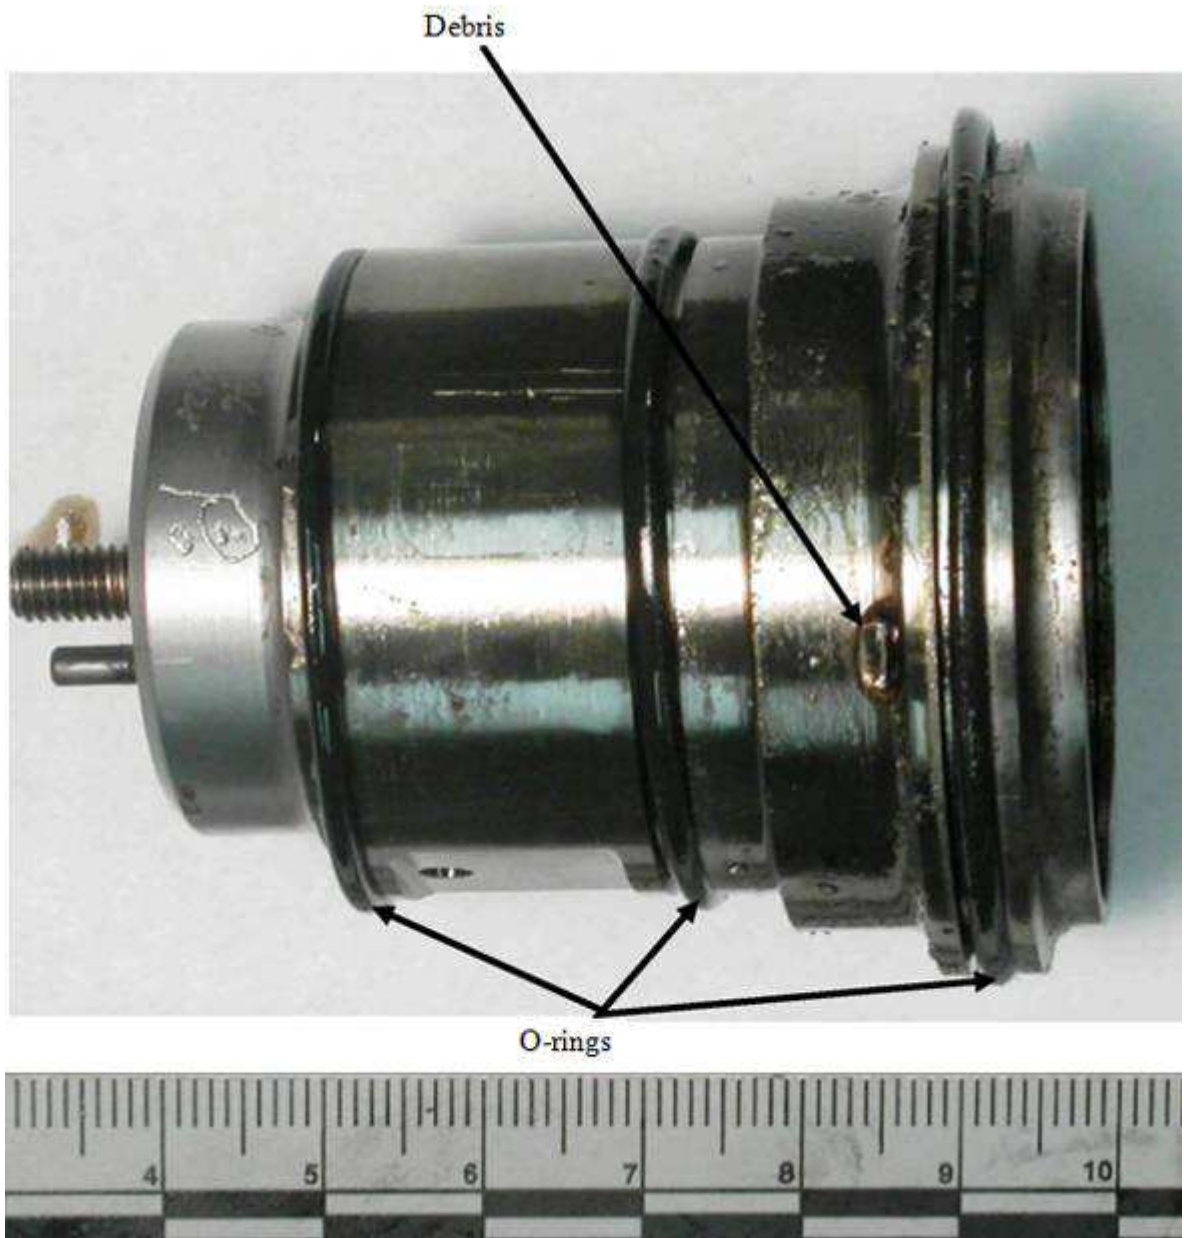
Figure 48. The outer surface of the bearing housing assembly with debris

Figure 48 shows the outer surface of the bearing housing assembly and the debris on its outer surface. The rubber O-rings were swelled and loose fitting.
