TRANSPORT ACCIDENT AND INCIDENT INVESTIGATION BUREAU

FINAL REPORT Nr.5/2012(3-2014)

**of HELICOPTER MD 369E, REGISTRATION OH-HJR ON JULY 12,
2012 AT KASTIRE**

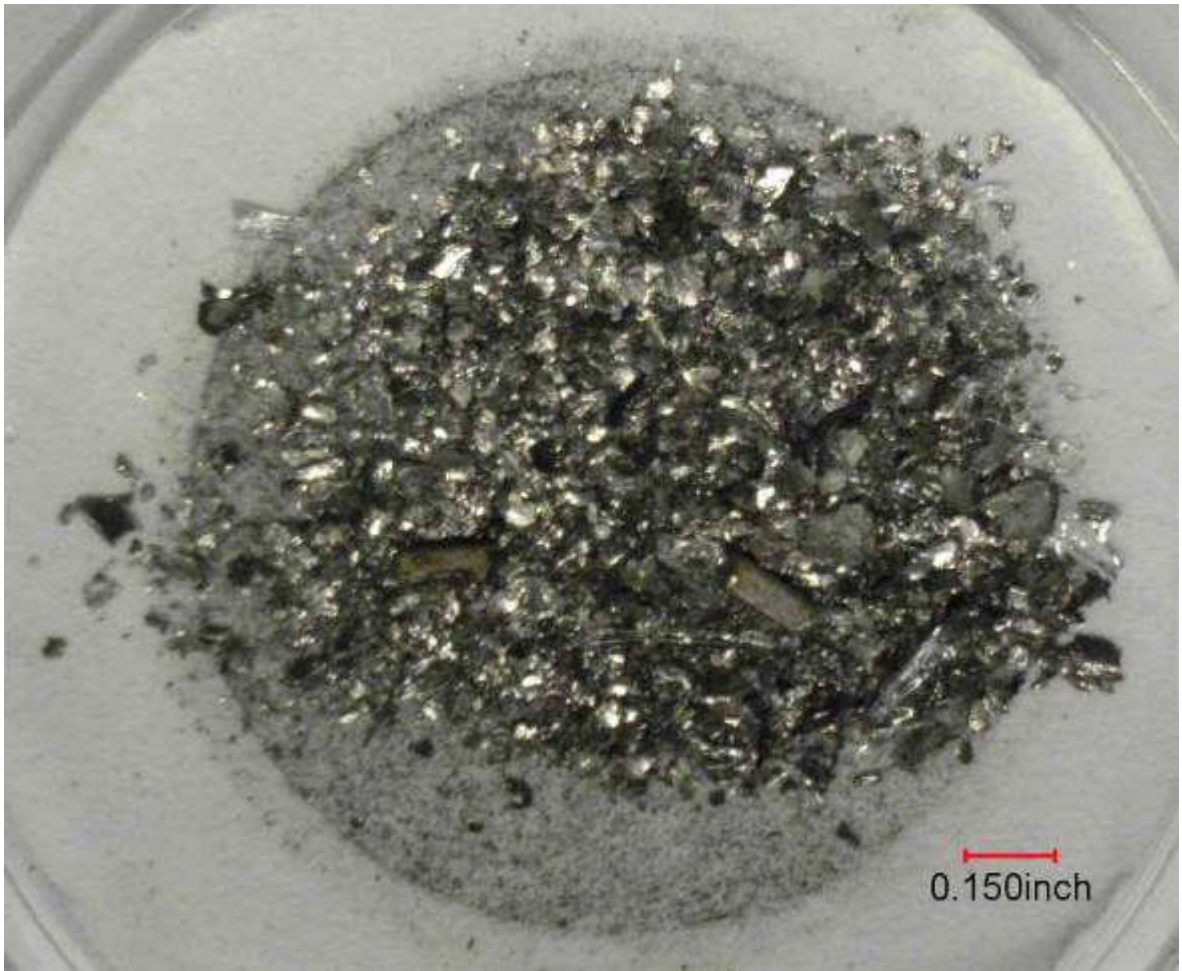
Figure 49. The debris flushed and collected from both the front compressor support and the bearing housing assembly.

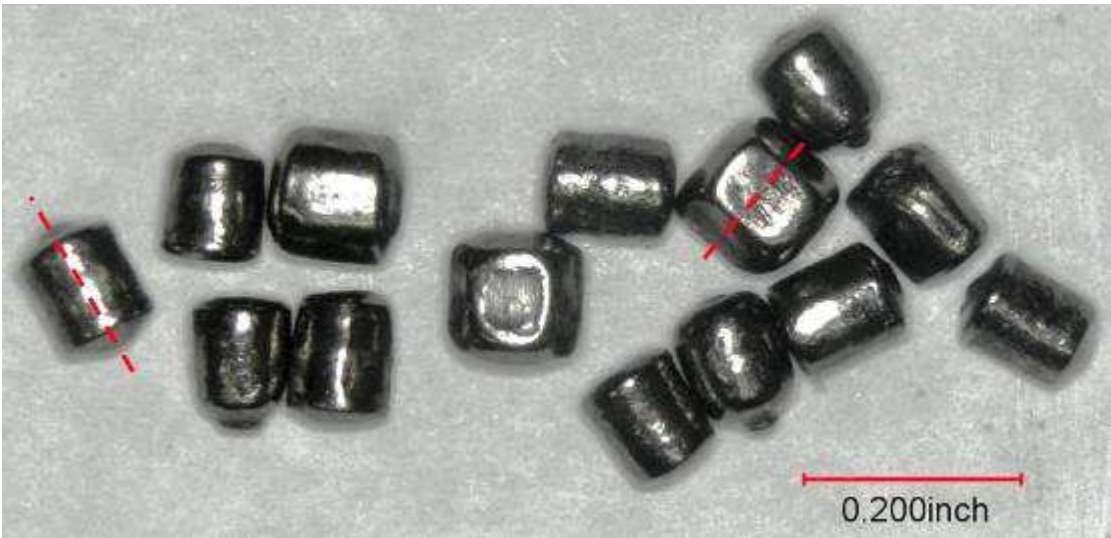
Figure 51. The variety of damage that the 14 (fourteen) rollers exhibited from the No1 bearing. The red dashed lines represent the planes for metallurgical sectioning

All fourteen (14) rollers were recovered and are shown in *Figure 51*. Many of the rollers contained flat spots, others exhibited bulging at the ends of the rollers, and some exhibited both conditions. Three rollers appeared larger than many of the other rollers, but roller diameter varied widely among all fourteen rollers.

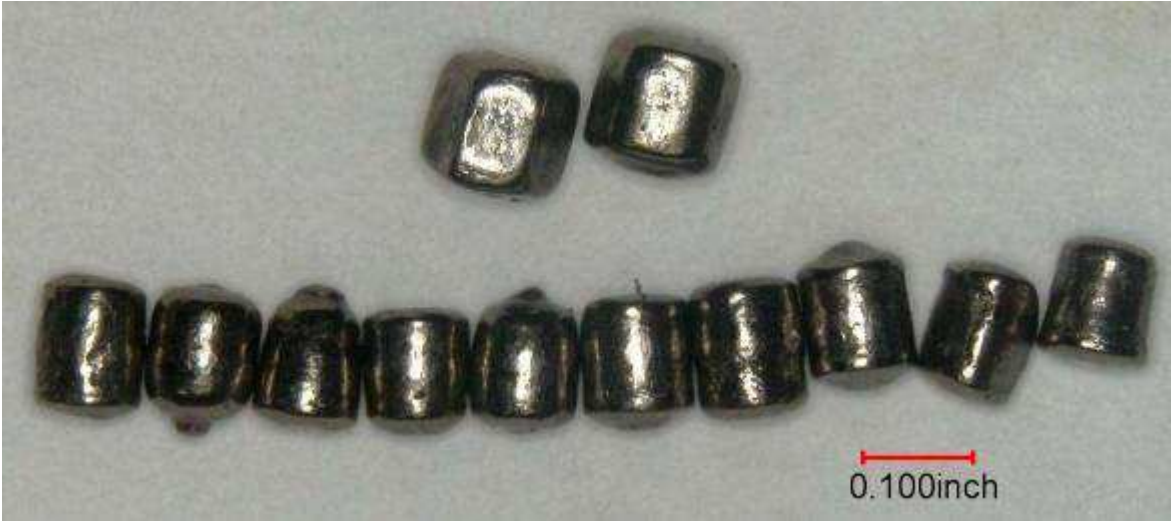
Figure 52 The variety of damage that the 12 (twelve) of rollers exhibited from the No1 bearing. Two rollers had undergone metallurgical evaluation and were unavailable for the photograph.

Figure 52 shows twelve of the rollers lined up to illustrate the variations in size and damage. The other two rollers were sectioned for metallurgical analysis prior to recording this photograph. Detailed dimensional measurements of their diameters were deemed unreliable because of the flat spots on the circumference. The general condition of these rollers and the damage observed is consistent with damage generated when the rollers become pinched or skid during engine operation.

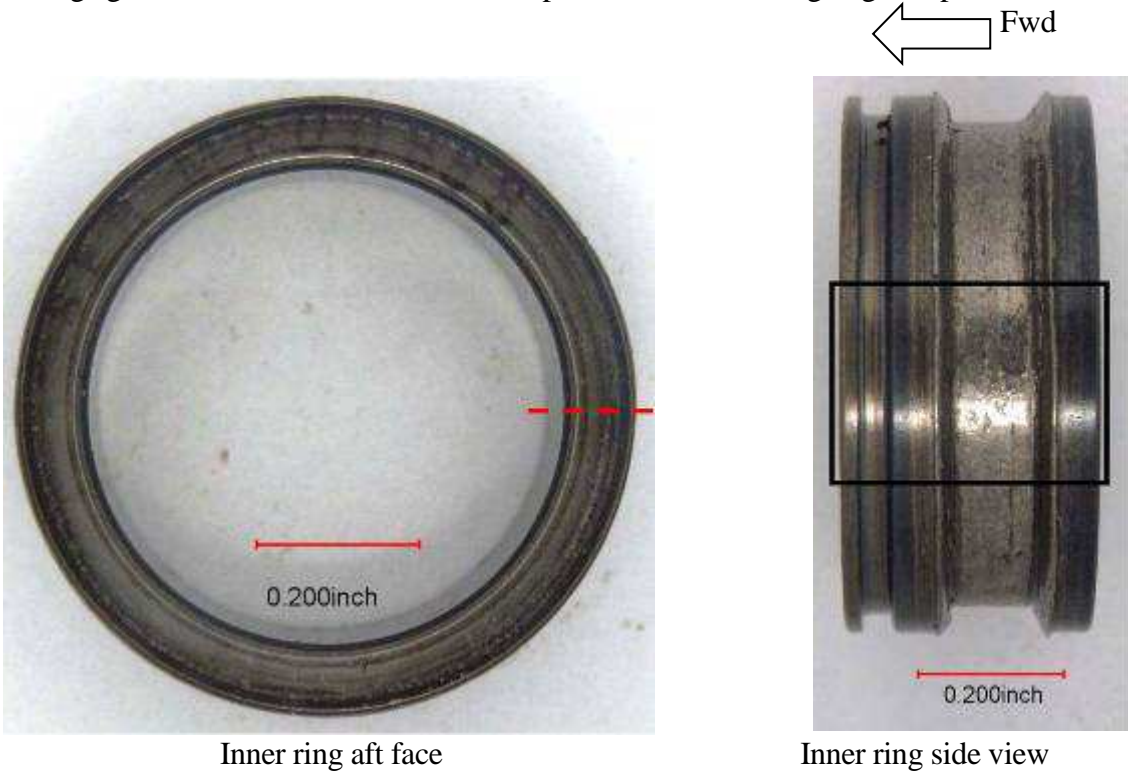
Figure 53 Condition of the No.1 bearing inner ring. The black box represents the area shown in *Figure 54*. The red dashed line represents the plane for metallurgical sectioning.

Figure 53 shows the general condition of the No.1 bearing inner ring. The serial number on the aft side of the ring's face reads "SER MP00888". The right side image shows a general side view of the inner ring and highlights the area shown as a detailed view in Figure 54.

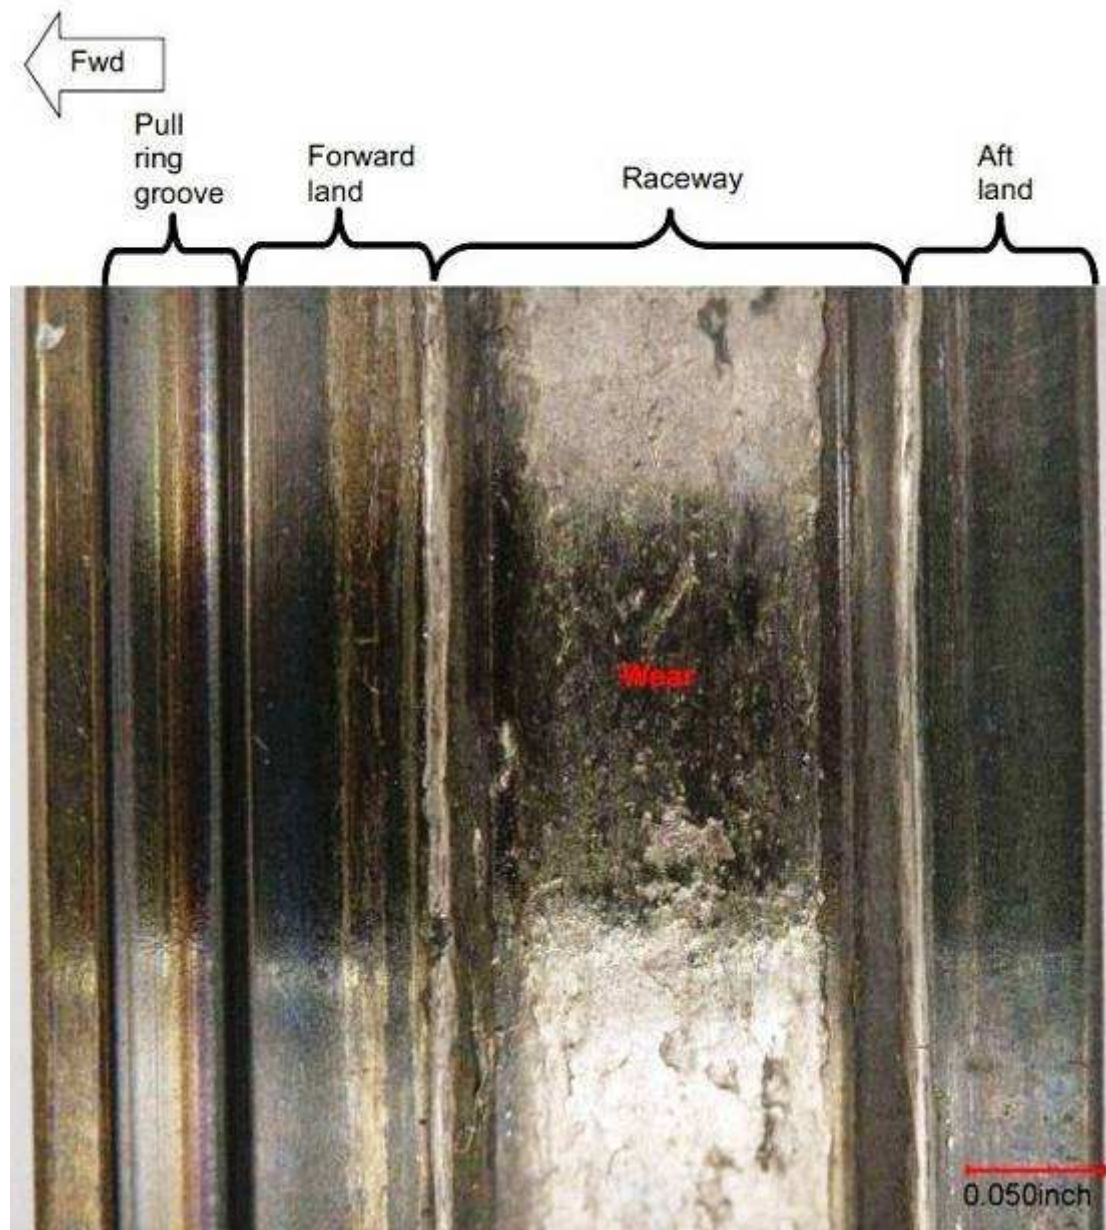
Figure 54. A localized portion of the No.1 bearings inner ring (see black box in Figure 53).

The raceway exhibited localized impact dents from rolling over debris and transferred or smeared material around the raceway circumference. The shoulders were also smeared and deformed outward resulting in an extruded or smeared material lip on the outer corners. The general condition of the raceway is consistent with damage generated during roller skidding during operation.

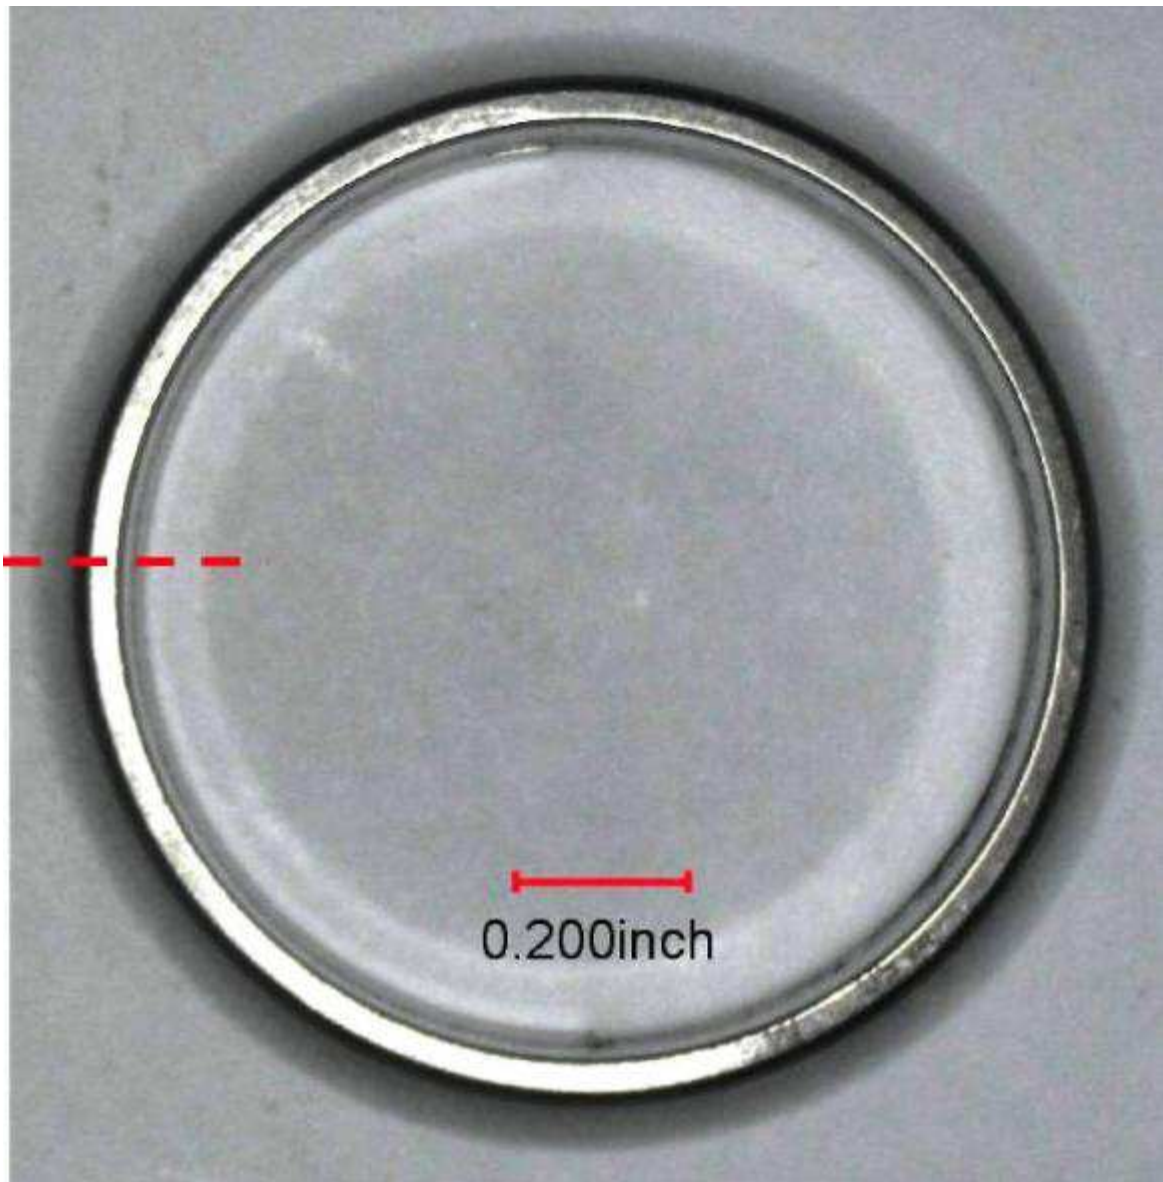
The bearing housing was sectioned and the No.1 bearing outer ring was extracted. Figure 55 shows the general condition of the No.1 bearings outer ring after it was removed from the bearing housing.

Figure 55. The general condition of the No.1 bearings outer ring after it was removed from the bearing housing. The red dashed line represents the plane for metallurgical sectioning.

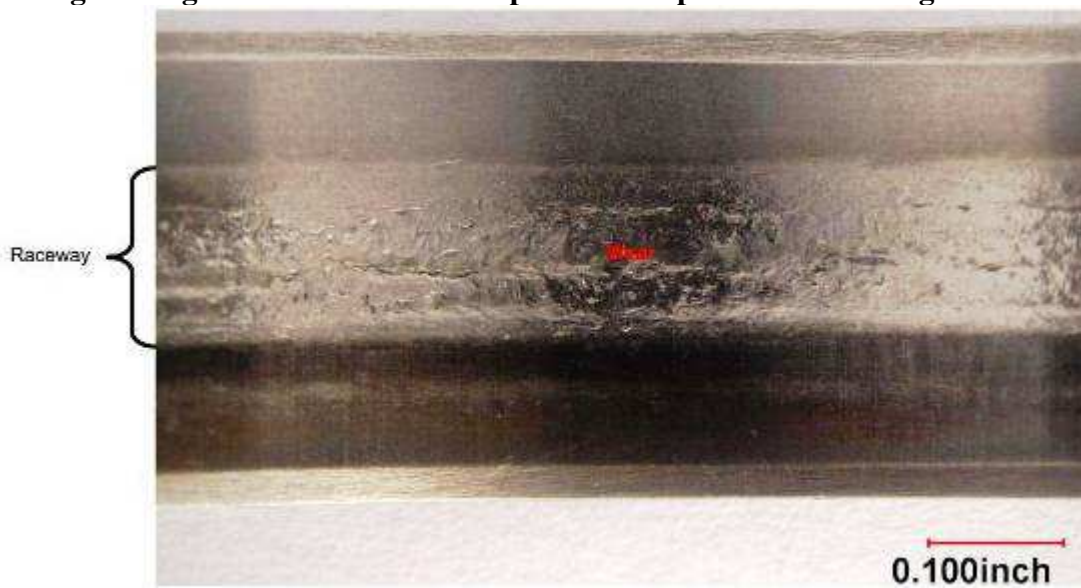
Figure 56. A detailed view of the outer raceway

Figure 56 shows a detailed view of the outer raceway. This surface appeared similar to the inner raceway and exhibited impact damage from rolling over debris and smearing. The aft side of the ring was slightly darker and heat tinted than the forward half.

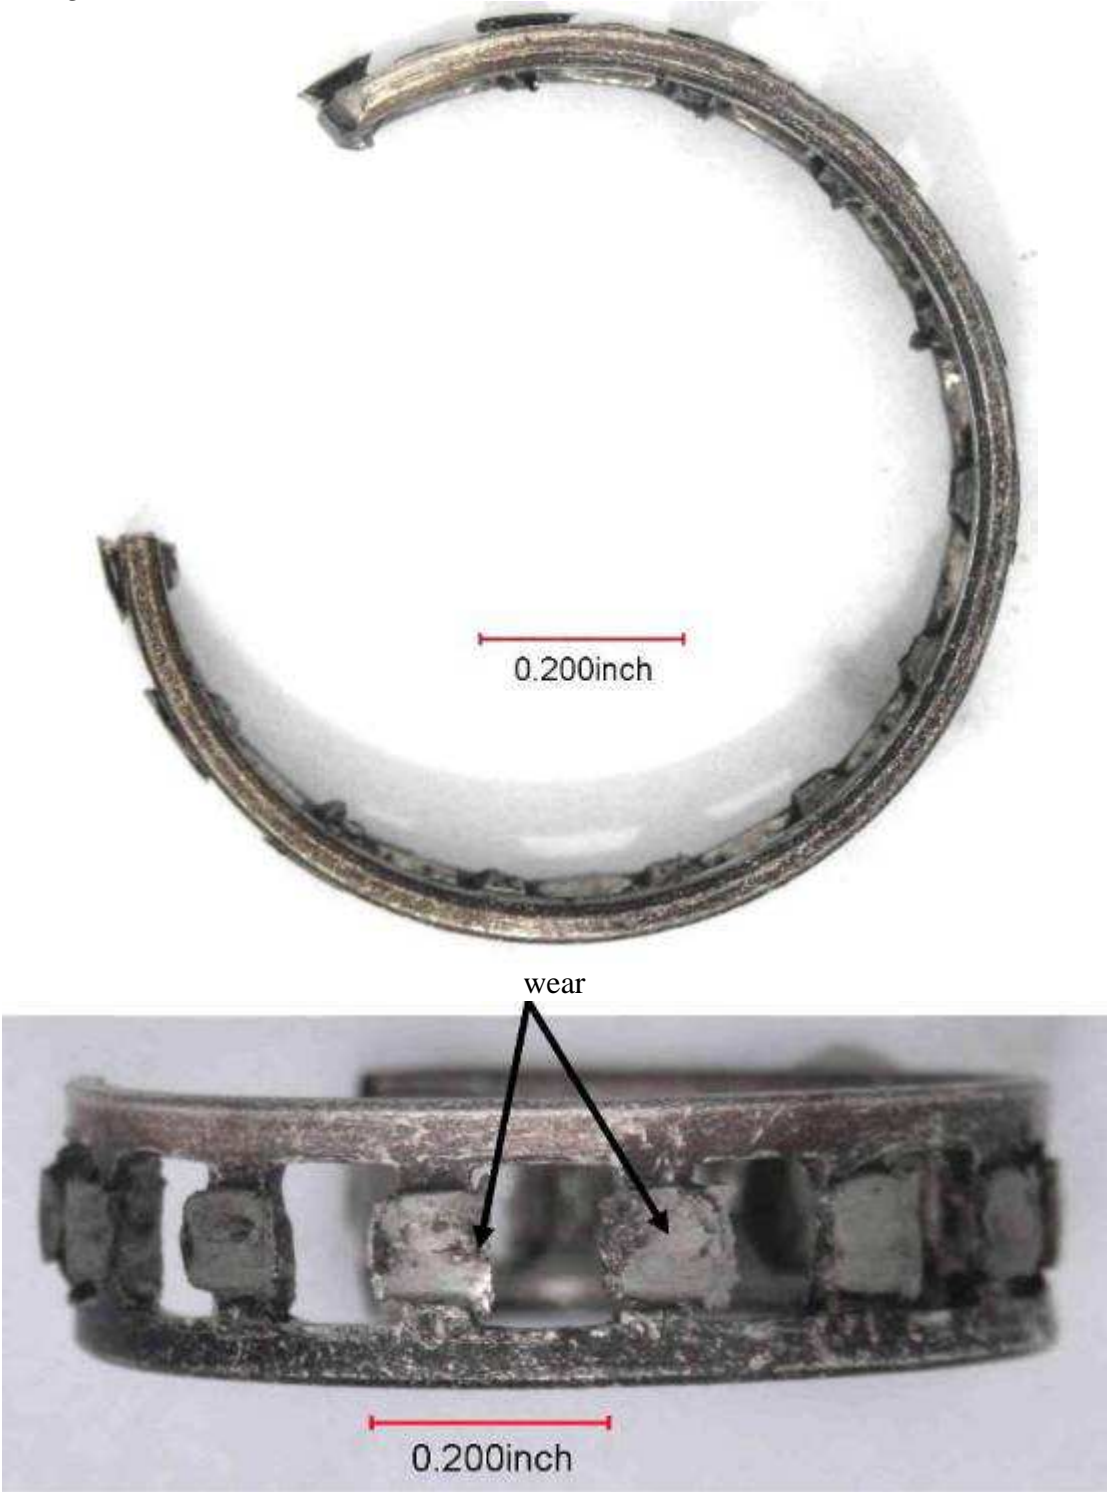
Figure 57 shows the general condition of the No. 1 bearings separator. The top image shows that the separator had fractured and two of the roller pockets were missing. The bottom image shows a view of the outer diameter of the separator. Significant wear and smearing was observed on the roller retention features and pocket web areas on the outer diameter of the separator as shown in the bottom image of Figure 57.

Figure 57. Condition of the No.1 bearing separator

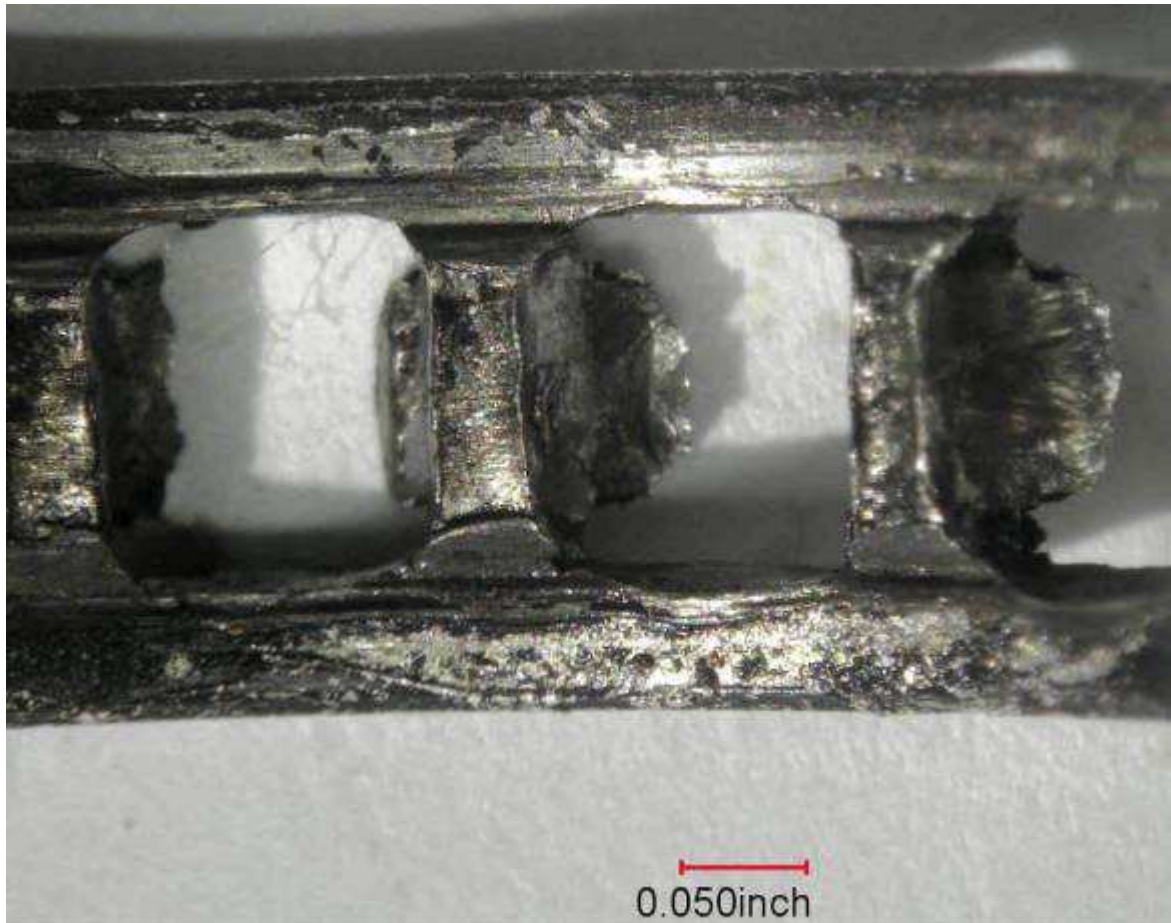
Figure 58. Wear deformation from the inner surface of the No. 1 bearing separator pockets.

Smearing and plastic deformation was also noted in the roller pockets and on the inner surface of the separator rails as shown in *Figure 58*. Detailed fractographic analysis was not conducted on this component as the fracture damage was considered secondary.

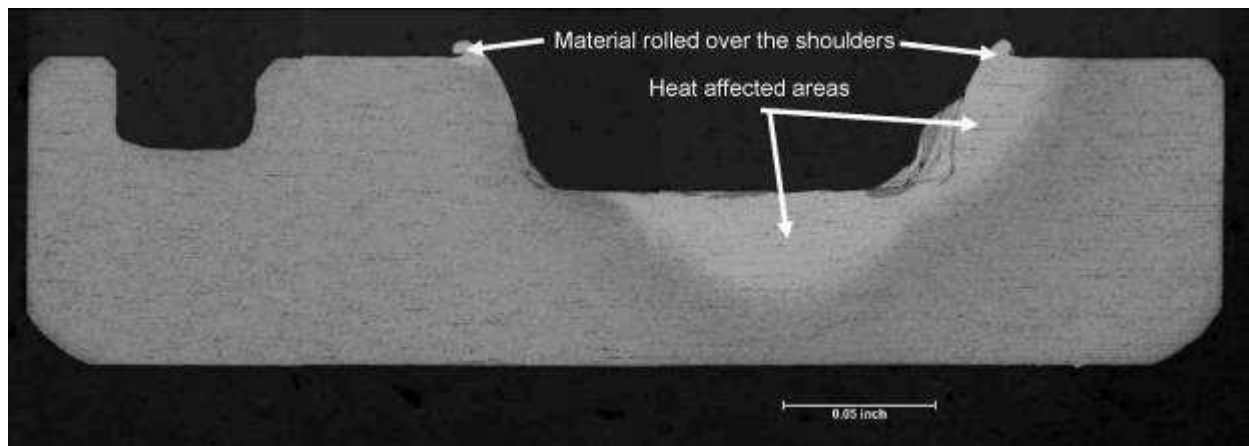
Figure 61 The montage metallographic image shows a cross section through the No.1 bearing's inner ring. Used etchant: Nital 5%

The montage metallographic image of *Figure 61* shows a cross section through the No.1 bearing's inner ring and illustrate the heat distress and plastic deformation around the center and aft raceway areas. Also shown are plastic deformation and smearing damage along the forward and aft raceway shoulders where material has been extruded or rolled over the bearing's raceway corner.

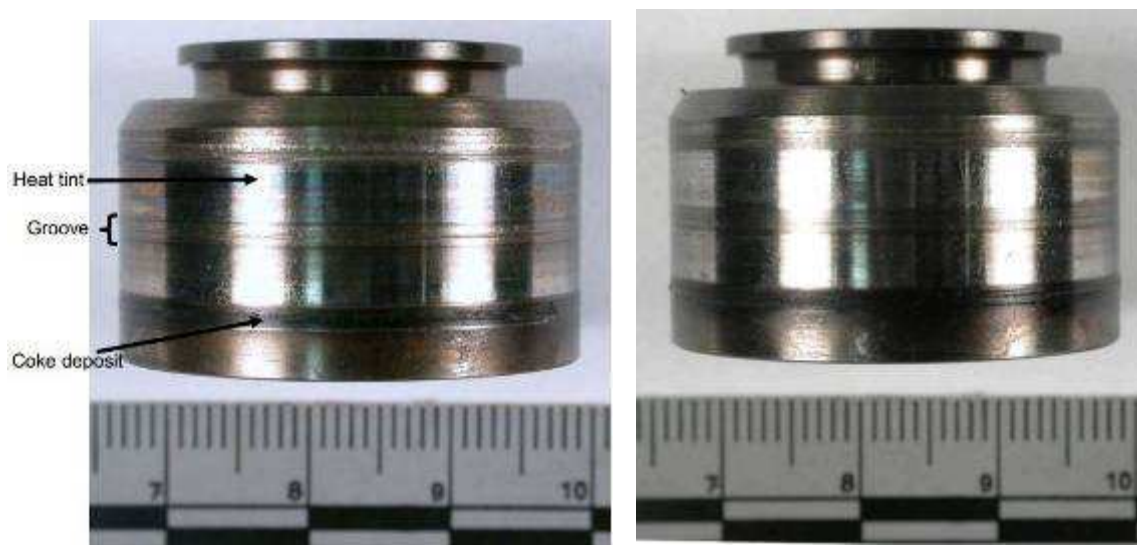
The general condition of the carbon seal runner is shown in Figure 65. The raceway exhibited a heat tint (bluish color) that encompasses approximately 180 degrees of the seal runner's circumference. There was a groove in the center between the contact areas of the two carbon elements and coke deposits along the aft portion of the runner, but no other obvious damage was noted. No metallurgical, hardness or chemical analyses were conducted on this component.

Figure 65 The images of two views approximately 180° apart showing the general condition of the carbon seal runner (Divisions = mm)

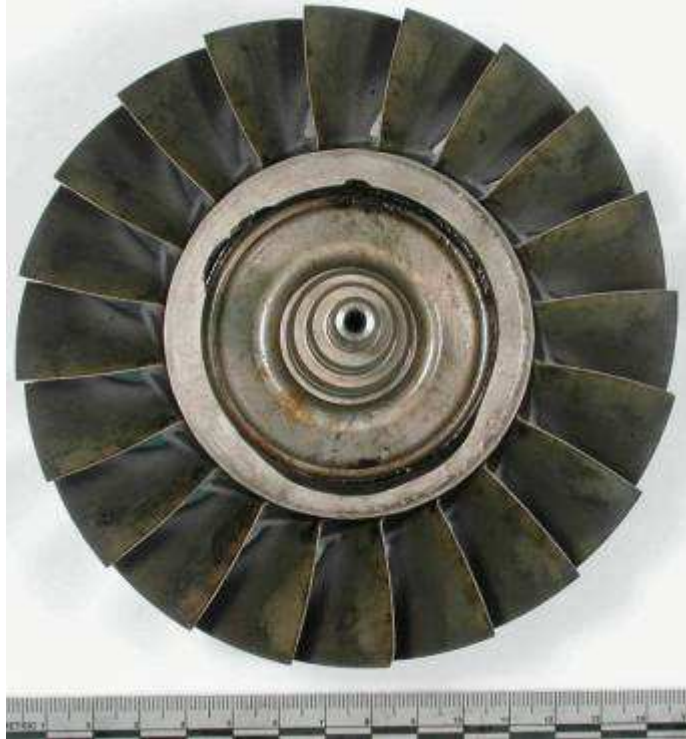
The condition of the stage 1 compressor wheel is shown in *Figures 66* and *67*. There was no obvious damage along the leading edges of the airfoils and no obvious sign of knife seal rub. Blade tip rub was evident around the entire circumference of the wheel and was consistent with damage noted along the blade path in the compressor case. *Figure 68* shows representative example of tip rub damage. No metallurgical, hardness or chemical analyses were conducted on this wheel.

Figure 66 The image of the leading edge surface of the stage 1 compressor wheel (Divisions=mm)

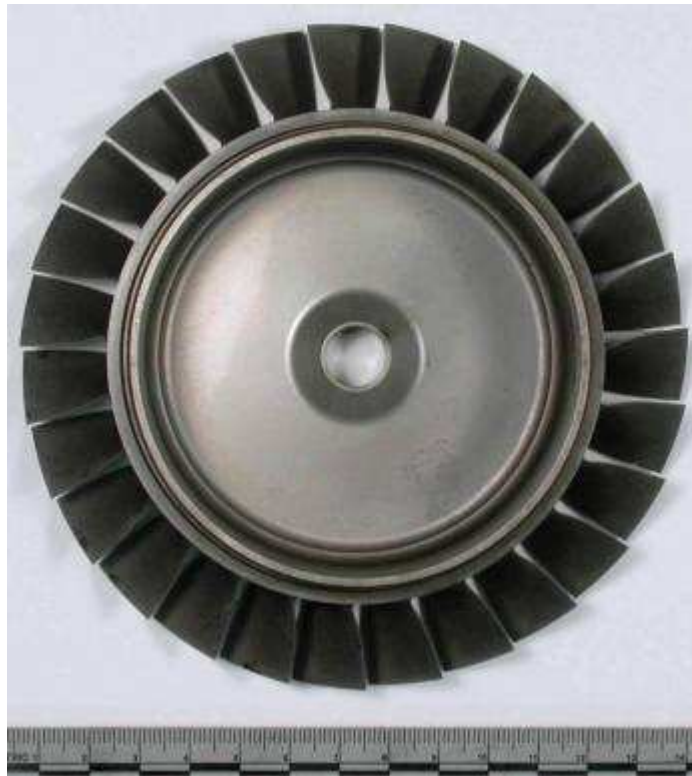
Figure 70. The image of the trailing edge surface of the stage 2 compressor wheel (Divisions = mm)

The condition of the stage 2 compressor wheel is shown in *Figures 69 and 70*. There was no obvious damage along the leading edges of the airfoils and no obvious sign of knife seal rub.

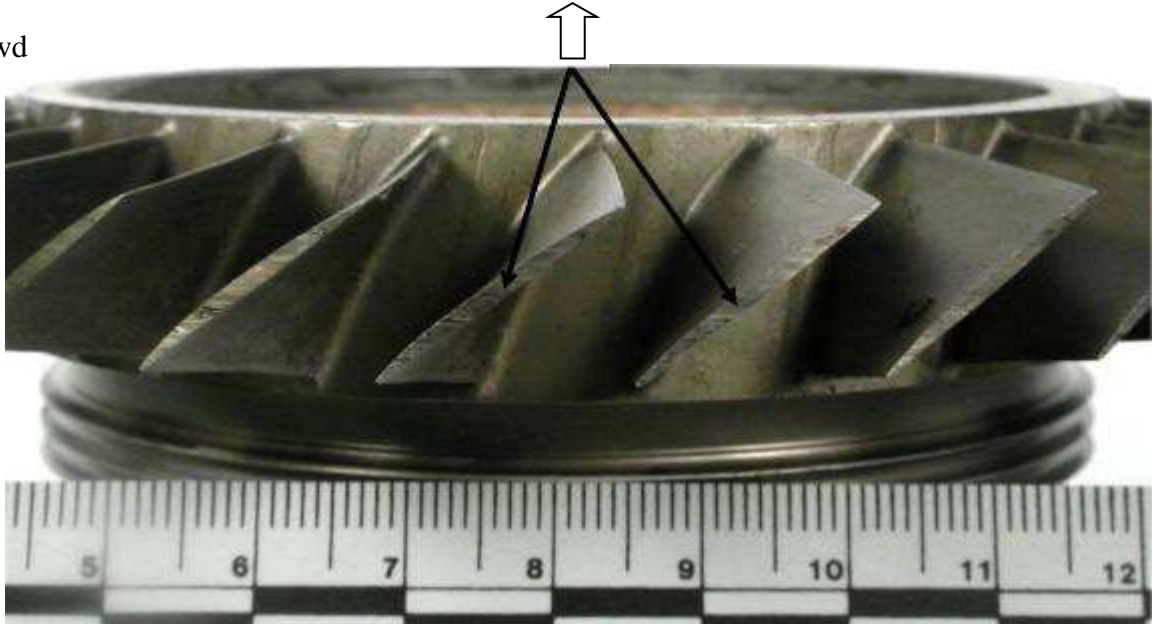
Figure 72. The image of a representative example of tip rub exhibited by the stage 2 compressor wheel. Divisions = mm

Figure 72 shows an image exhibiting a representative example of tip rub damage. No metallurgical, hardness or chemical analyses were conducted on this wheel.

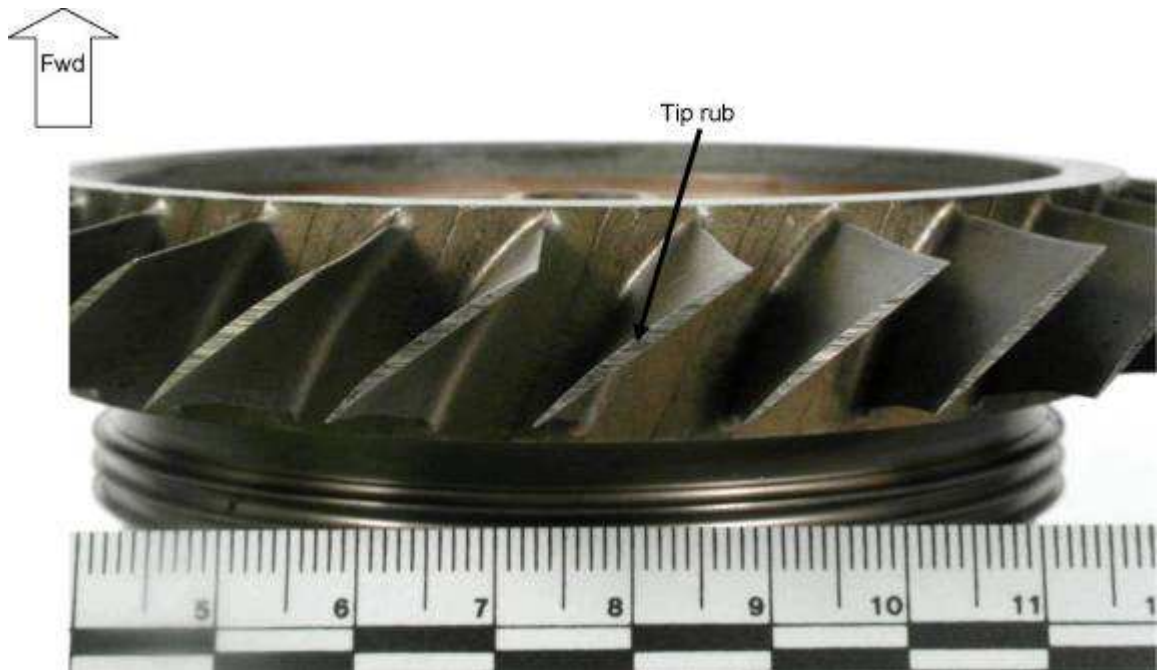
Figure 76. The image of a representative example of tip rub exhibited by the stage 3 compressor wheel. (Divisions = mm)

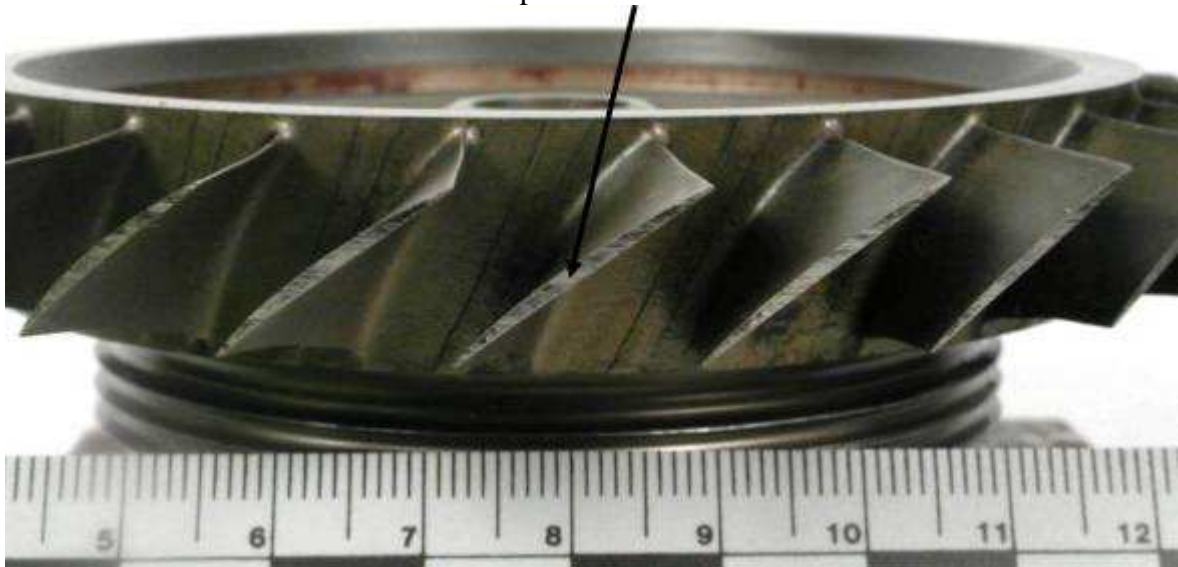
Figure 79. The image of a representative example of tip rub exhibited by the stage 4 compressor wheel. (Divisions = mm)

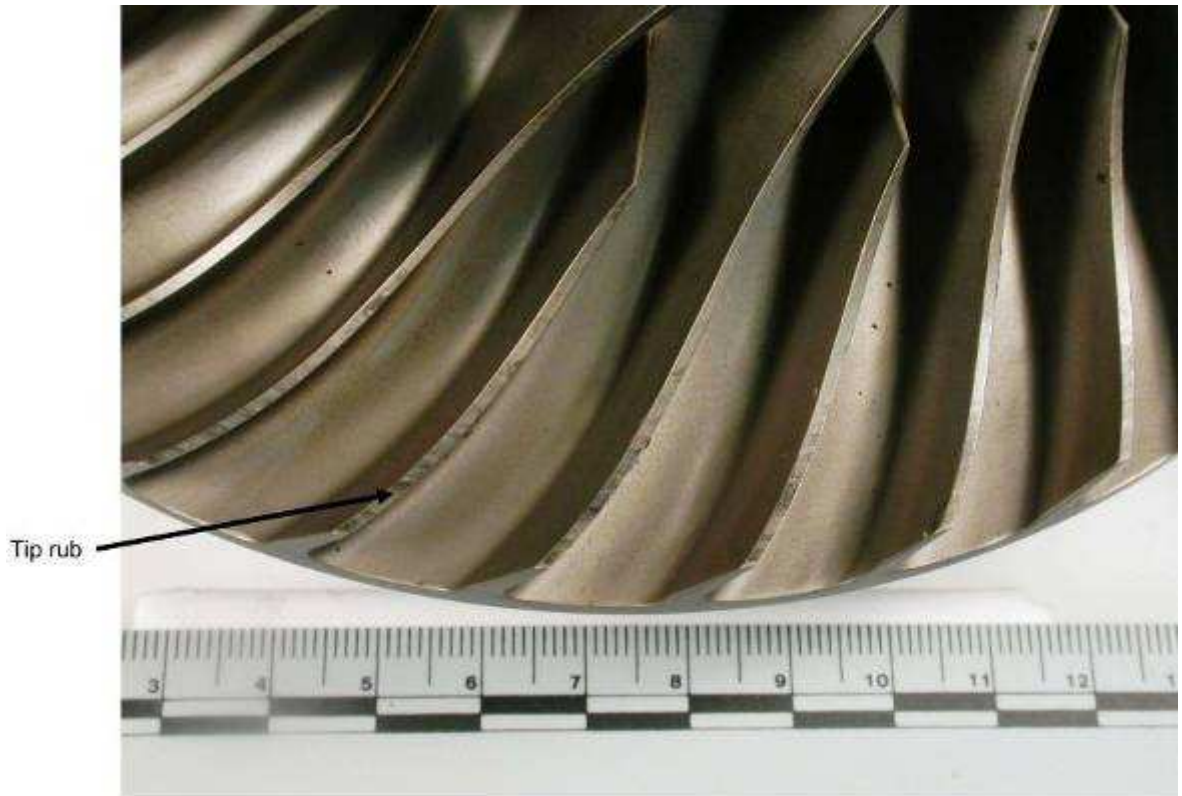
Figure 82. The image of a representative example of tip rub on the impeller. (Divisions = mm)

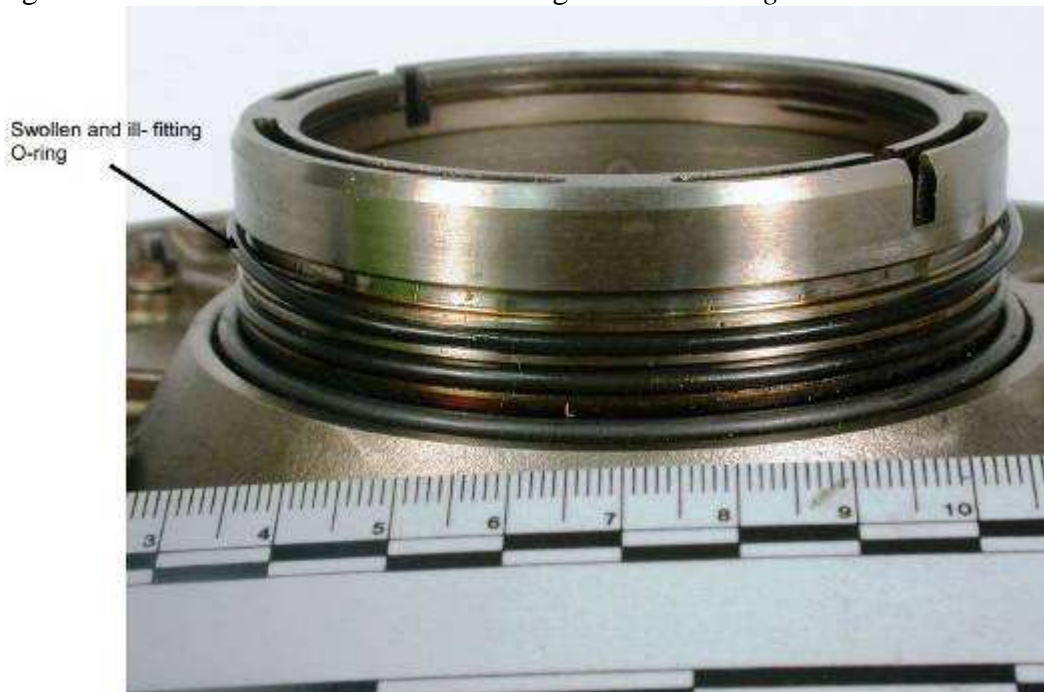
Figure 100 The image of the loose fitting O-ring on the compressor rear support and diffuser as viewed from the aft face
