Transporta nelaimes gadījumu un incidentu izmeklēšanas birojs

## **Simplified report Nr. 1-2019**

### **Heavy contact of Madeira flagged vessel Lyra with pier 51 A in Port of Liepāja port on 26<sup>th</sup> October 2019**

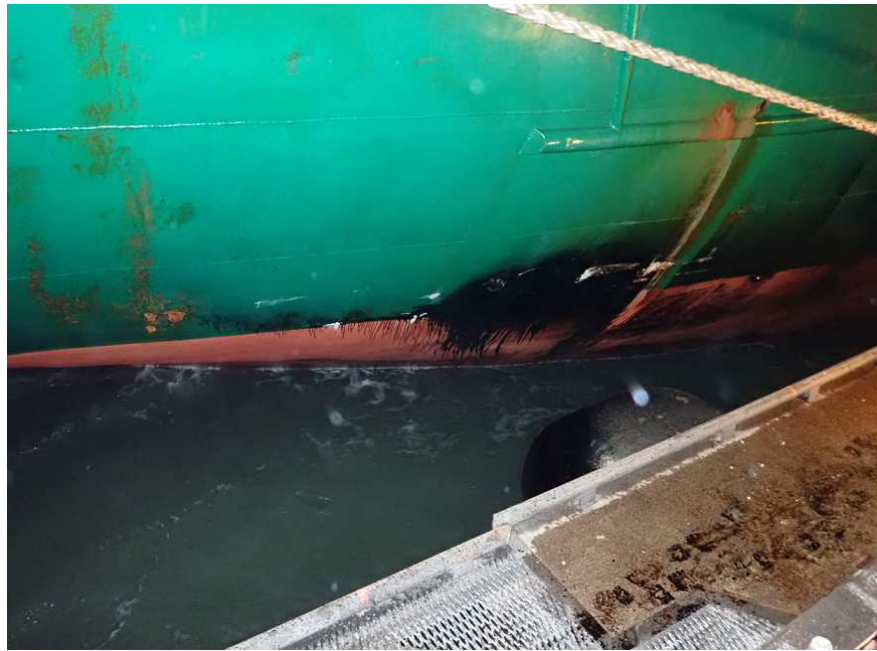
6. At 07.10 aft is drifting toward pier, main engine working "slow astern". Master tries to compensate drift giving command "hard to starboard". Vessel facilitates drift to pier and heavily contacts pier's bollard, resulting piercing of hull and consequent piercing of fuel tank. Fuel discharges in water and onto pier surface.

Image1: Hole in LYRA hull (appr 20x10 cm) with residues of polluted fuel

5.2.6. Master's command to helmsman "hard to starboard" instead of "hard to port" while engine working in "slow astern mode" resulting amplifying and facilitating of vessel aft drift toward pier with consequent lean on bollard and hull piercing.

Considerable pollution of heavy oil from daily usage fuel tank : around 150 litres. Liepaja port authorities has launched oilspill combating operation iaw port instructions and standards.

Vessel's hull is damaged. Pierce app 20x10 cm in fuel tank

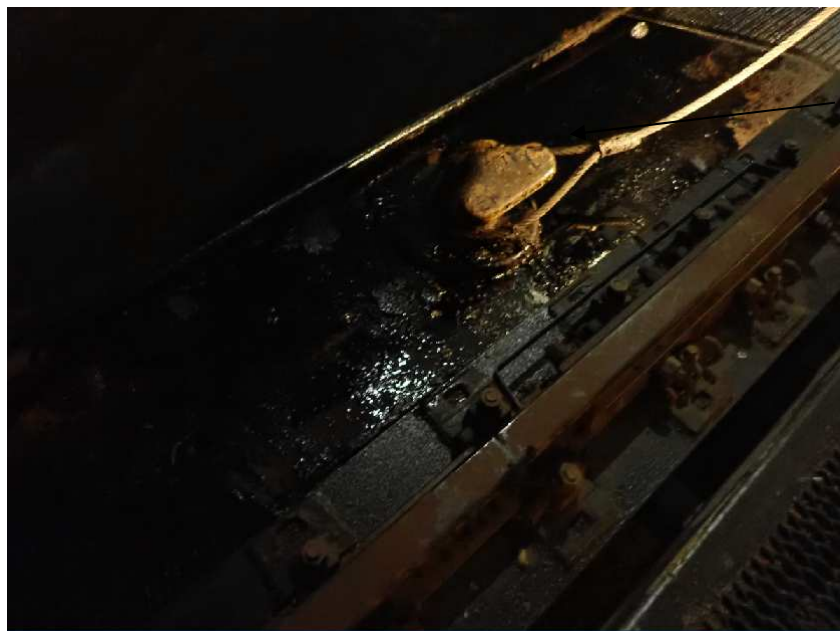
Image 2: Bollard and surroundings just after LYRA berthing ( image taken in 15 minutes after the accident)

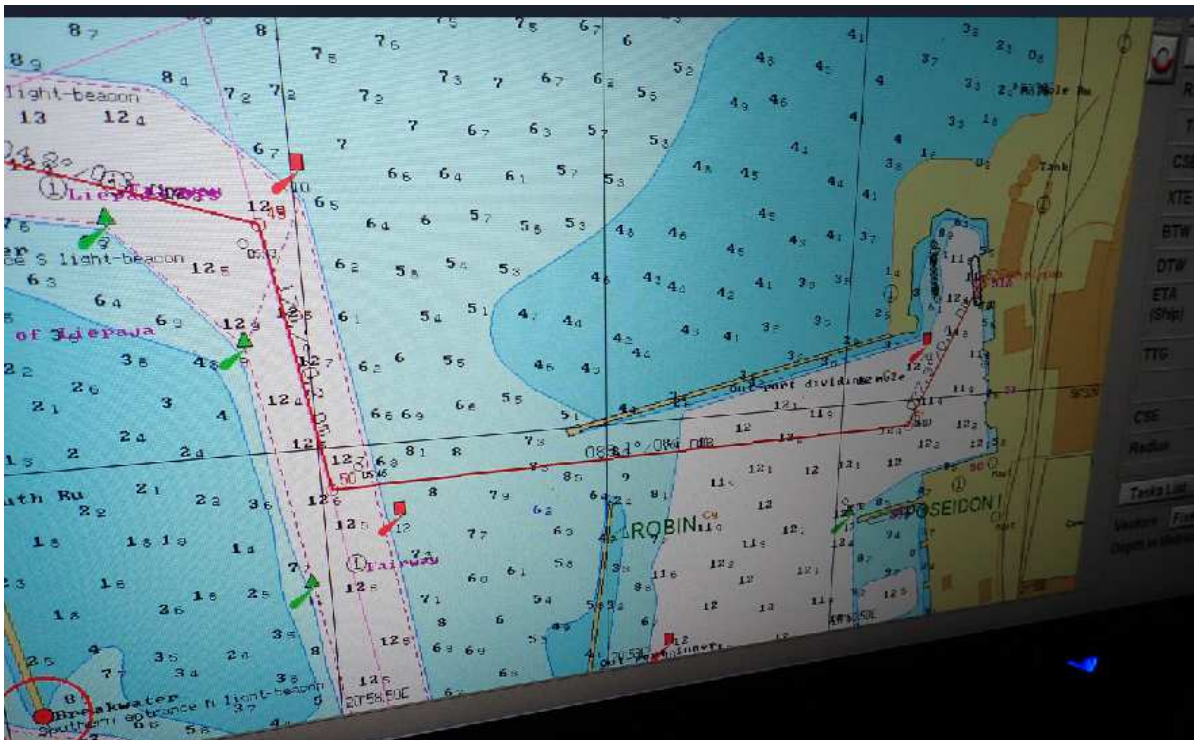
**Vessel's voyage plan:** There was ready and Master's approved voyage plan written on paper as well as within the ECDIS.

Image 3: Snapshot of LYRA arrival voyage plan in ECDIS
