Transporta nelaiemes gadījumu un incidentu izmeklēšanas birojs

MARINE SAFETY INVESTIGATION REPORT Nr.1-2021

Safety investigation into the Grounding of CEG ORBIT at Isle of Man on AUGUST 26th, 2021

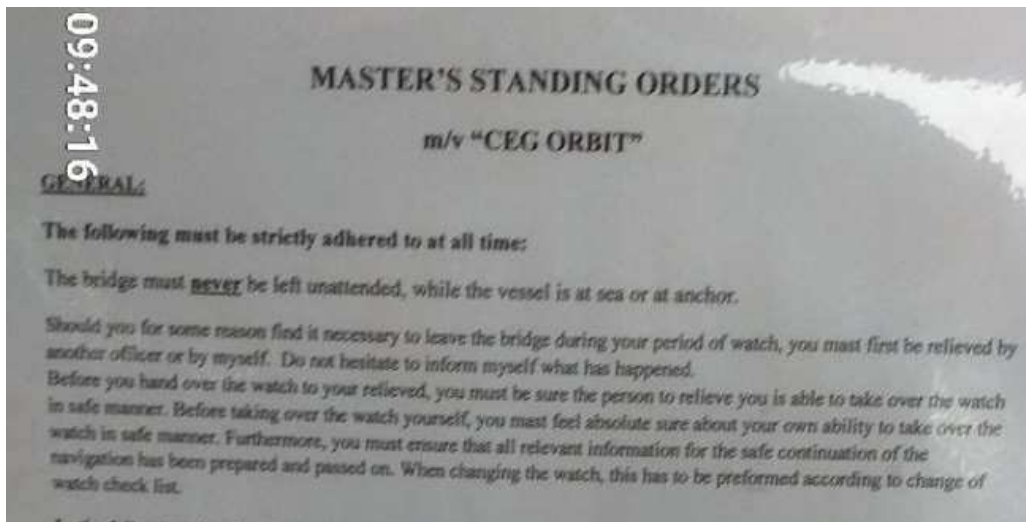
Extract from the Master's standing orders with a clear statement that the bridge must **never** be left unattended and should it be necessary to leave the bridge during watch you must first be relieved by another □ Officer or by the Master himself.

The Company Safety Management System instructions and Masters standing orders are very clear, they MUST be followed at all times to ensure the safety of the crew, the vessel and the environment.

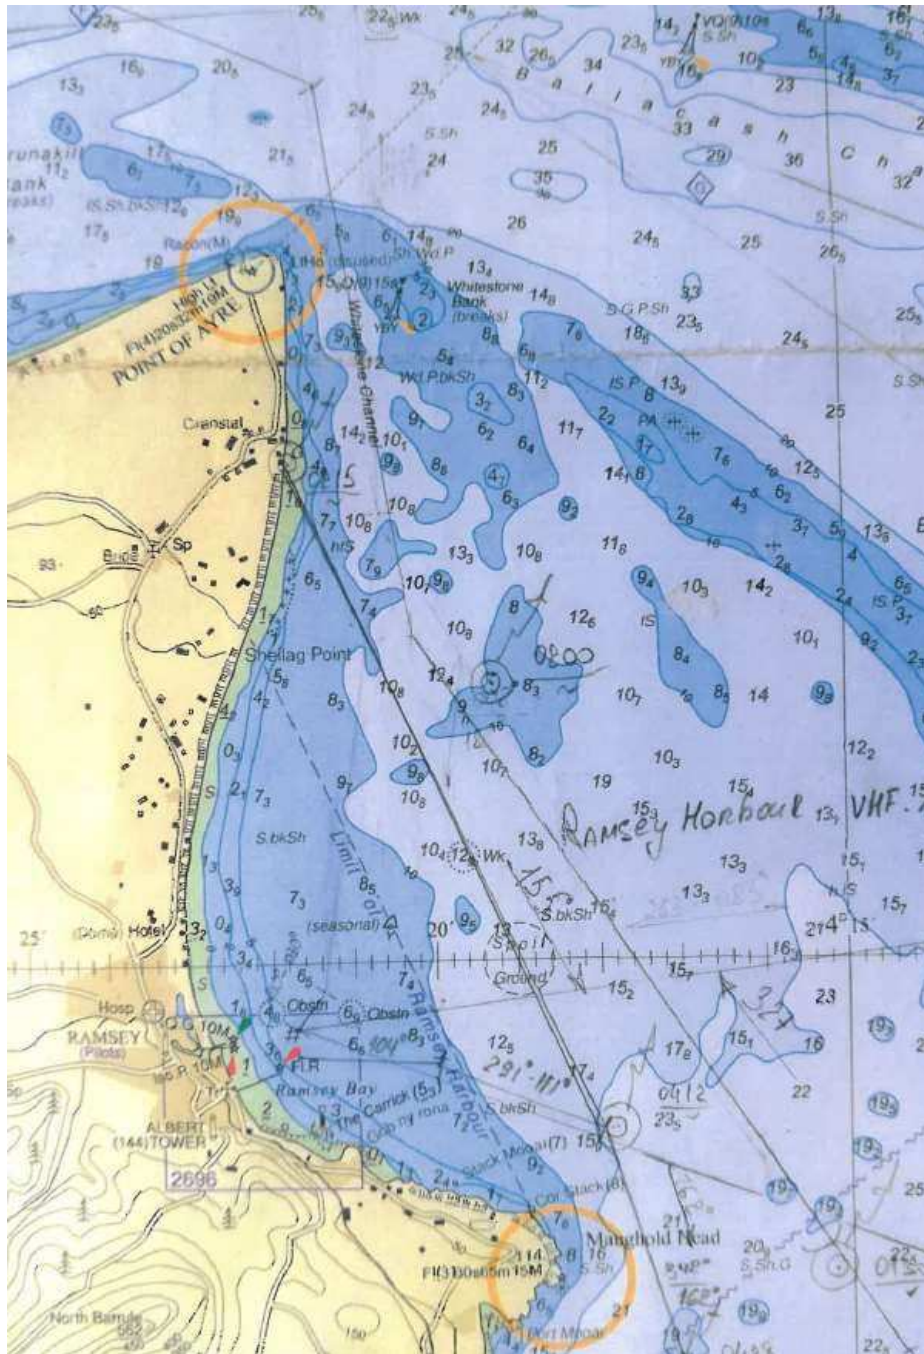
Chart extract showing the vessels position at 02:00hrs BST.

- A position marked on the chart at 02:00hrs put the vessel to the right of her intended track.
- The Chief Officer - due to sudden intestinal pain, left the bridge completely unattended to go to the toilet one deck below the bridge at some time between 02:00 when the chart was marked and 02:15 when the vessel was running aground and the BNWAS declared as sounding.

- The Master or the Engineer Officer, were not called to the bridge whilst the Chief Officer went to the toilet.
- The vessel's heading was not changed to the new course prior to the Chief Officer going to the toilet, which would have taken CEG Orbit away from a collision course with the shore.
- Due to the clear conditions, moonlight and proximity it would be expected the shoreline was visible to night adjusted eyesight.
- On the vessel's track and at the chart position indicated at 02:00hrs The Point of Ayre lighthouse would have been clearly visible.

Approximately halfway through her intended voyage, the vessel grounded in a position following the 327.1 bearing since the intended course alteration was not made.
