FINAL REPORT No. 4-02/ 3-18 (3-2019)

On THE ACCIDENT of AIRCRAFT BUCKER Bu 133C JUNGMEISTER, REGISTRATION SE-AJA ON JULY 8, 2018 AT BAUSKA DISTRICT

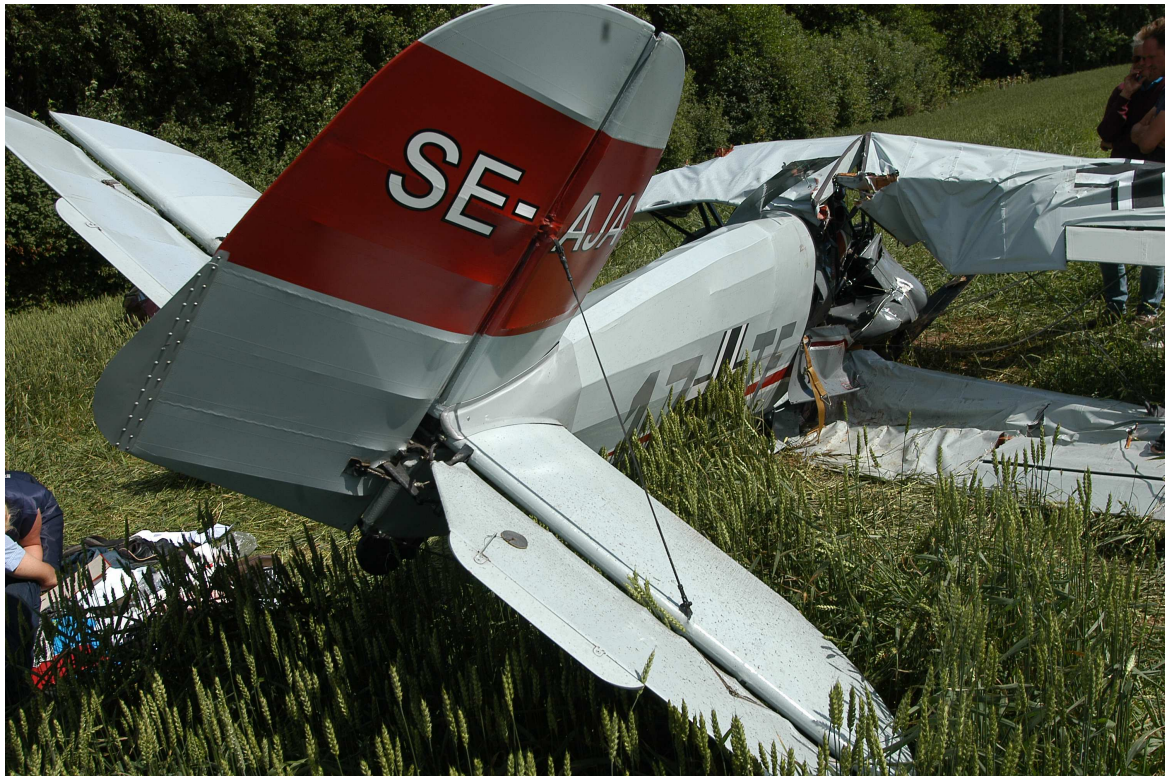
Picture 2 Accident site

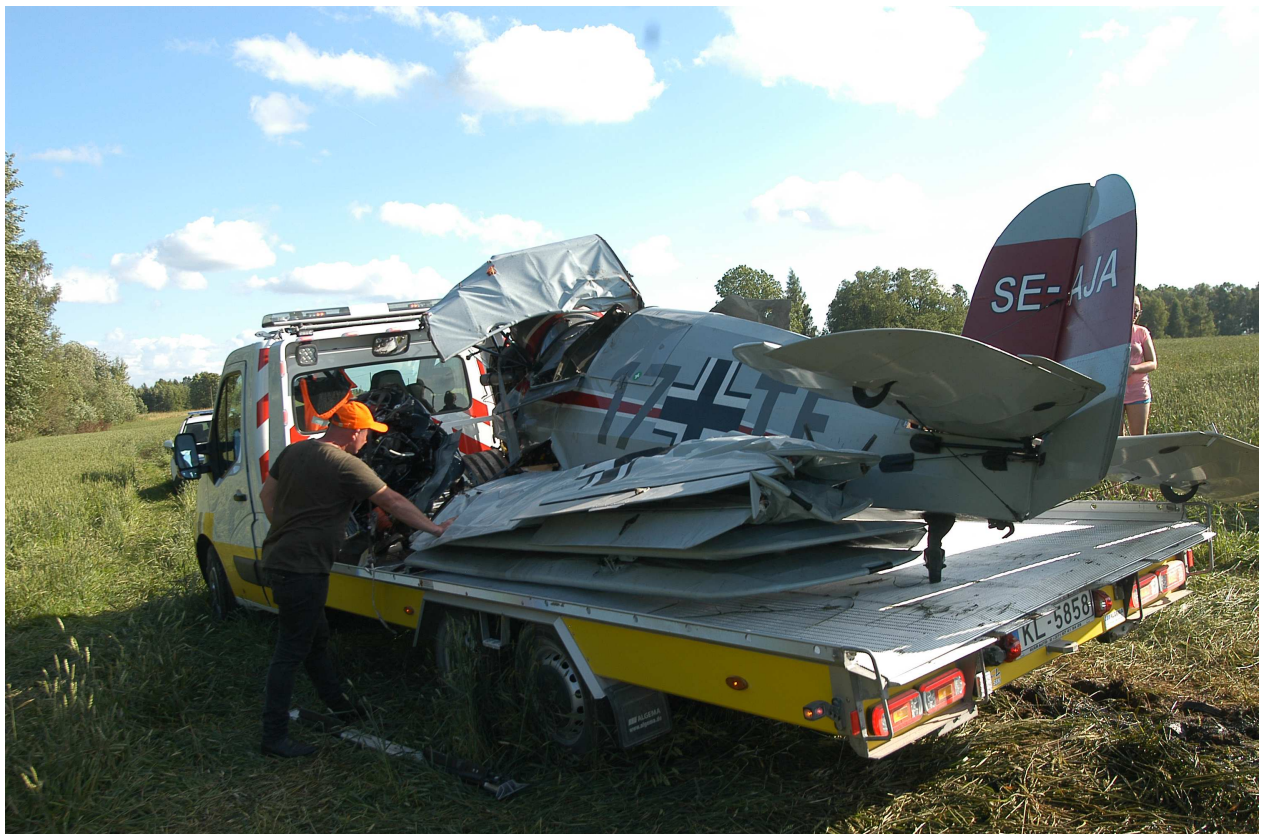
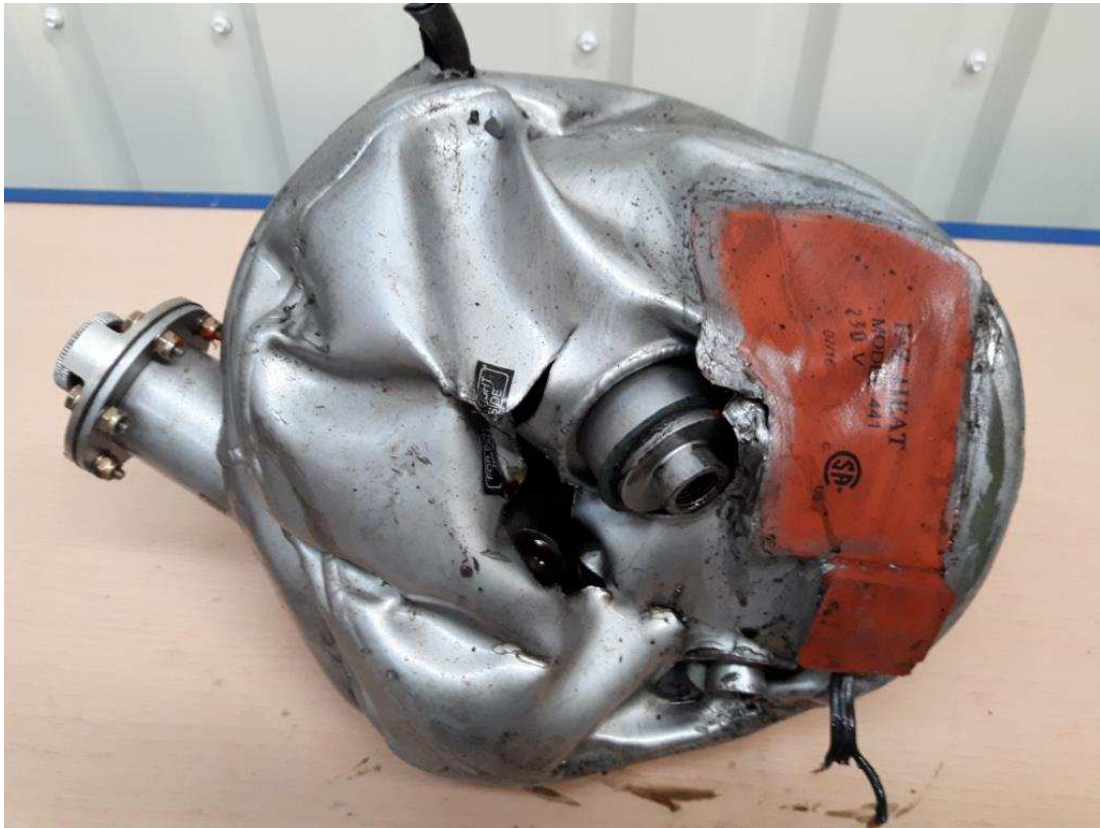
The aircraft was recovered from the accident site to the hangar of Transport Accident Incident Investigation Bureau. Inspection revealed that the front par of aircraft and engine elements sustained substantial damages, landing gear broken, propeller broken, aircraft wings deformed and control elements damaged. Oil tank was damaged and had raptured holes.

Picture 13 Damaged oil tank

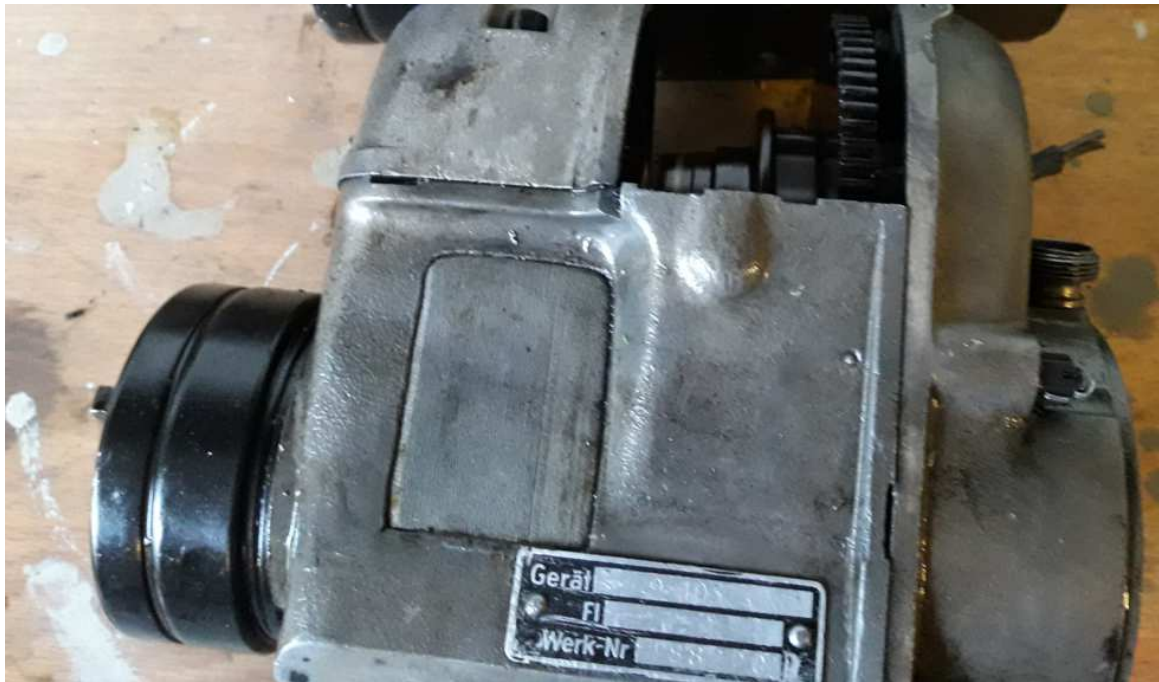
Checking of ignition point not performed due to engine elements damage, all valve rockers were rotatable, no signs of damage. LH Magnet free rotatable, no visible damage, RH Magnet jamming, cover broken.

RH Magneto jamming, cover broken.

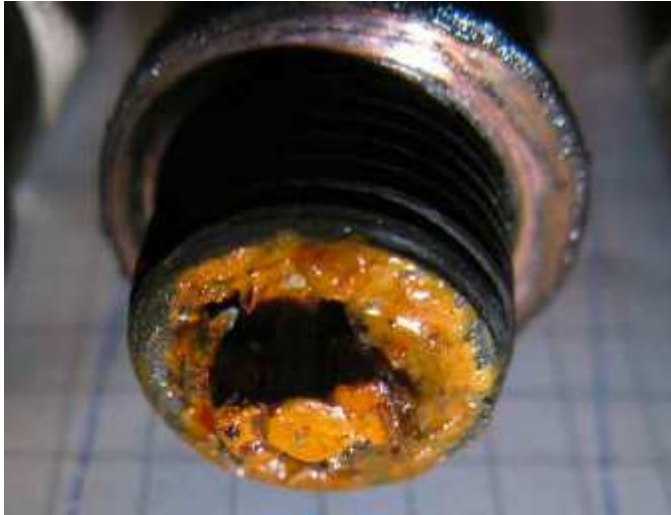
Spark Plug #6 front

The presence of water inside the engine and as result with severe plague and corrosion of Piston #6 and spark plug #6 also is the result of aircraft processing with water after crash.

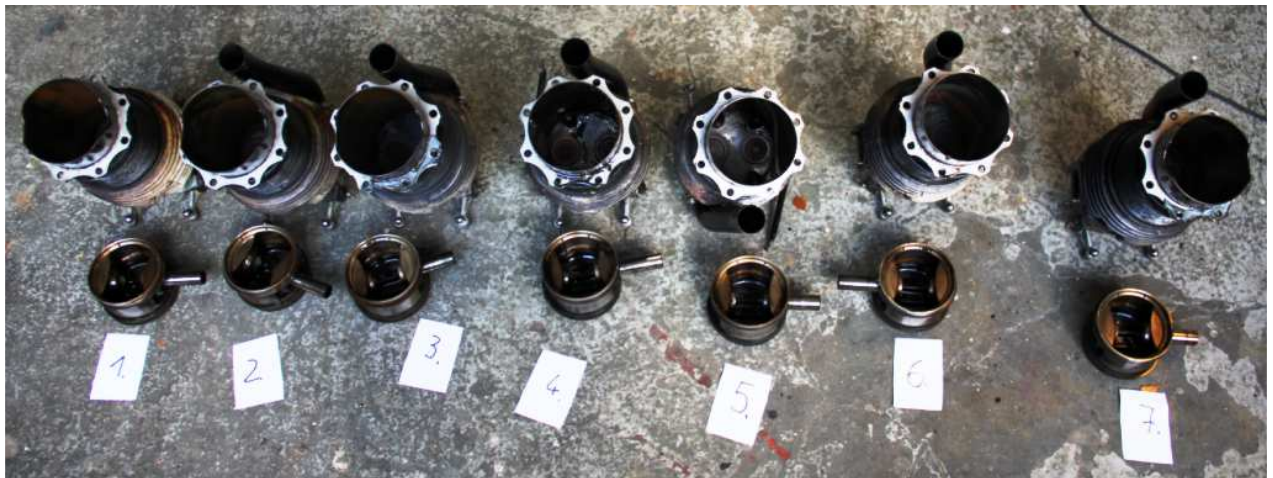
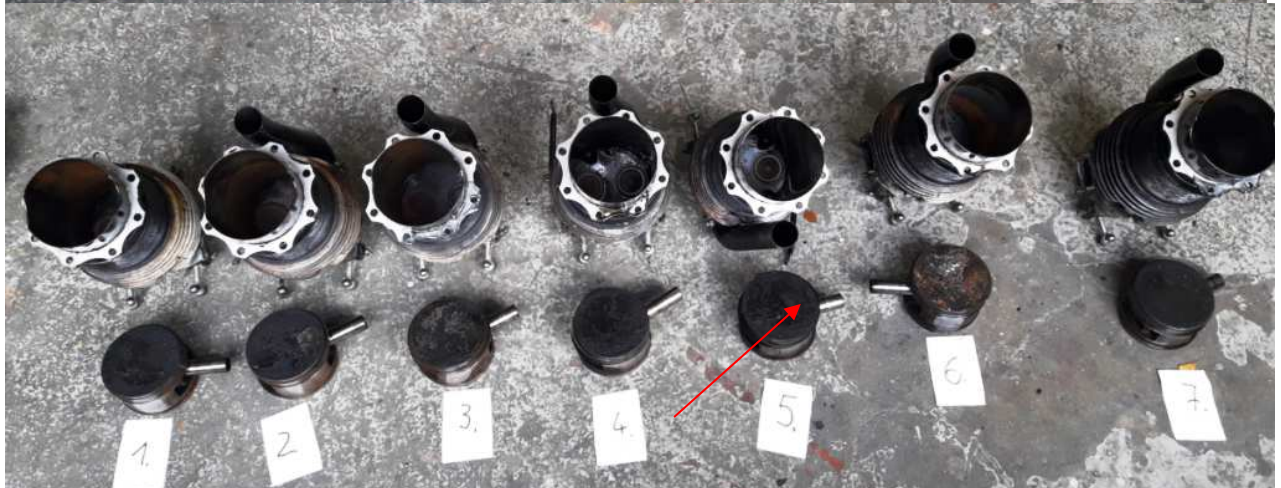
Cylinder 6 with signs of corrosion

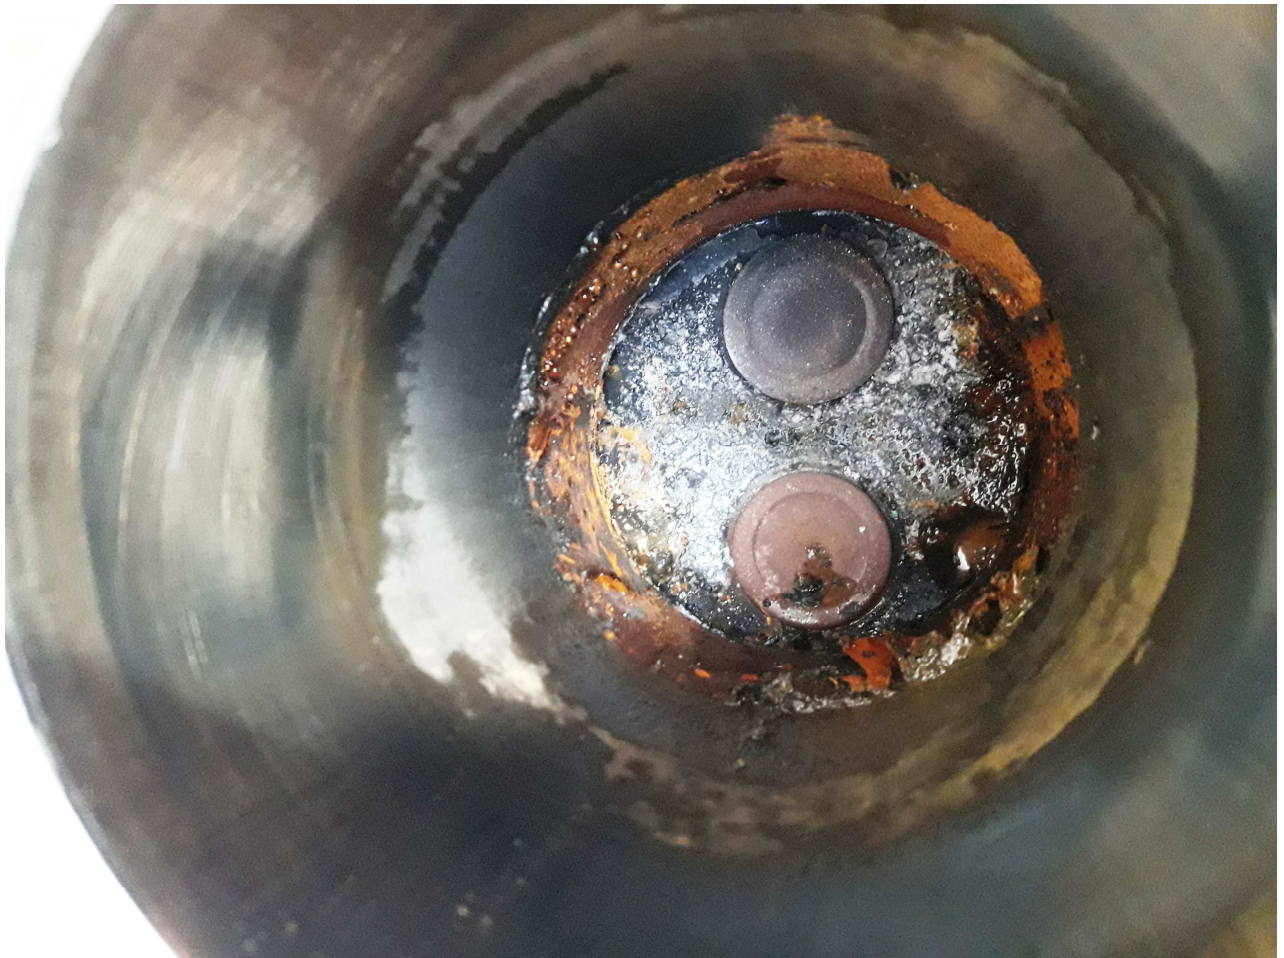
Piston #6 with severe plague and corrosion

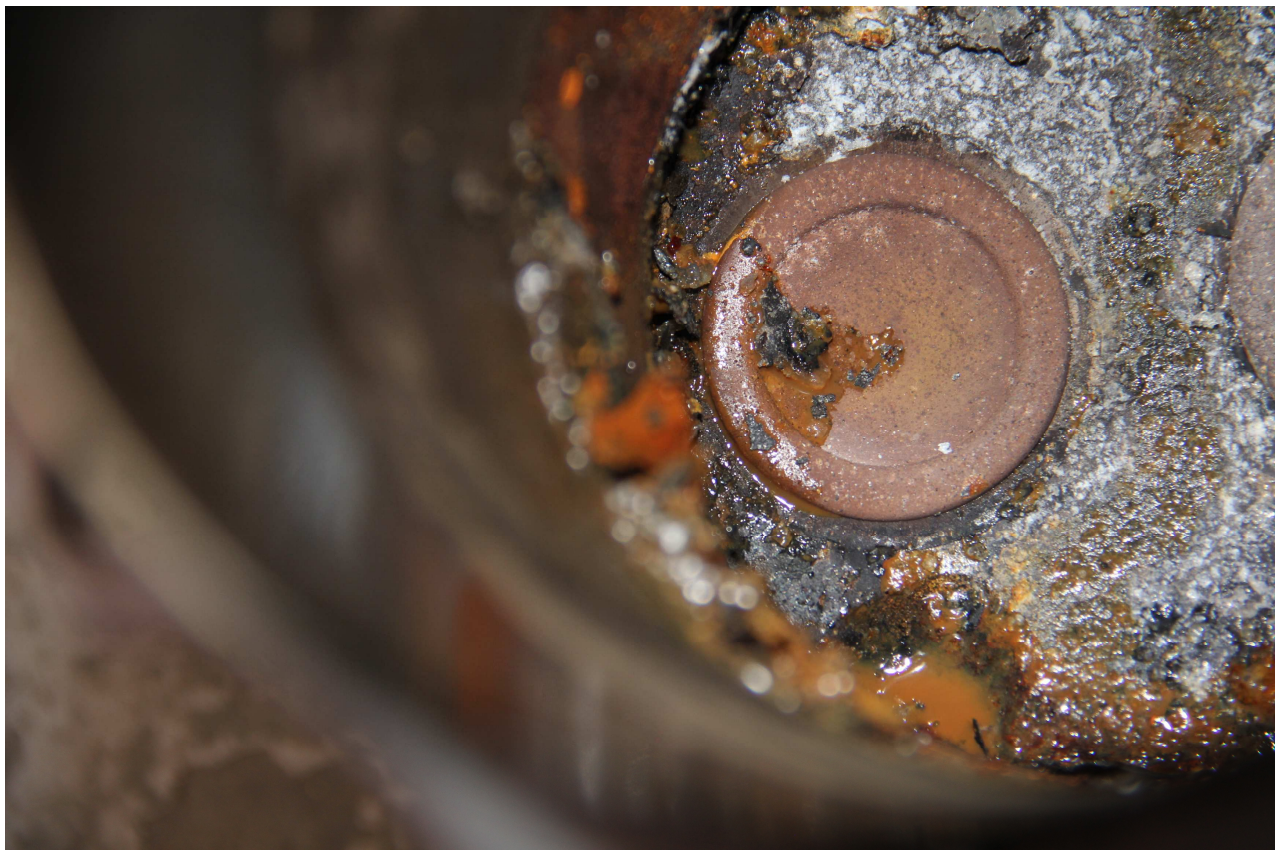
Piston #6 with severe plague and corrosion

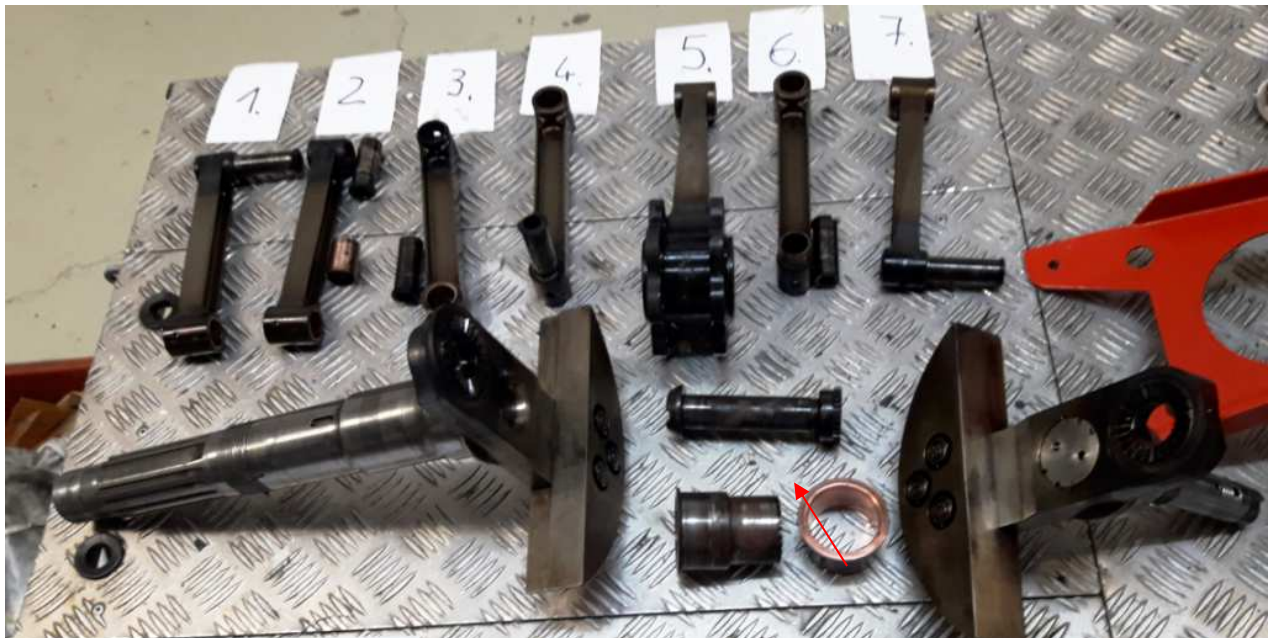
Crankshaft pin and bushing

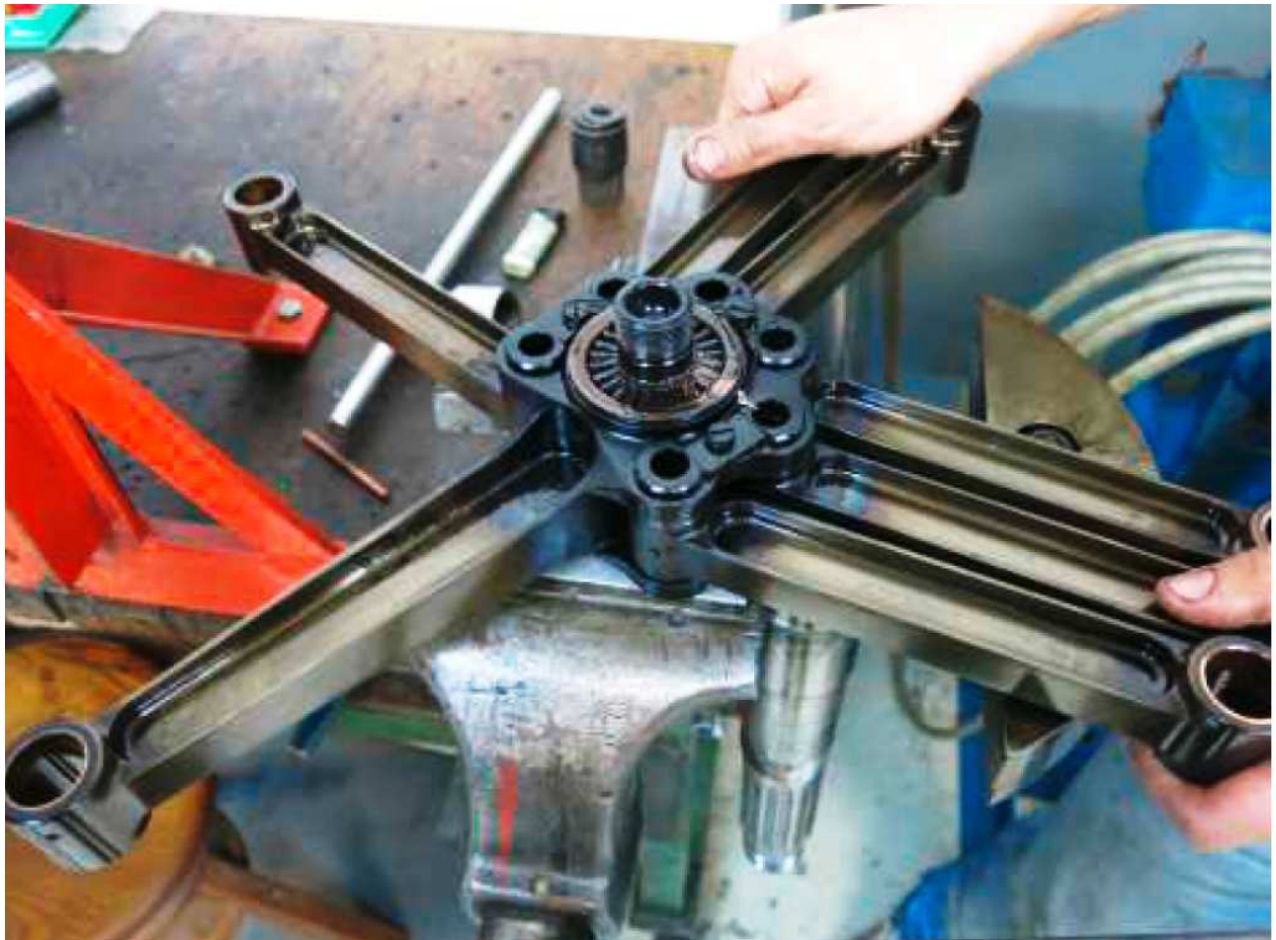
All piston rods showed blue colour marks on lower and upper end.

Piston rod assembly- blue colour marks on lower and upper end

During engine inspection there was no single mechanical failure found which may cause a loss of engine power. The engine showed clear traces of overheating and limited lubrication on the piston rod bearings.

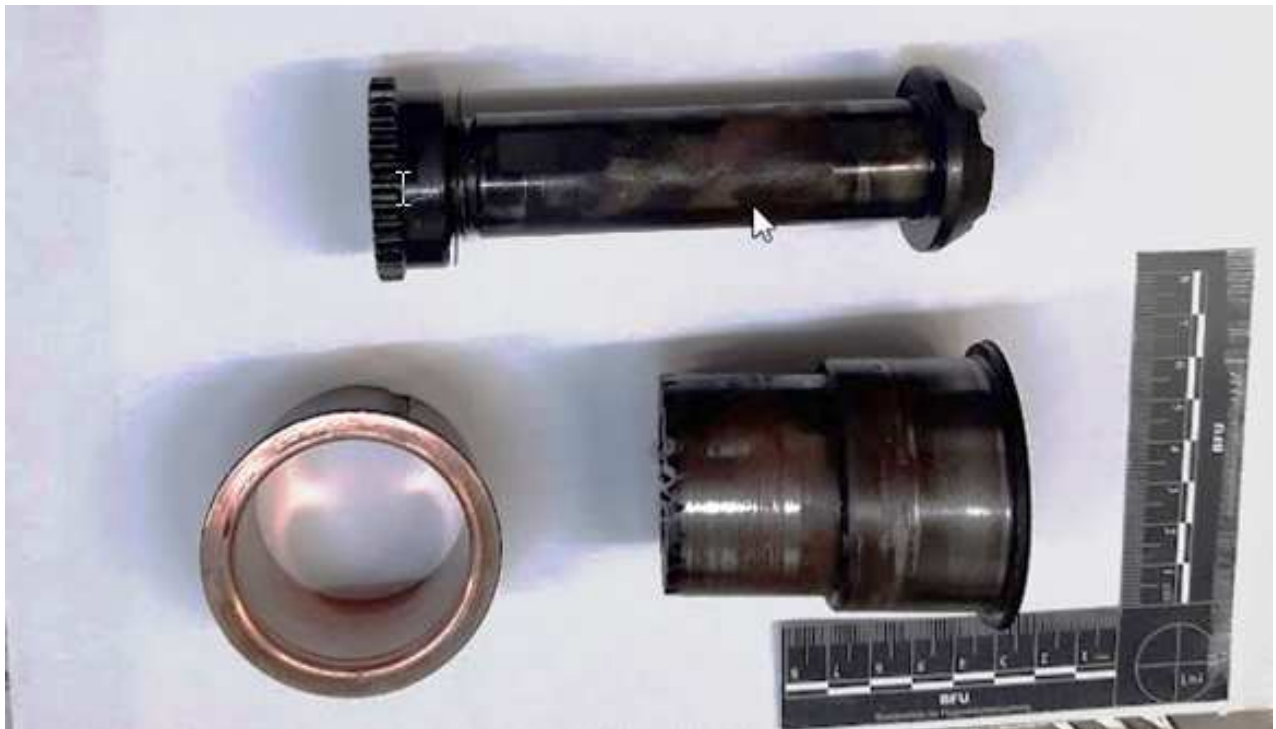
Crankshaft pin and bushing (magnified view)

Crankshaft pin and loose / front bushing of the big end bearing of the main piston rod. The front bushing of the big end bearing of the main piston rod was loose but fixed with the crankshaft. It showed severe wear. The rear bushing was fixed to the main piston rod but in a deflected (turned)

position (approximately 30°). Thus, the lubrication orifices (holes) were also shifted about 30 degrees respectively.

Due to the deflected (turned) position of the bushings the lubrication of the big end bearing (crankshaft) and small end bearing (piston) was interrupted as a result the engine had failed due to reduced lubricant (oil) supply.

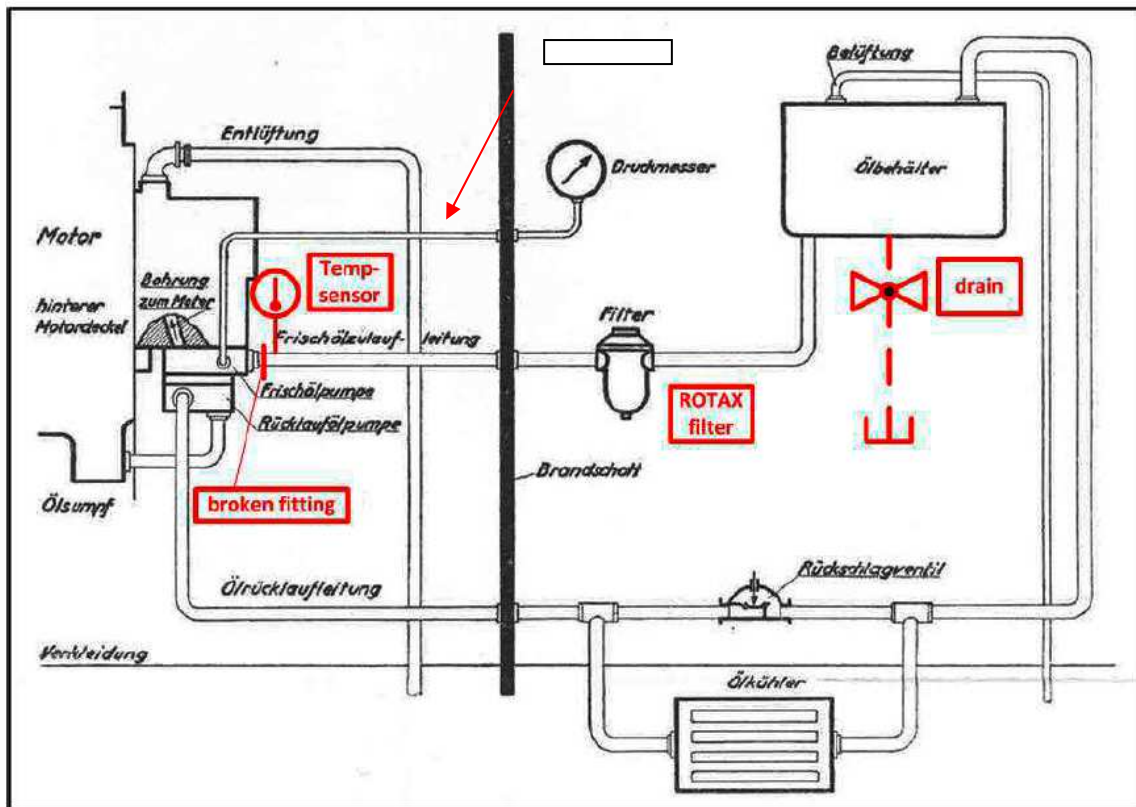
Actual oil system was different to the drawing - additional installation of an oil temp sensor and of a drain valve on the oil tank. Installation of a non-standard oil filter (ROTAX, Part No: 825014/016) (see drawing - parts in red). Connecting hoses were non-standard. Oil tank was seriously damaged.

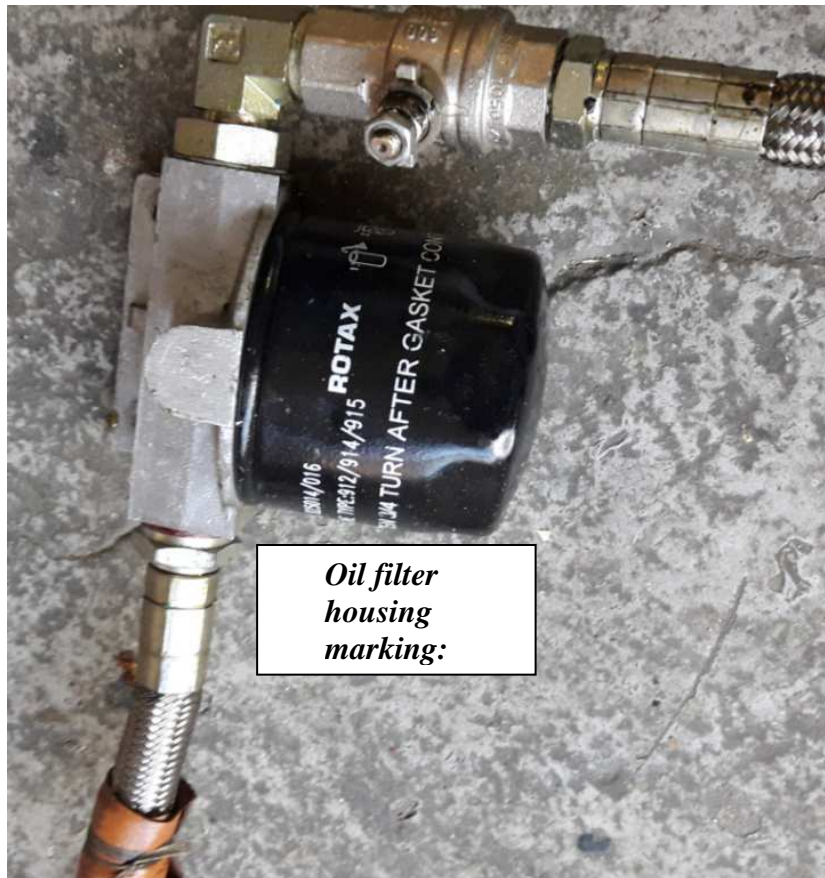
Actually installed oil filter on the engine

During an accident investigation of a Bucker 133”Jungmeister it was stated that an oil filter “ROTAX” installed on the aircraft fire bulkhead is not in compliance with type certification of the Siemens/Bramo Sh 14 A4 engine and as result could be possible the limited oil flow if filter is installed in the suction line.

1. The oil filters of the affected aircraft must be inspected. All installed oil filters must be in compliance with the type certification of the aircraft.
2. All oil filters which are not in compliance with the type certification of the aircraft must be replaced. Information about approved oil filters can be found in the declared manufacturer’s spare part list.

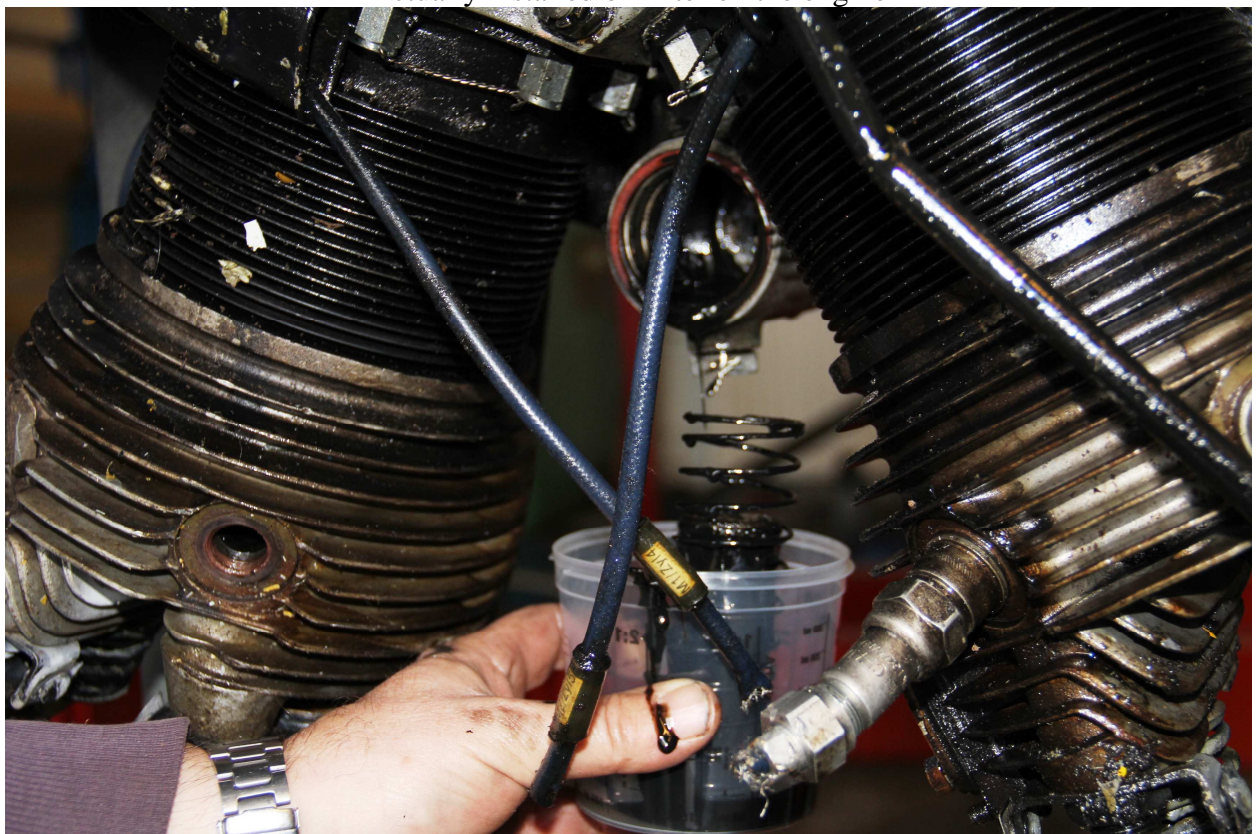
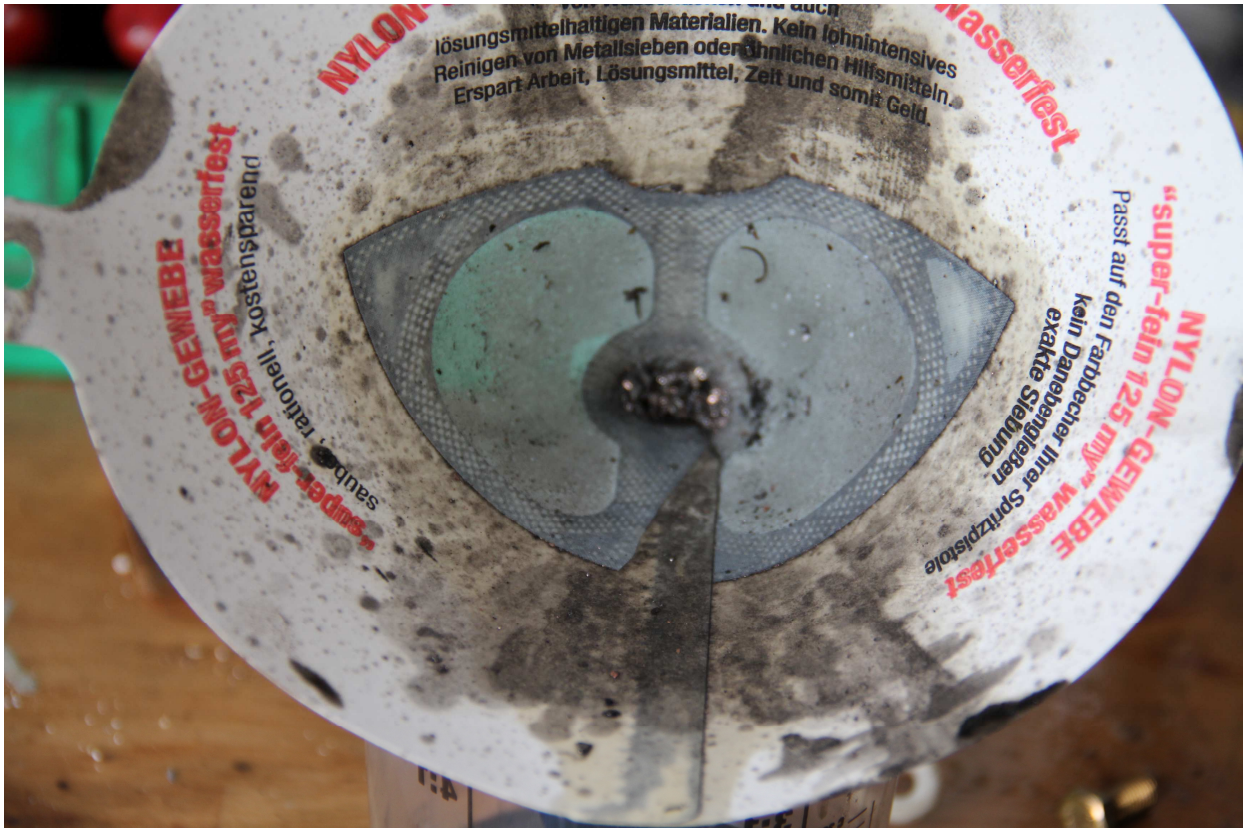
Coarse filter was loose and not secured. There was a noticeable amount of water in filter housing. There were found metallic particles in the filter – mostly bronze colour.

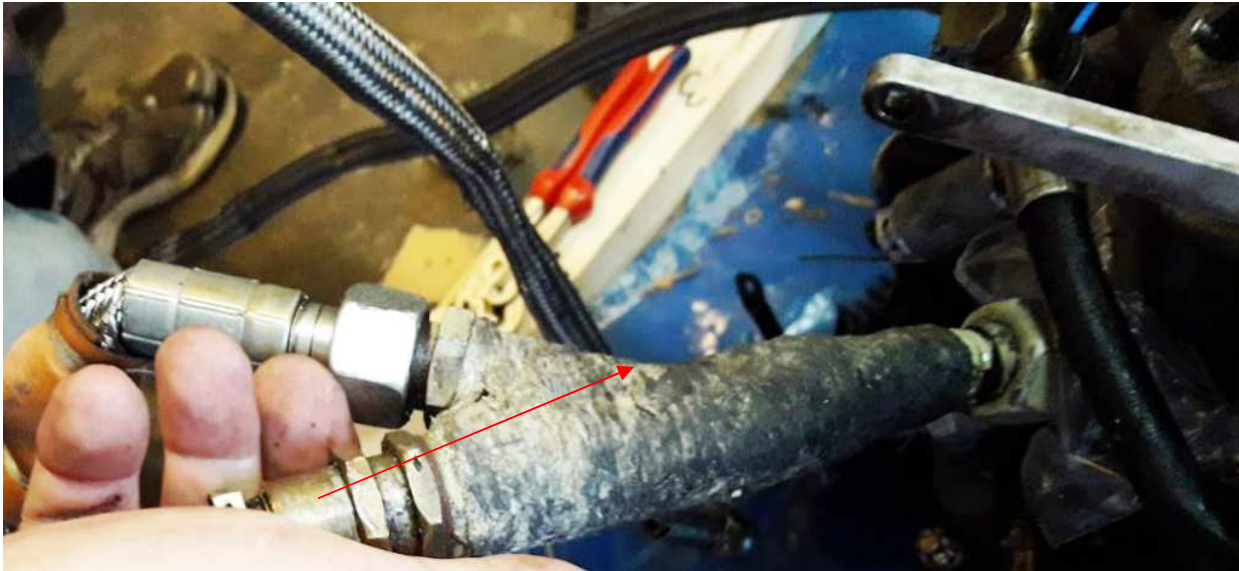
Temperature sensor with broken fitting

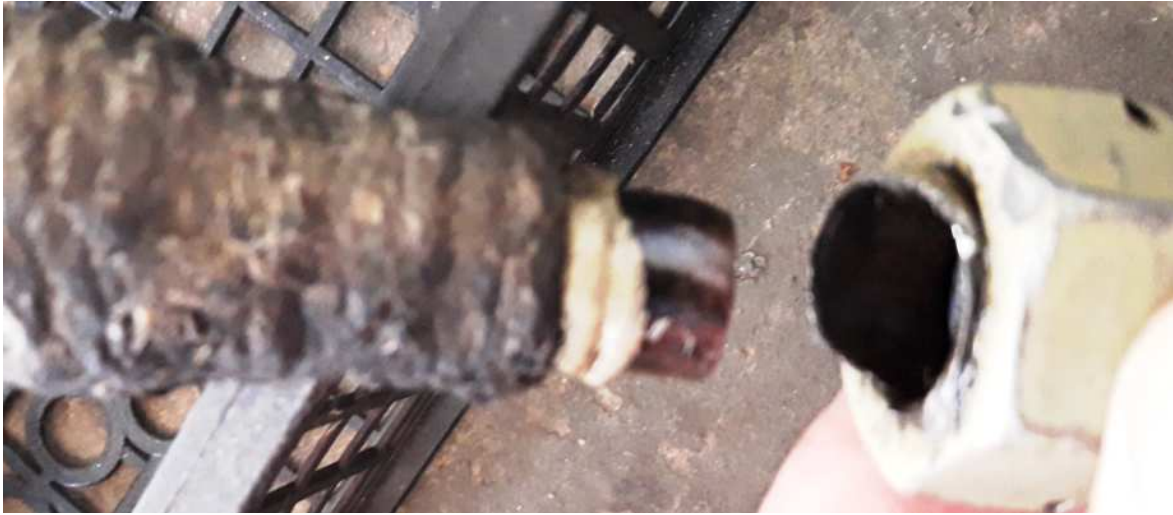
Fitting on the oil pump (to oil filter) was broken. The fitting was loose and there was a plastic cover foil on the fitting over the throat.

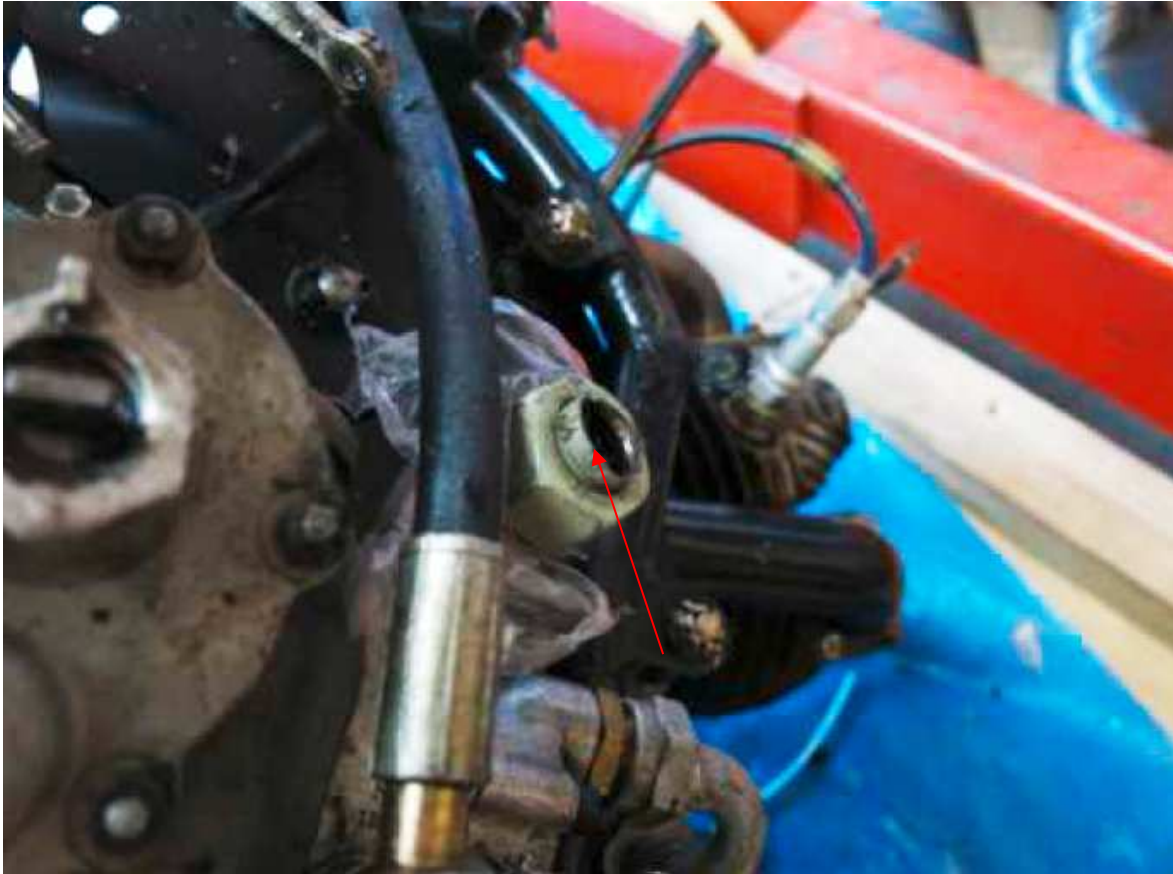
Broken fitting on the oil pump (to oil filter)

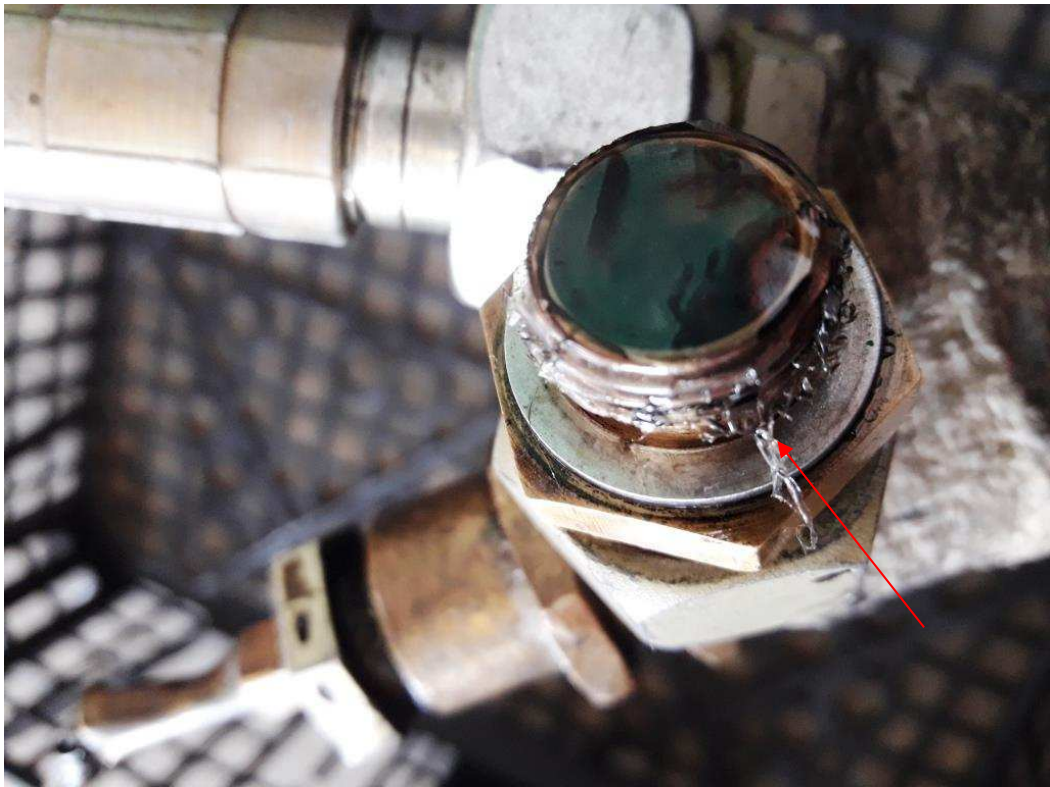
The fitting over the throat was covered with plastic foil and roped up with metallic wire

The investigation revealed that the plastic foil over the throat of the broken fitting was covered and roped up with metallic wire during preparation of the aircraft for transportation to hangar to avoid oil leakage.
