FINAL REPORT No. 4-02/1-16(1/2017)

INVESTIGATION SEPARATION MINIMA INFRINGEMENT BETWEEN THE AIRCRAFT LANCAIR EVOLUTION, REGISTRATION N503AL and AIRCRAFT Boeing B738, flight RYR-55RM IN RIGA FIR (56°45'09"N 023°08'43"E) ON APRIL 21, 2016.

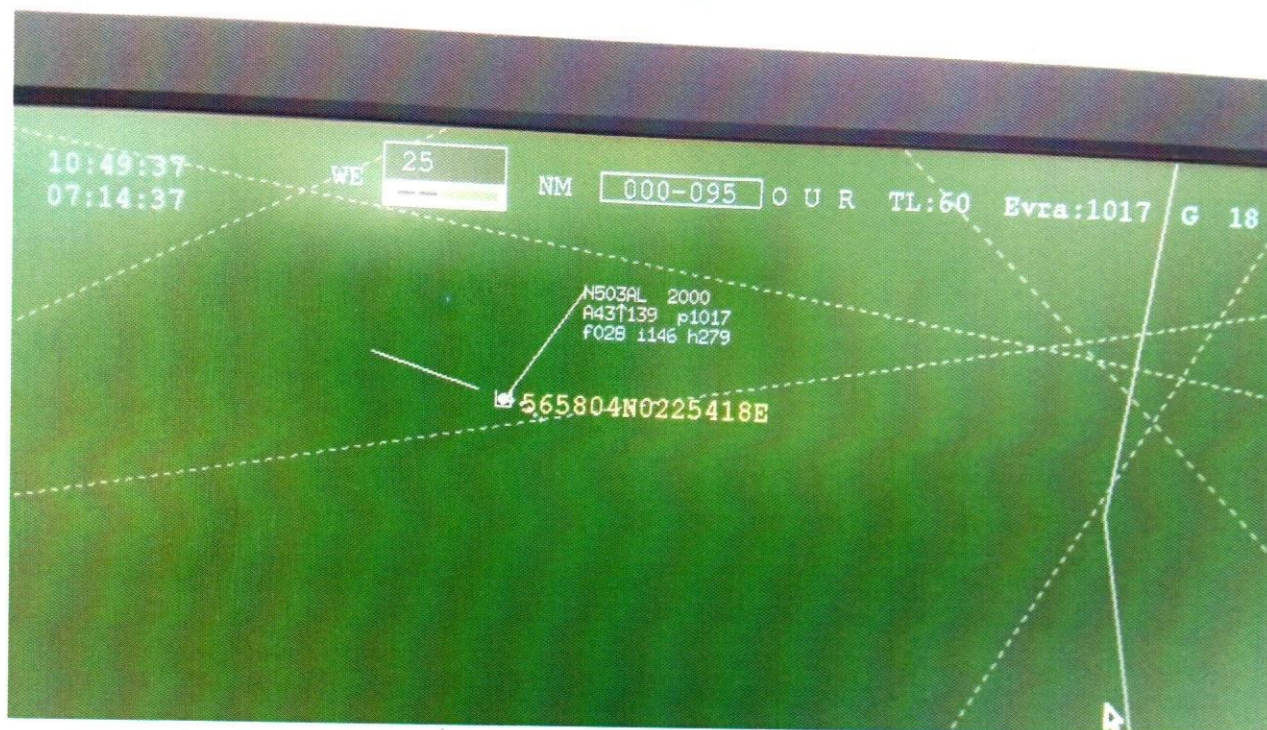
At **07:14:37** involved in the incident aircraft N503AL, crossing level 4200FT, established first radio contact with the APP Controller on frequency 129,925MHz: **"Riga "Approach" N503AL"**. At that moment aircraft was flying in controlled airspace already (see Figure 1)

Radar picture 1. ATCC radar data at 07:14:37 when NA503AL established first contact with APP Controller

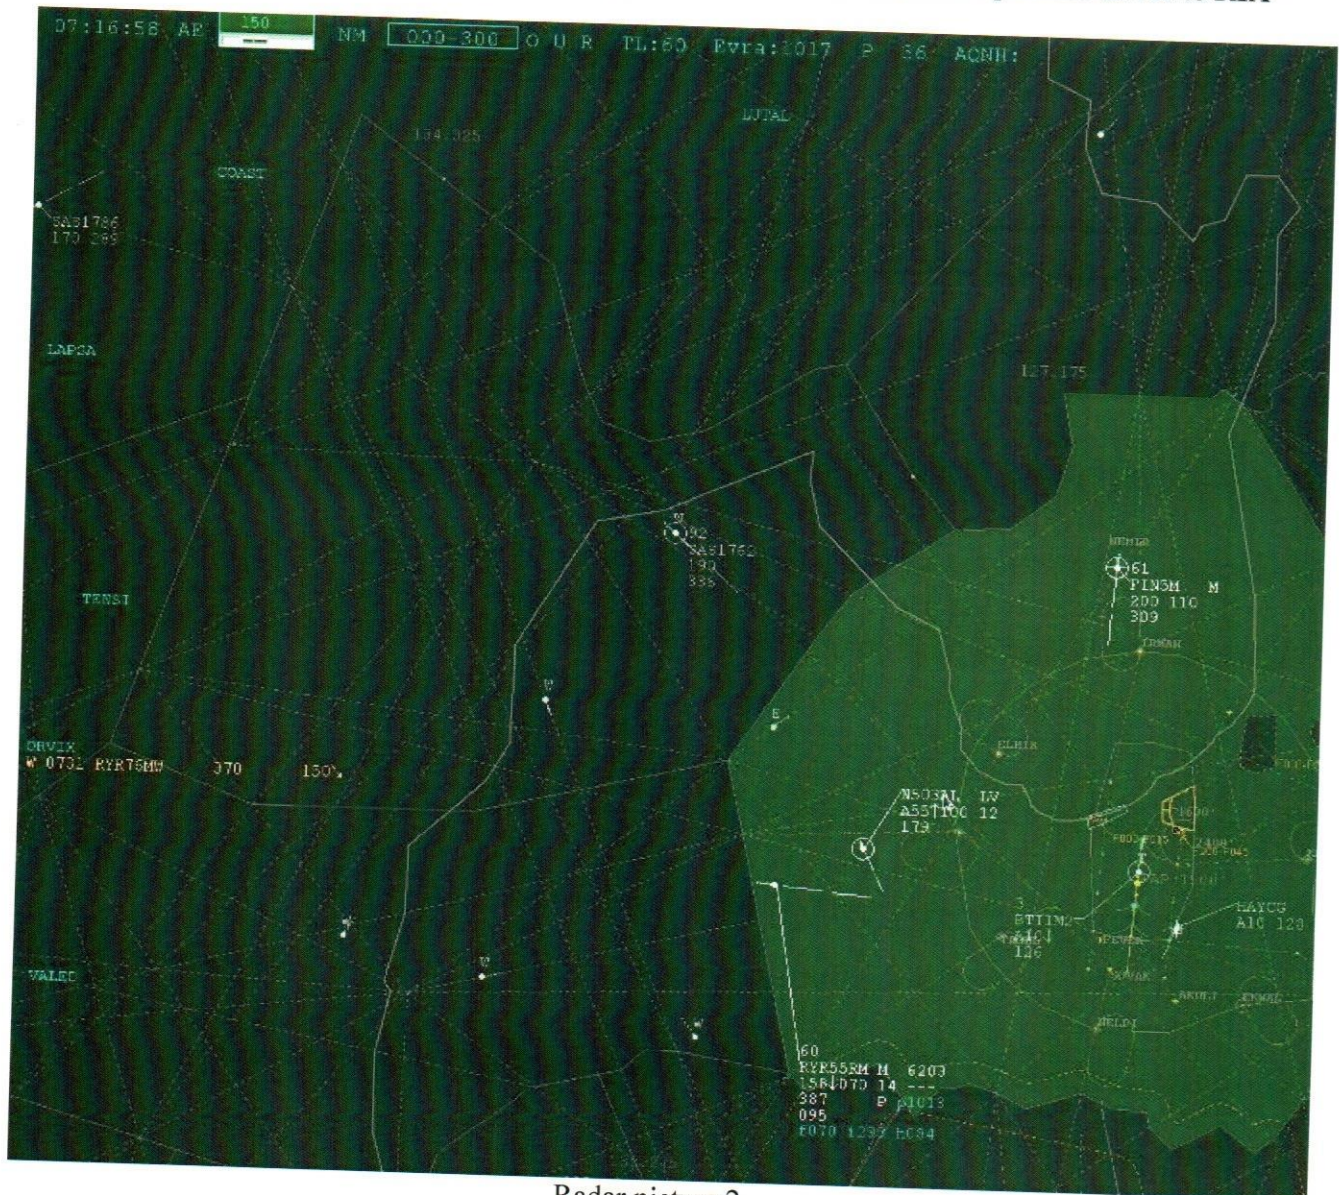
Radar picture 2.

At **07:16:58** the Controller gave instruction to pilot of N503AL ***”N-AL from present direct to RIA”***

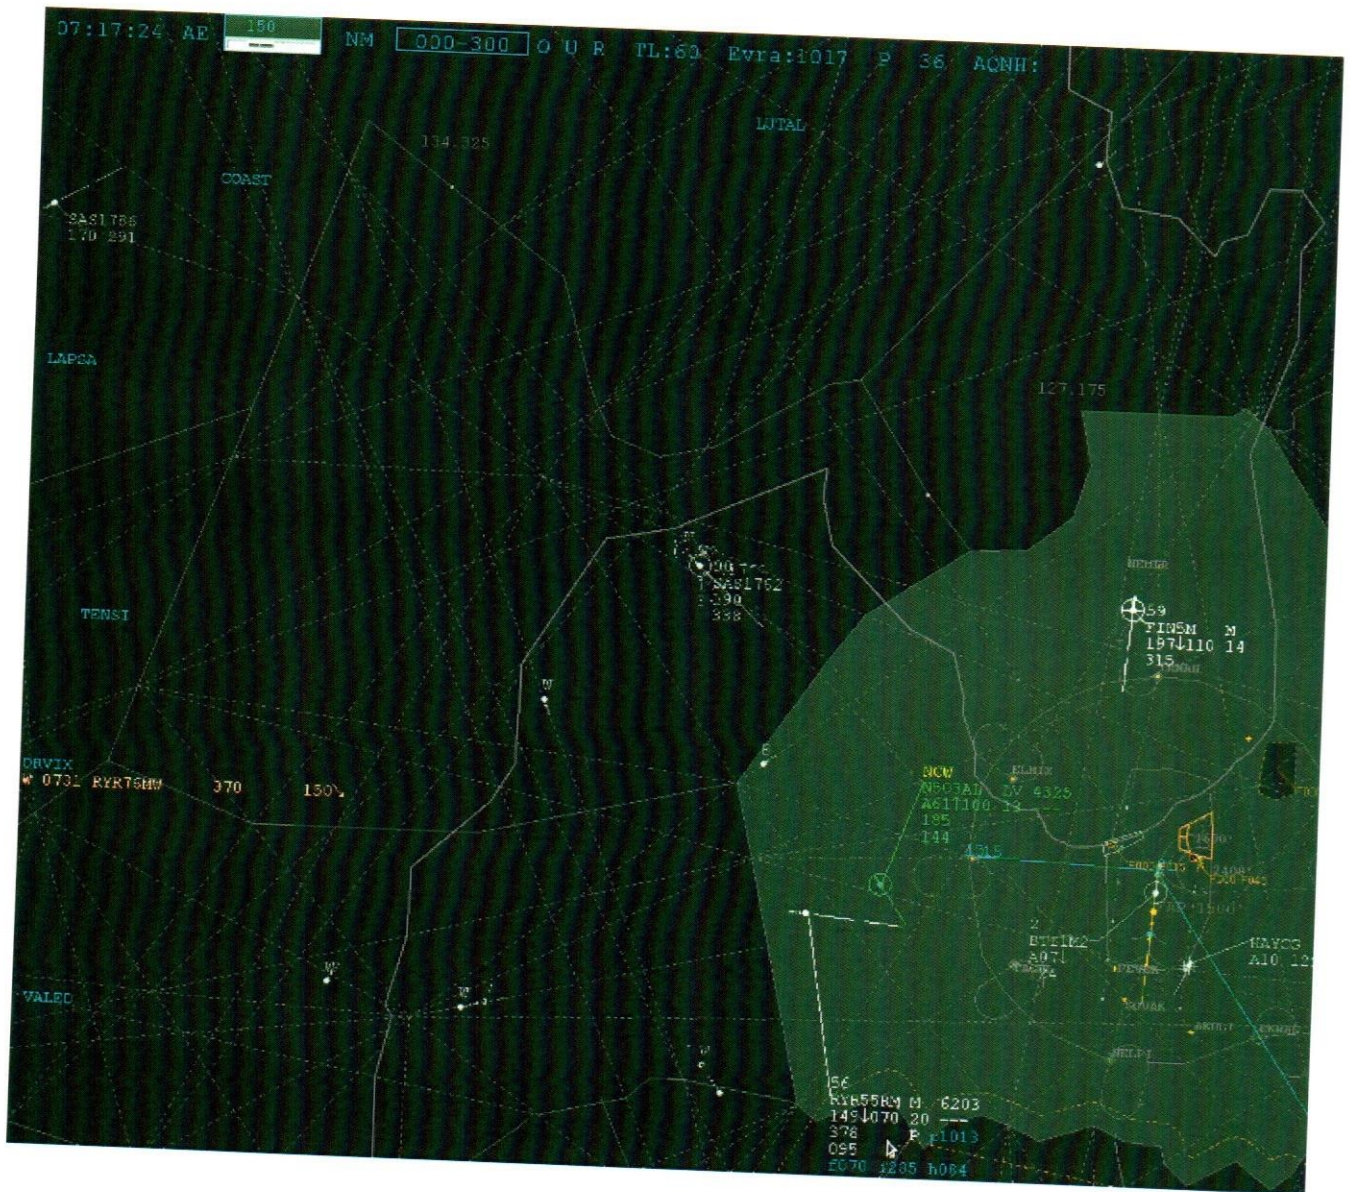
Radar picture 3.

N503AL at 07:17:24 was flying in the controlled airspace to direction ERIVA, but no direct to RIA as according to flight plan as well as according by Controller clearance.

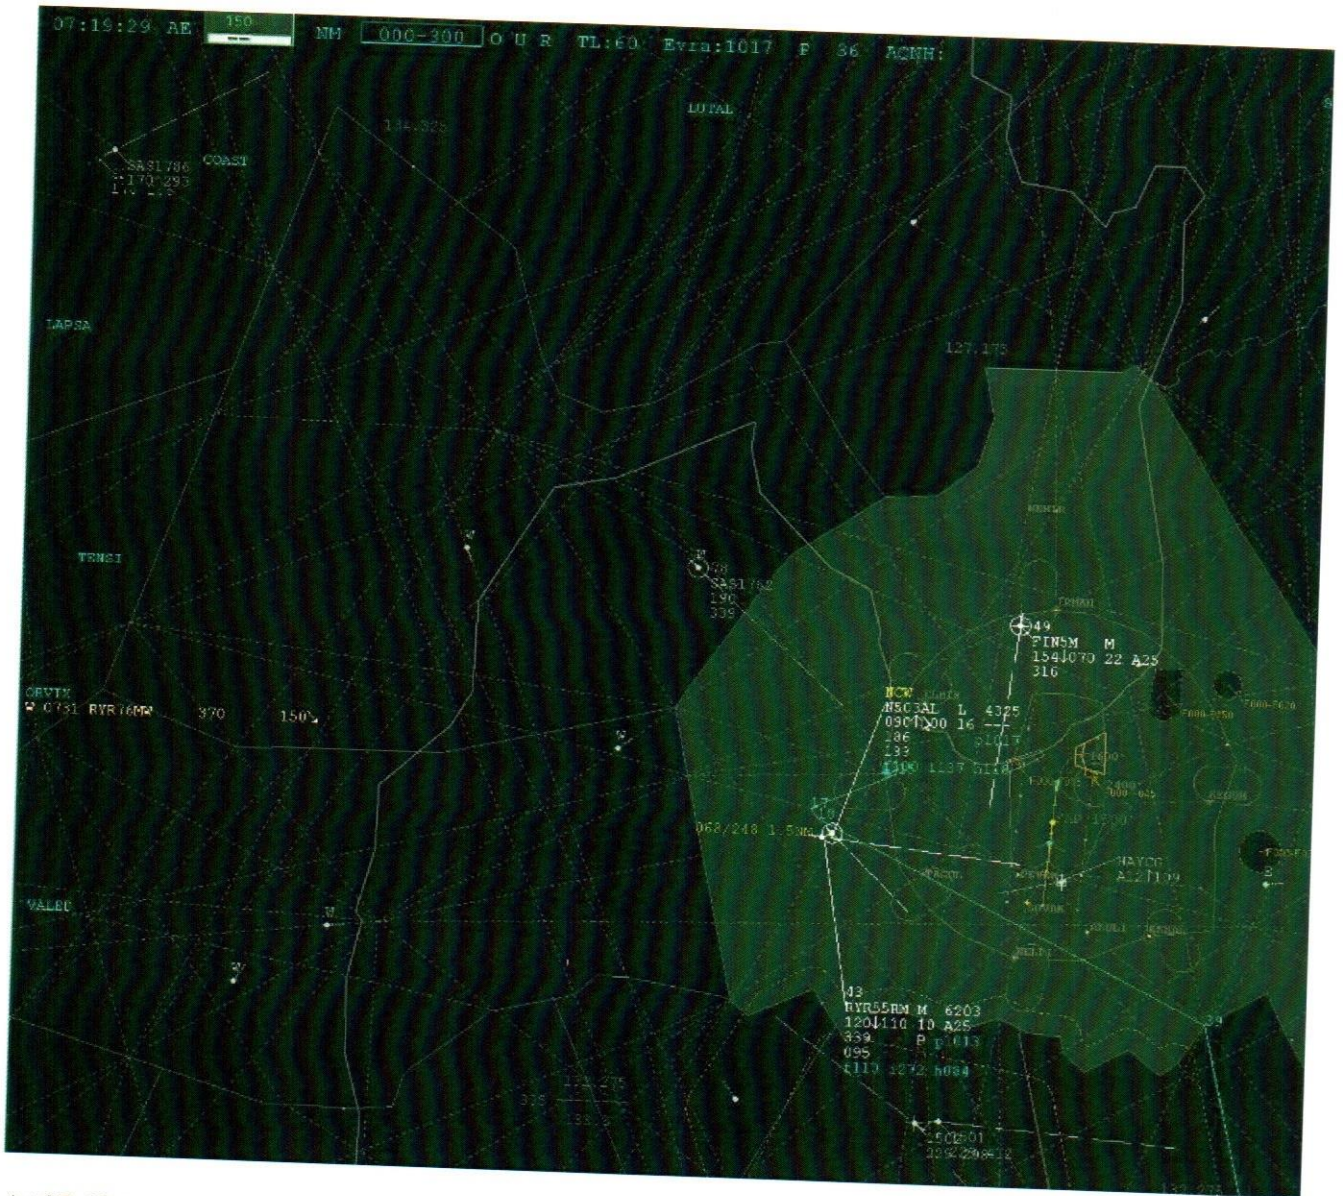
Radar picture 5.

At 07:19 29 N503AL was at FL 90 climbing to FL 100.

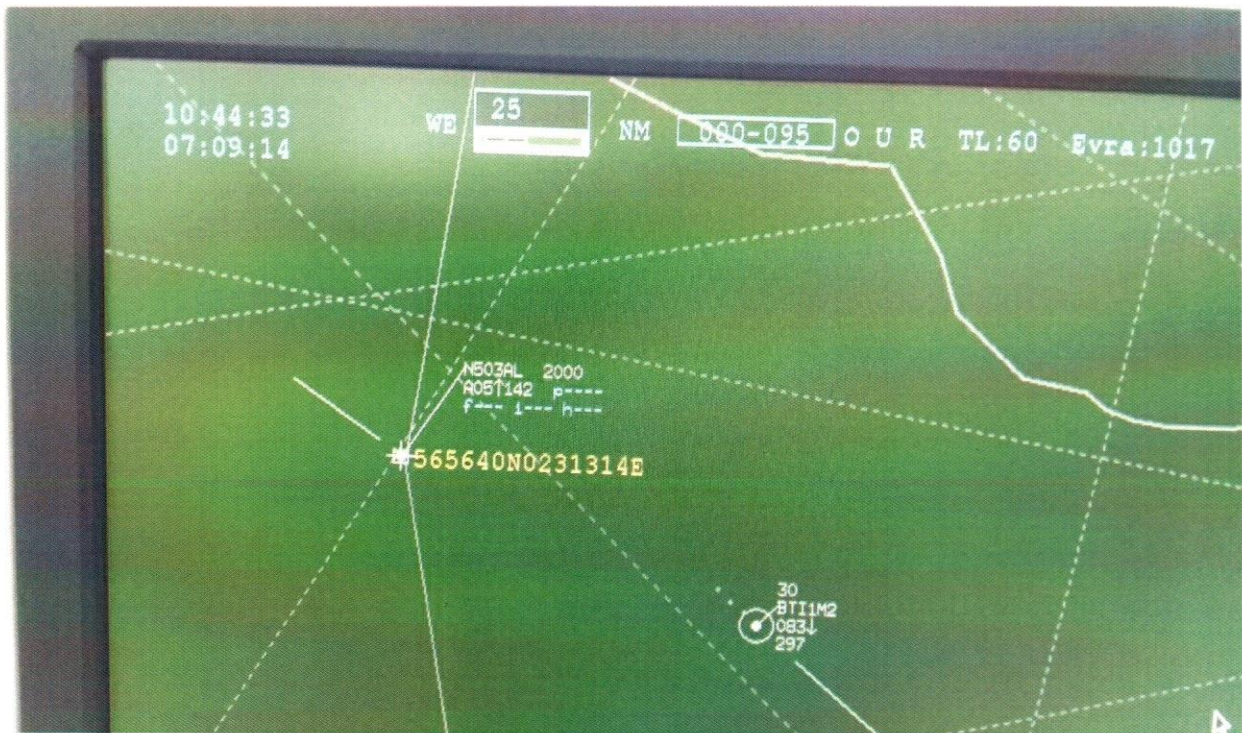
Radar picture 12.

At **07:09:14** N503AL was flying already in the controlled airspace (565640N;0231314E)

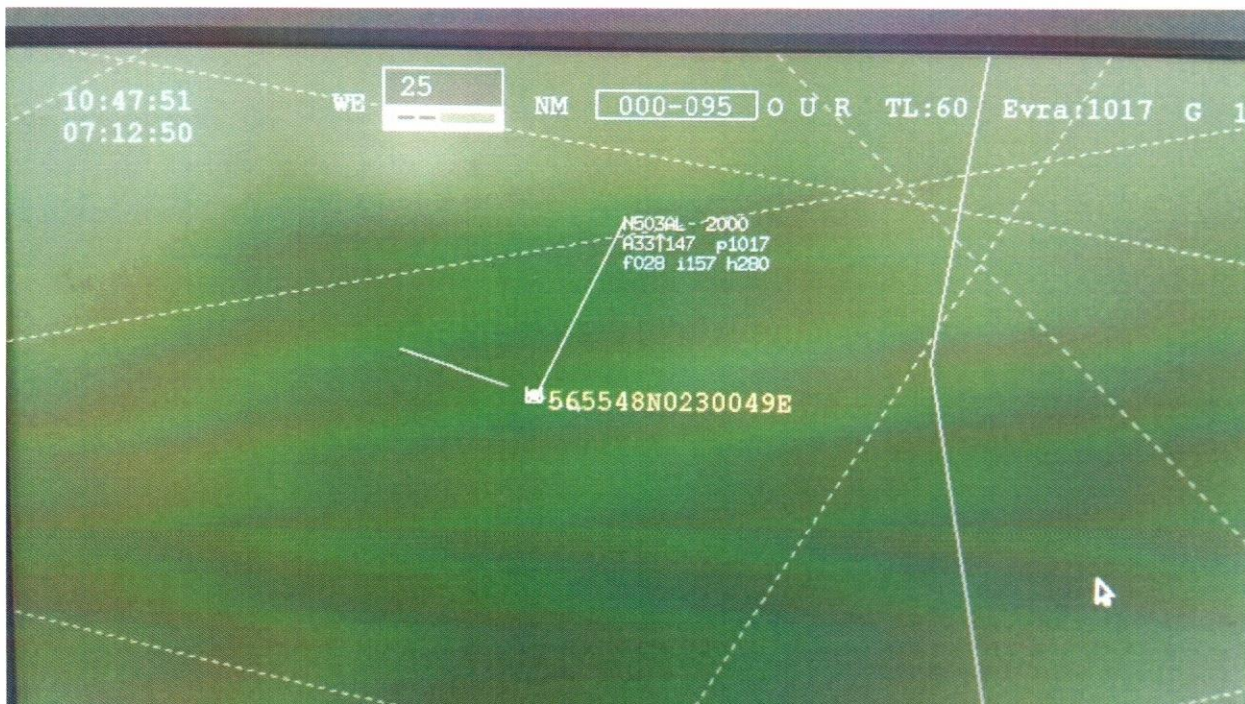
Radar picture 13.

At 07:12:50 N503AL still was flying in the controlled airspace without APP controller permission

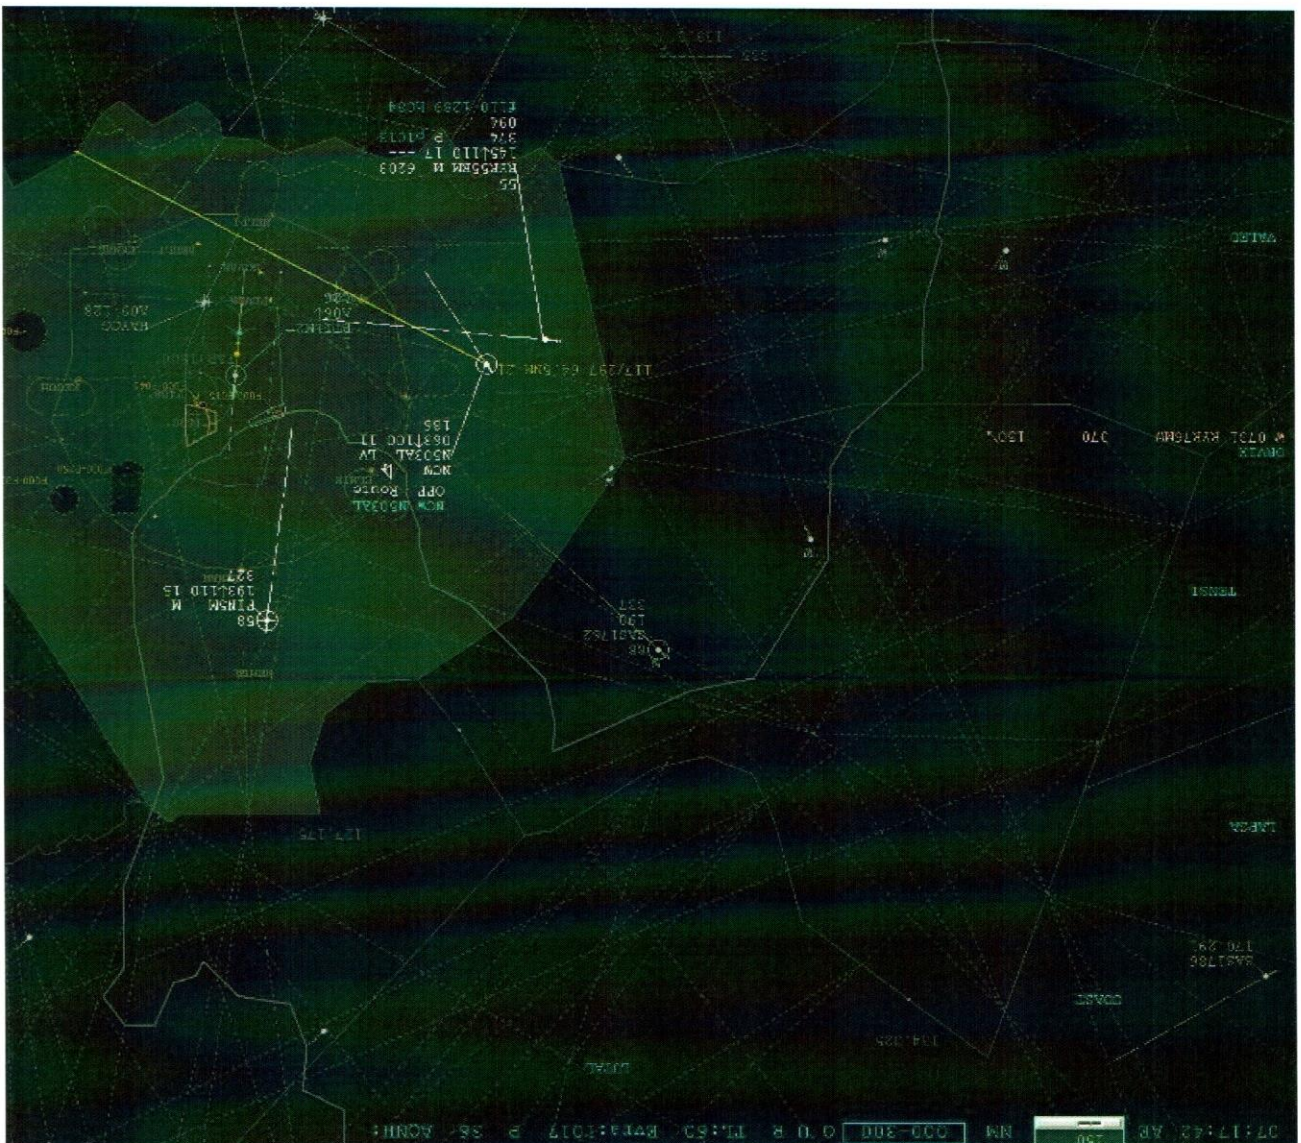
Radar picture 15. According to Mode S information flight level set on the N503AL is 100

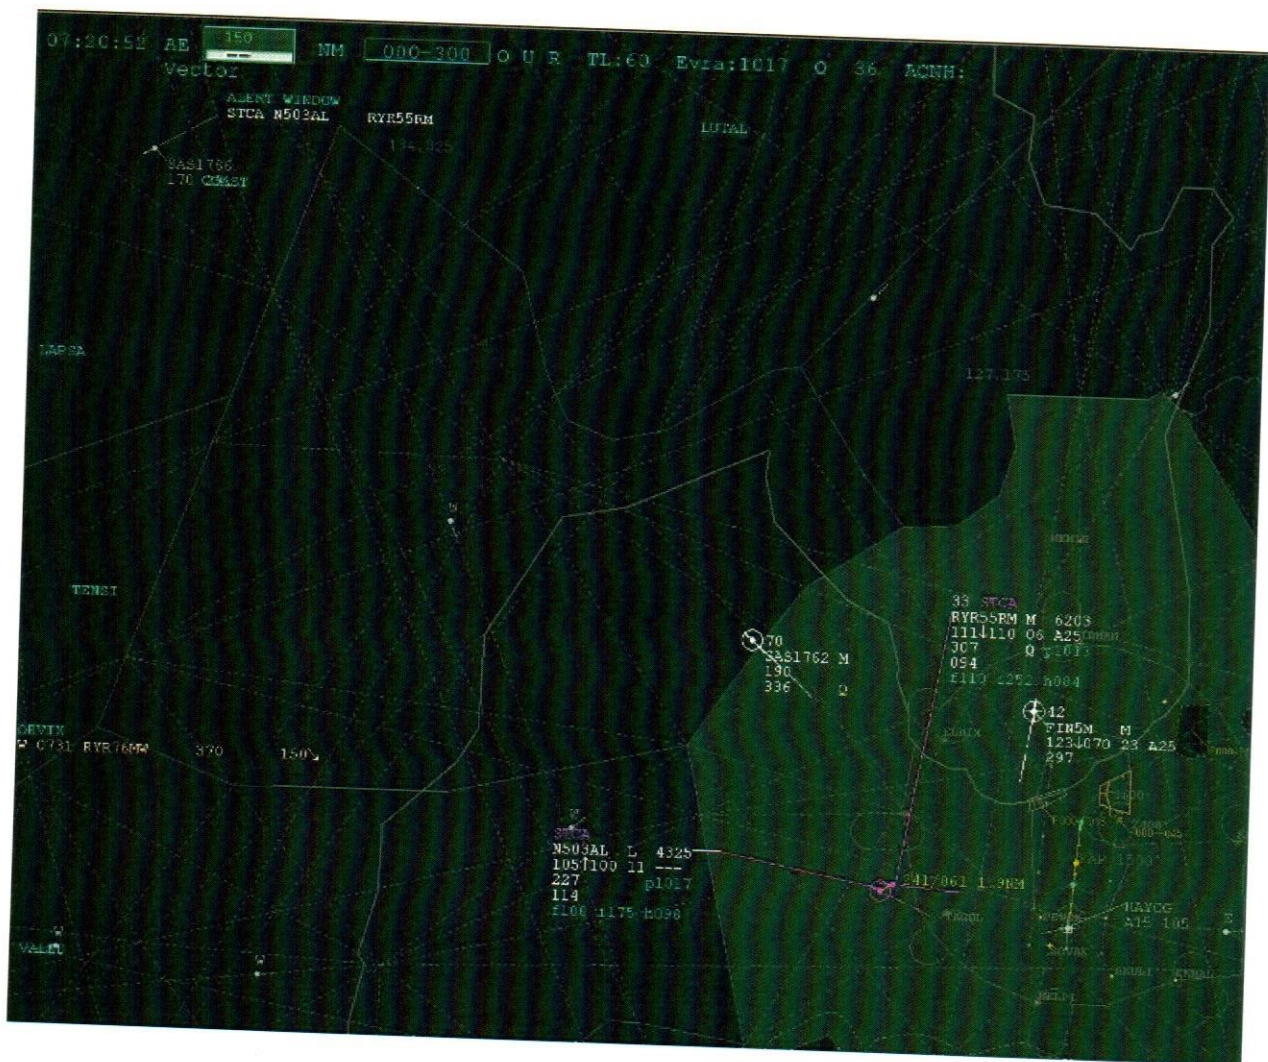
Radar picture 16. STCA triggered on

When STCA triggered on APP controller instructed pilot of N503A to maintain FL 100 and warned about aircraft vicinity: “N-AL maintain flight level 100, traffic above”. The pilot confirmed clearance: “Maintain 100 due to traffic”. The pilot did not hold controller’s authorized FL 100, continued climbing, level bust occurred and the aircraft crossed FL 108 at final.

Infringement of the horizontal and vertical separation standards was a consequence of the fact that the pilot of aircraft N503AL did not maintain (level bust) APP controller's authorized flight level 100 and climbed to FL108.
