FINAL REPORT No 4-02/1-23(1-24)

on the serious incident to the aircraft Airbus A220-300 (CS300) registered YL-AAP operated by airBaltic runway excursion at the Riga International Airport (RIX), on March 8, 2023

Investigation No 4-02/1-23	Aircraft Registration: YL-AAP
Aircraft: Airbus A220-300 (Bombardier/BD-500-1A11(CS300))	Type of flight: Scheduled (BT 694), IFR
Engines: Pratt & Whitney PW1521G-3	Flight: BT1-4HE
Crew: 6	Passengers: 89
Place: Riga, Latvia	Date and Time: 2023.03.08/21.18 UTC

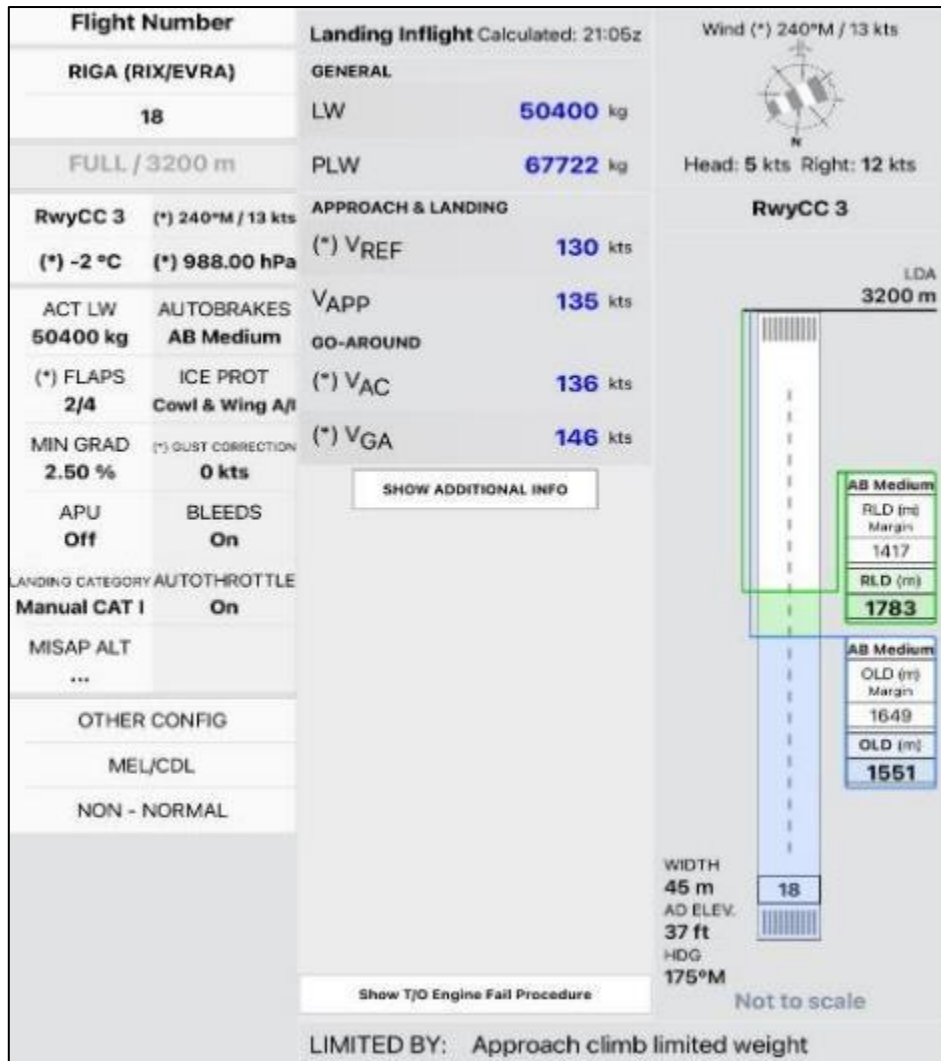
Figure 4: Landing performance

During the calculation the module calculated the operating landing distance (OLD) (see Figure 4).

The aircraft landing performance was calculated:

- Aircraft weight: 50400kg
- Flap 2/4 configuration
- Vappr: $V_{ref} + 5kt = 135kt$
- Autobrake Medium was selected
- The final approach was stabilized

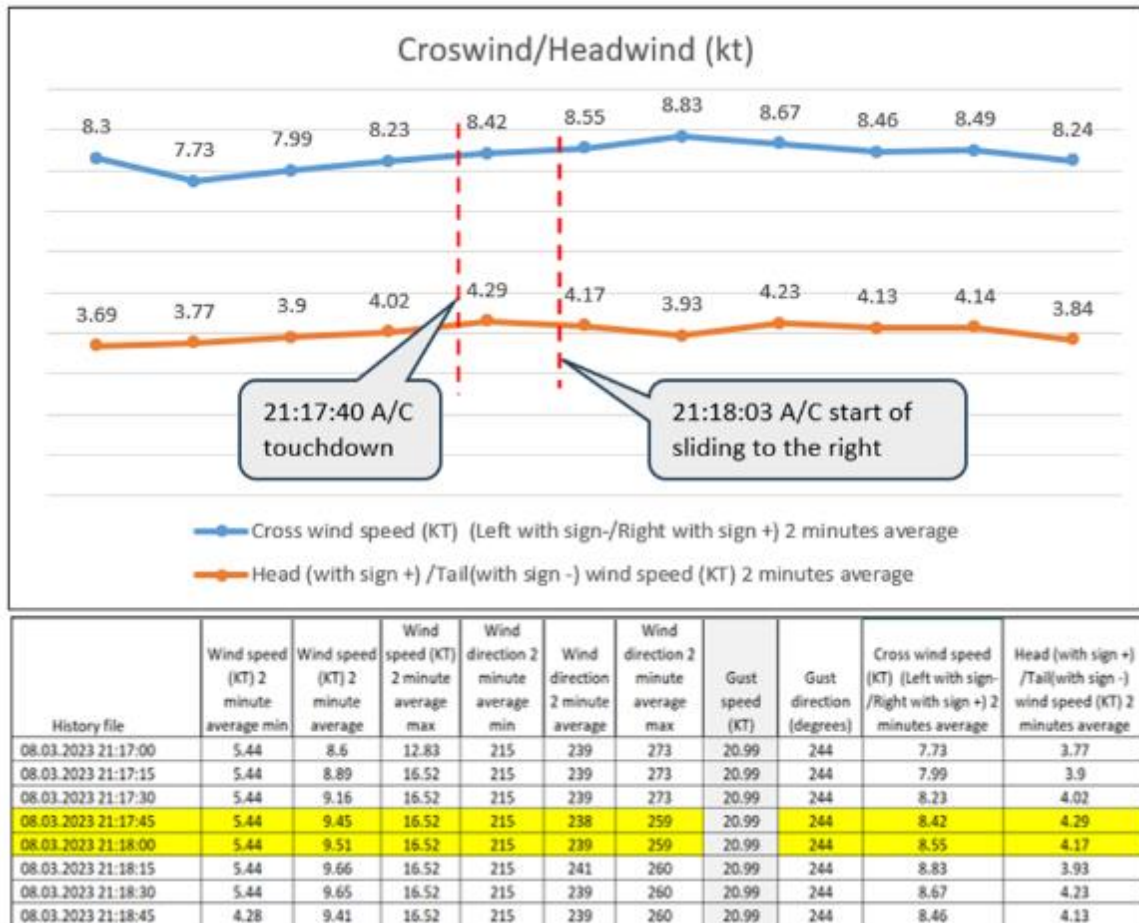
Figure 5: Meteorological information updated every 15 seconds with wind options measurements provided by ATC for landing at RIX

According to the meteorological wind measurements provided by ATC, the crosswind speed was about 8.3 kts, the headwind speed was about 4.2 kts, and the average gust speed was 20.99 kts when the aircraft made touchdown (see Figure 5).

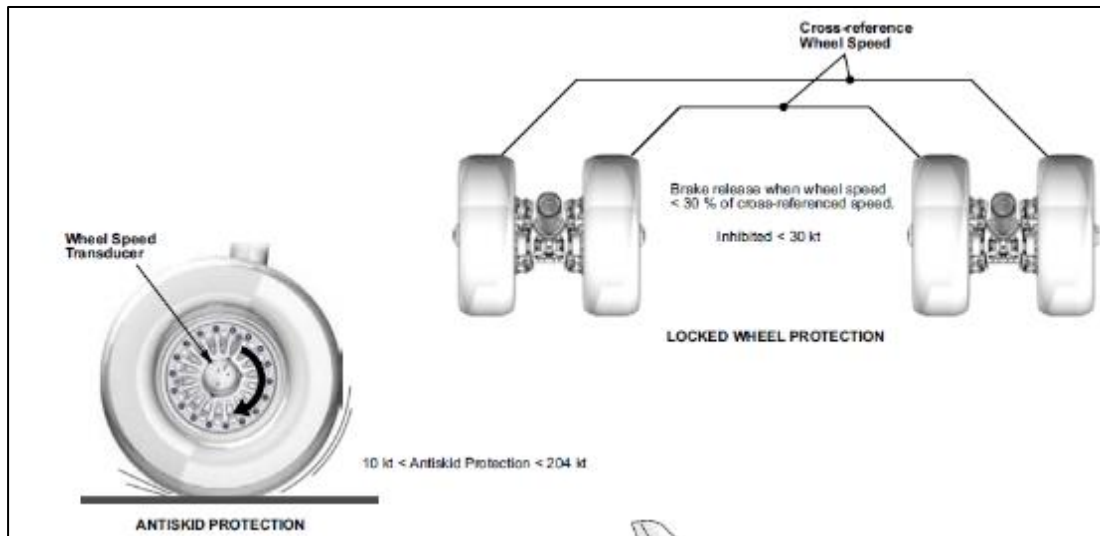
Figure 8: Braking Protection

Antiskid protection uses the wheel speed transducer signal to determine wheel speed. If one wheel speed transducer (WST) coil fails, the wheel speed signal from the other coil is used for wheel speed measurement (see Figure 8).

The EMACs provide locked wheel protection to a given wheel by controlling the brake release. The brake release occurs when the wheel speed is less than 30% of the reference wheel speed.

Locked wheel protection is inhibited when the reference wheel speed is below 30 kts. This feature avoids braking command release during turning manoeuvres on the ground. If locked wheel protection is active for more than 5 seconds, locked wheel protection is inhibited (braking allowed) for that wheel. The locked wheel protection re-engages when the reference speed is above 30 kts.

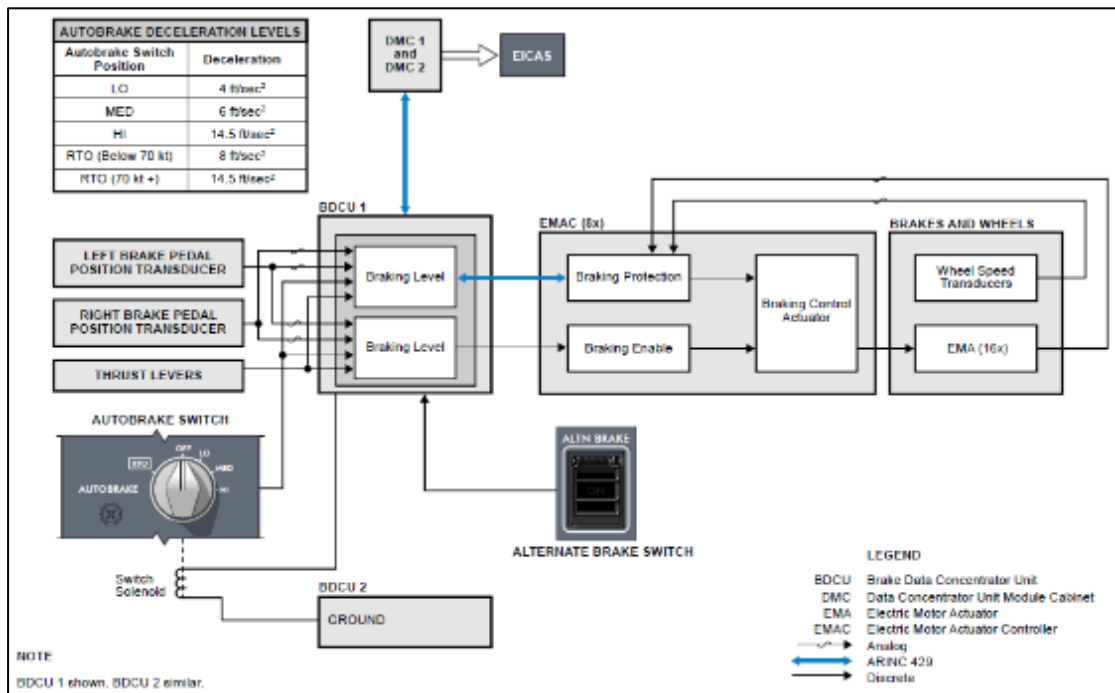
Figure 9: Autobrake Mode

During landing the AUTOBRAKE selection can be changed without disarming the system. On ground, if the throttles are advanced above idle or if any brake pedal is pressed more than 20%, the autobrake mode is disabled (see Figure 9).
