Final Report RS 2014:01e

Serious accident at sea on 15 October 2012 involving the vessel Liva Greta at Nockeby Bridge in the County of Stockholm, Sweden.

Diary No: S-165/12
2014-03-12

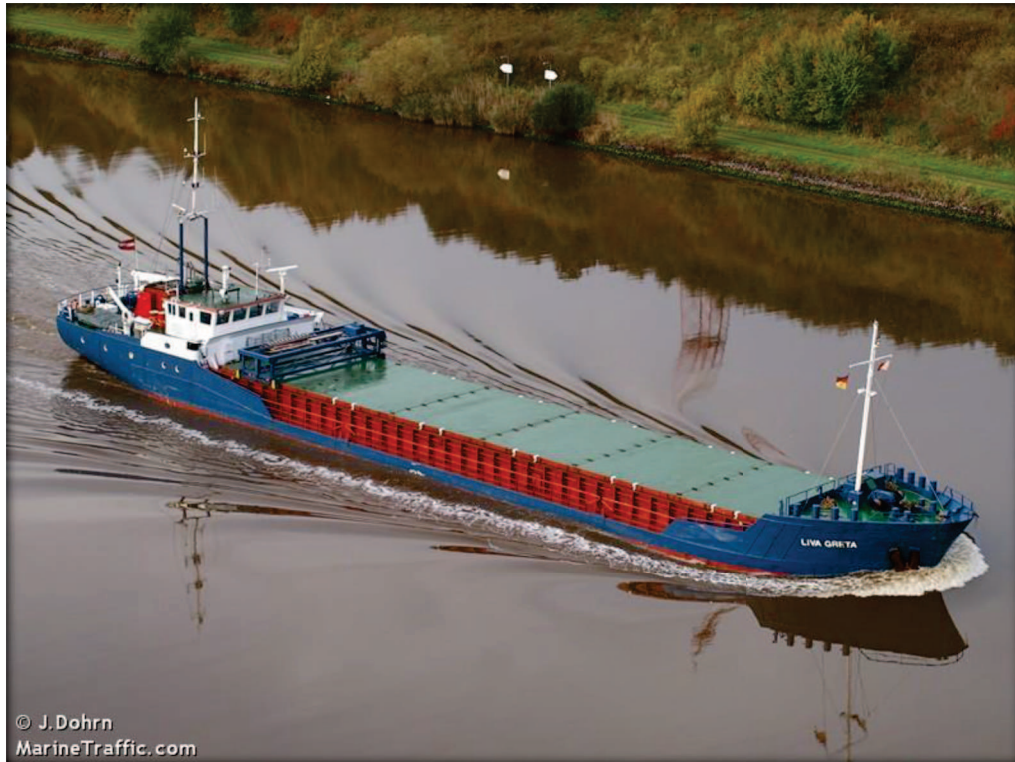
Fig.1 M/S Liva Greta. Photo: J. Dohrn.

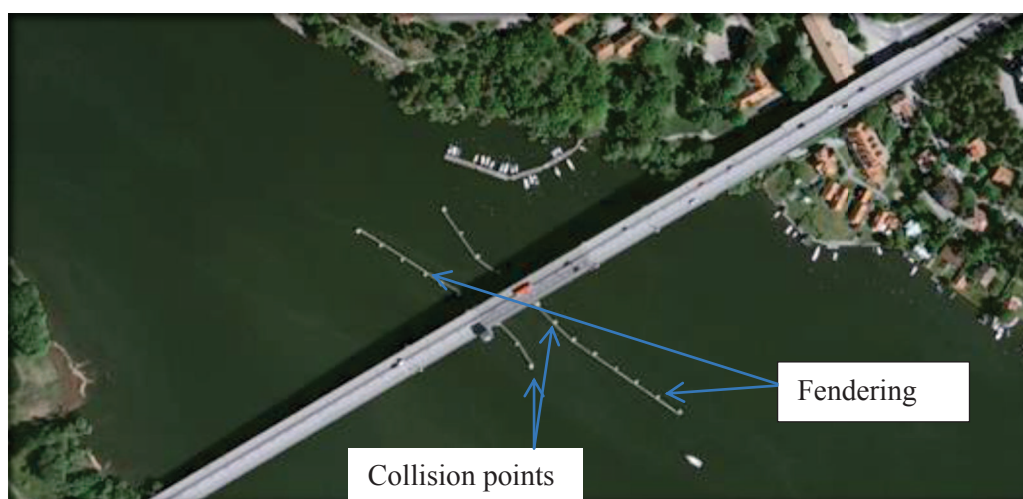
At Nockeby Bridge, extensive maintenance work was in progress on the fendering at the bridge (see Fig. 2). Any changes in navigation channels are to be reported to the Swedish Maritime Administration (Sjöfartsverket), which

Fig 2. General view, the scene of the collision taken at a point in time when the fendering was in position. Photo: © Lantmäteriet Diary No: R61749_130002

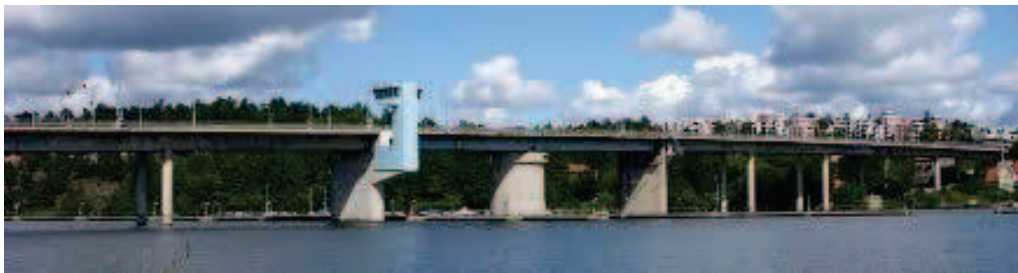
The Nockeby Bridge was built in 1973 and connects Drottningholm with Bromma in the County of Stockholm (see Fig. 8). The bridge is 694 m long and is openable by means of a swing span.

Fig.8. Nockeby Bridge viewed from the side. Photo: Holger Ellgaard
