TRANSPORT ACCIDENT AND INCIDENT INVESTIGATION BUREAU

FINAL REPORT Nr.5/2012(3-2014)

**of HELICOPTER MD 369E, REGISTRATION OH-HJR ON JULY 12,
2012 AT KASTIRE**

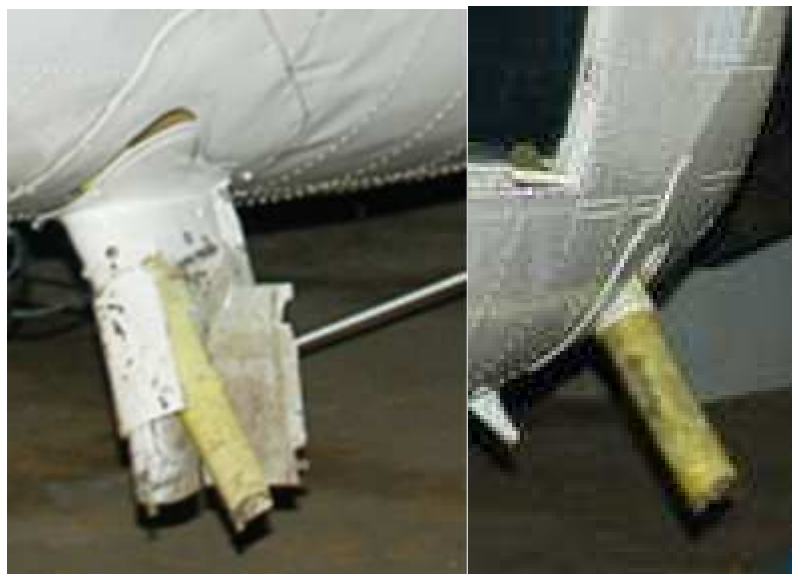
Figure 3

- left side landing skid front strut and rear strut broken;

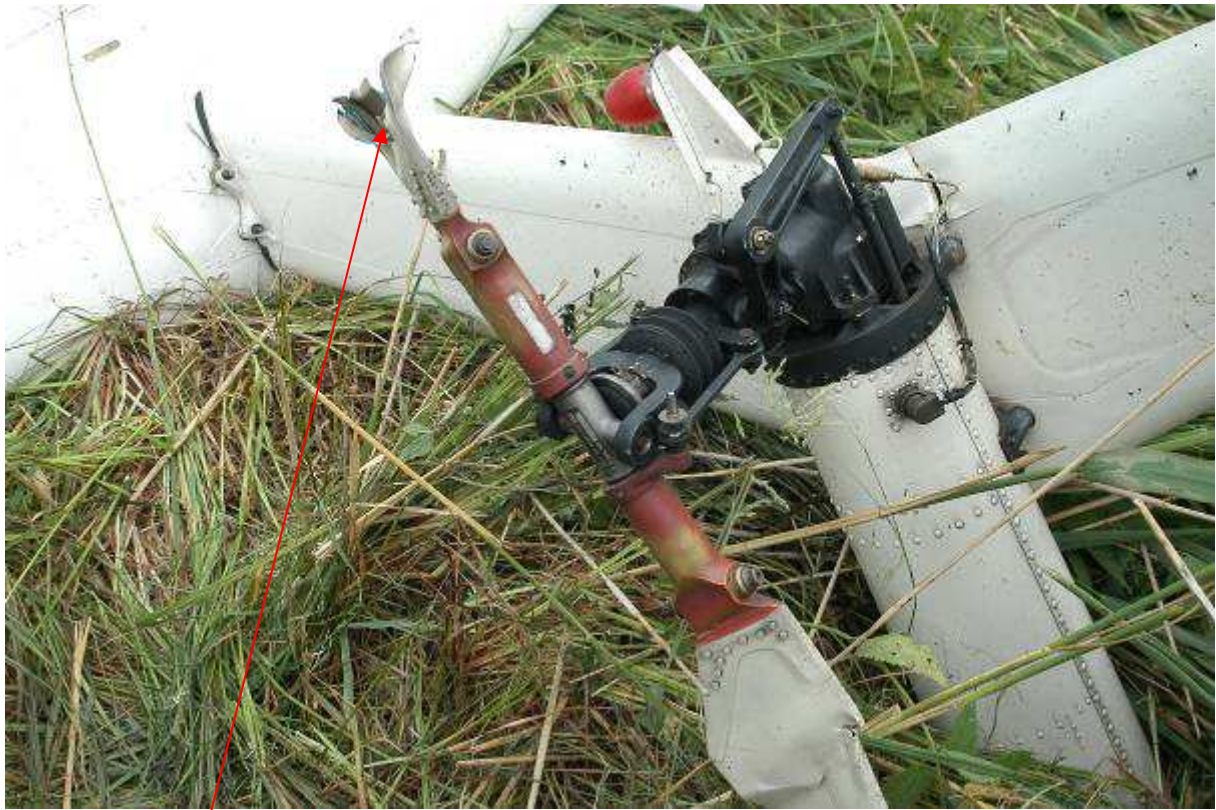
- one blade of two bladed tail rotor broke, other deformed (**Figure 6**);

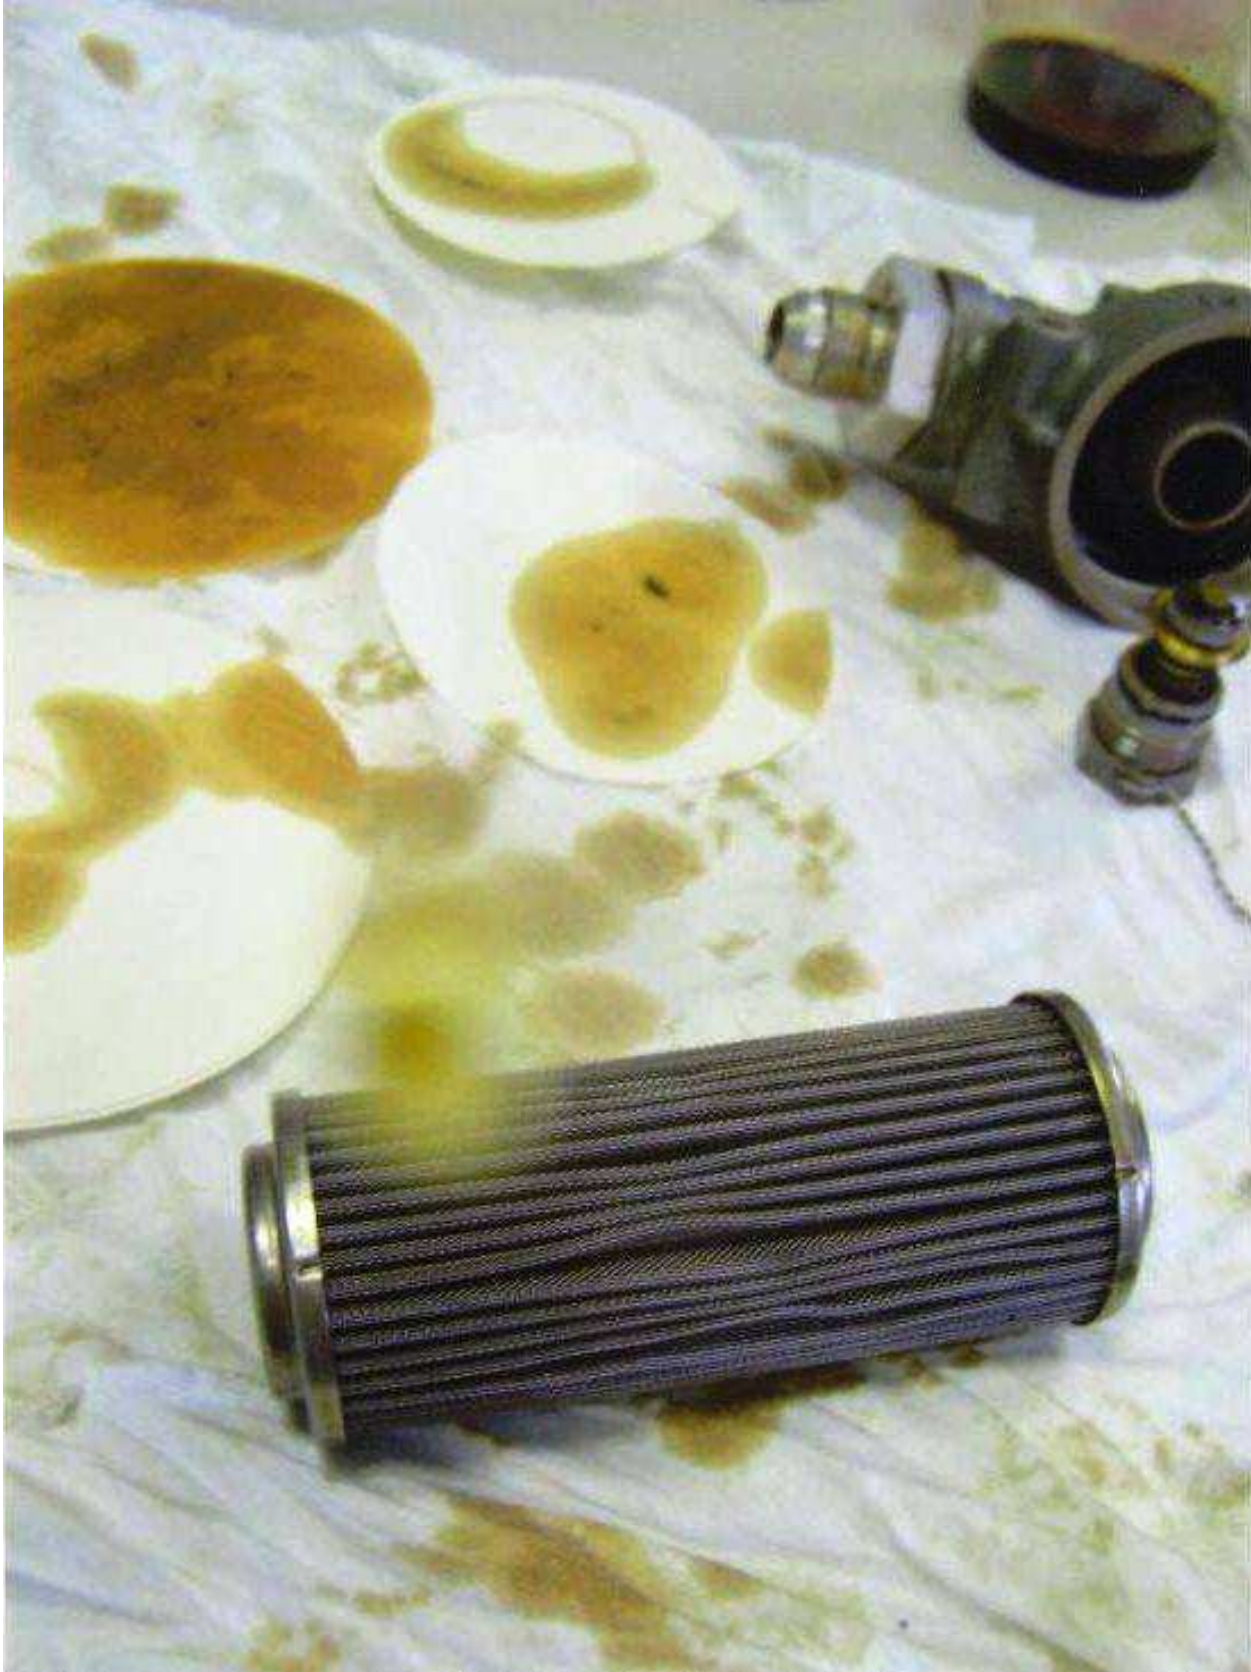
Figure 16. Disassembled Scavenge oil filter

As a result of inspection on outer side of metallic filter it was stated metallic chips. The rough filter element was cut and was stated that on inside filtering material of fine element from oil intake side are metallic chips. At oil outlet side there were not metallic chips or mechanical additives.

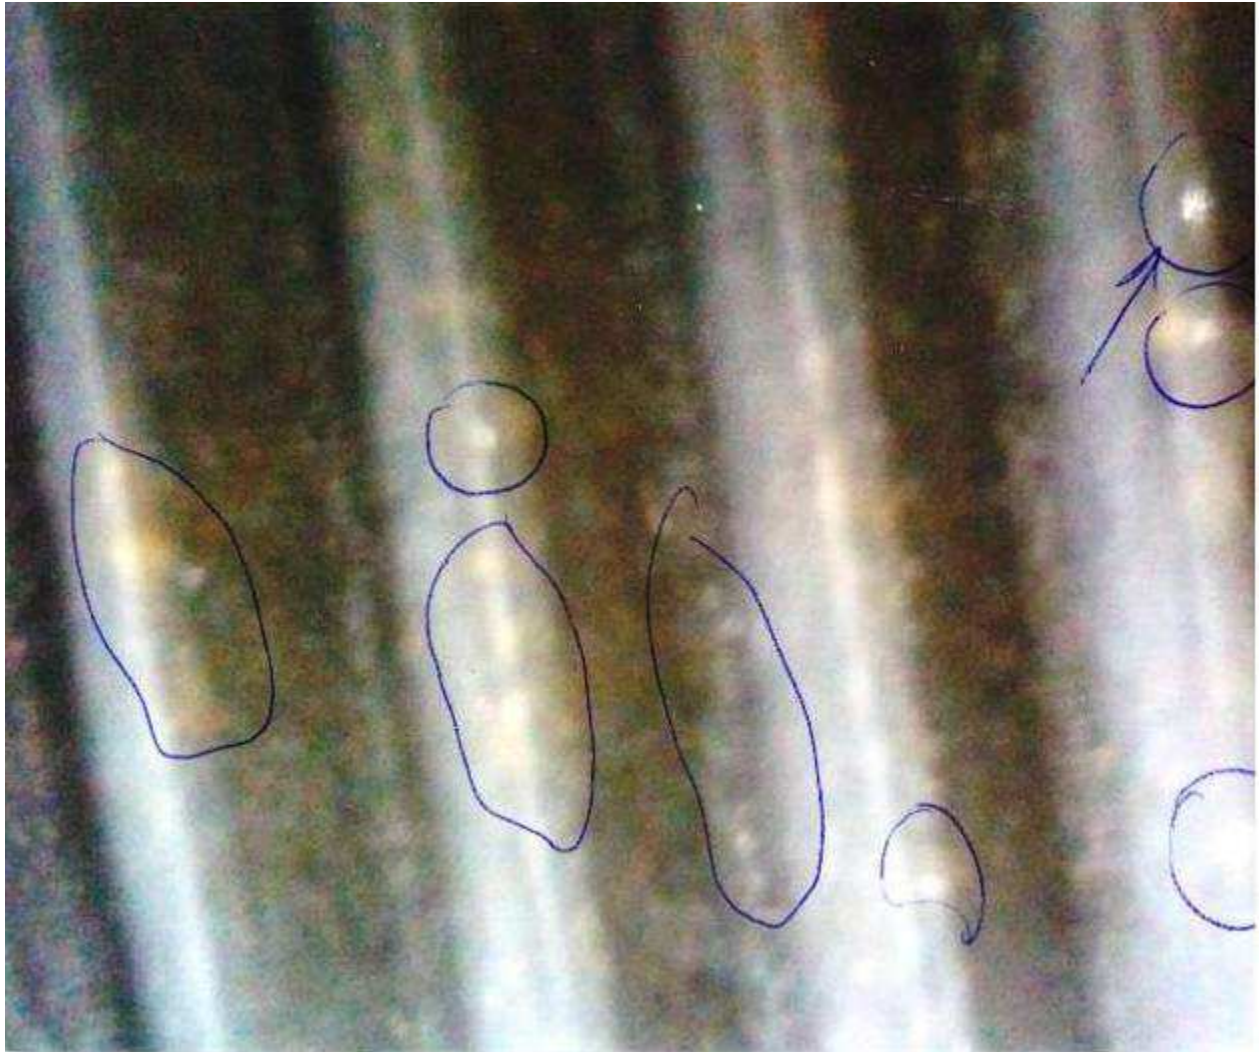
Figure 17. Metallic chips inside filtering material

- The engine oil has high content of metals –Fe and Al;
- On both filter elements (rough and fine) are metallic chips – ferromagnetic and nonmagnetic that could witness about engine bearings or other mechanical component failure;
- Oil filter not damaged and is in good working condition.

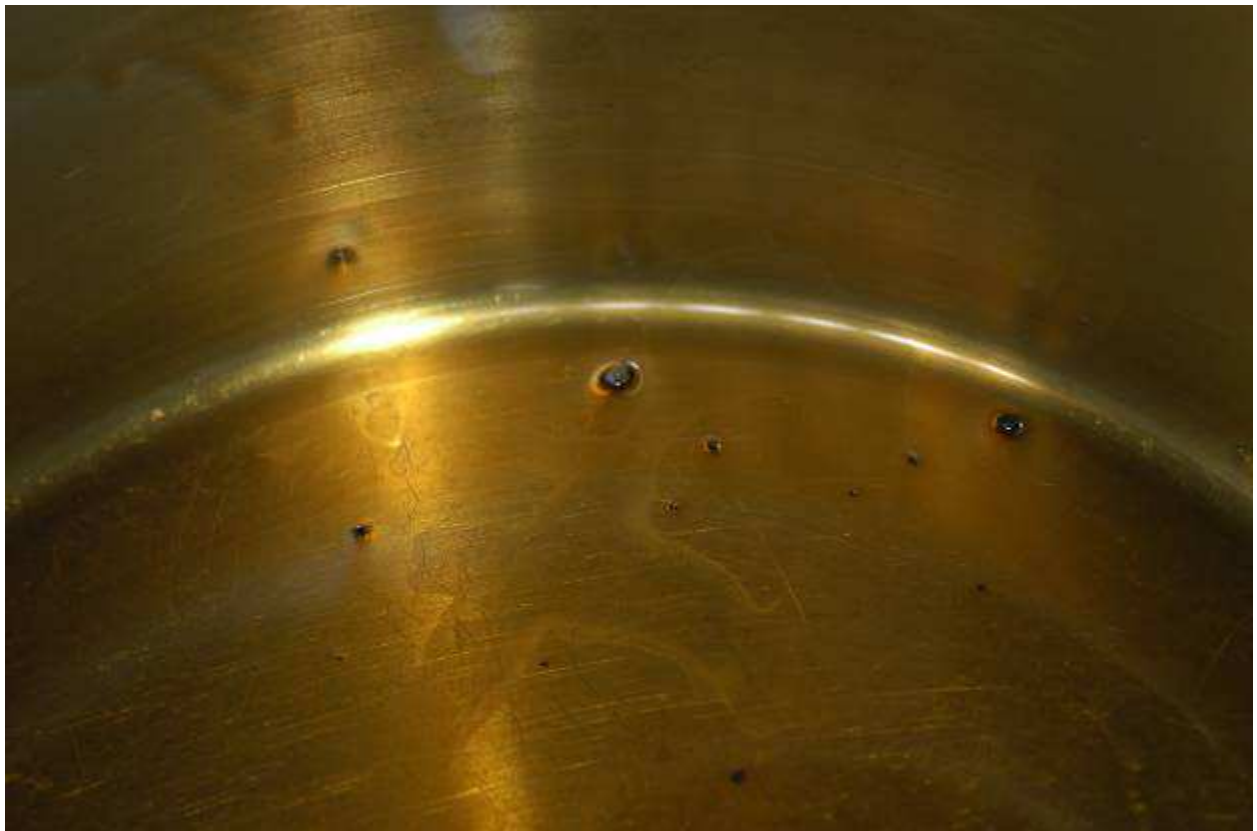
Figure 25. Pieces of metal in the poured oil from engine

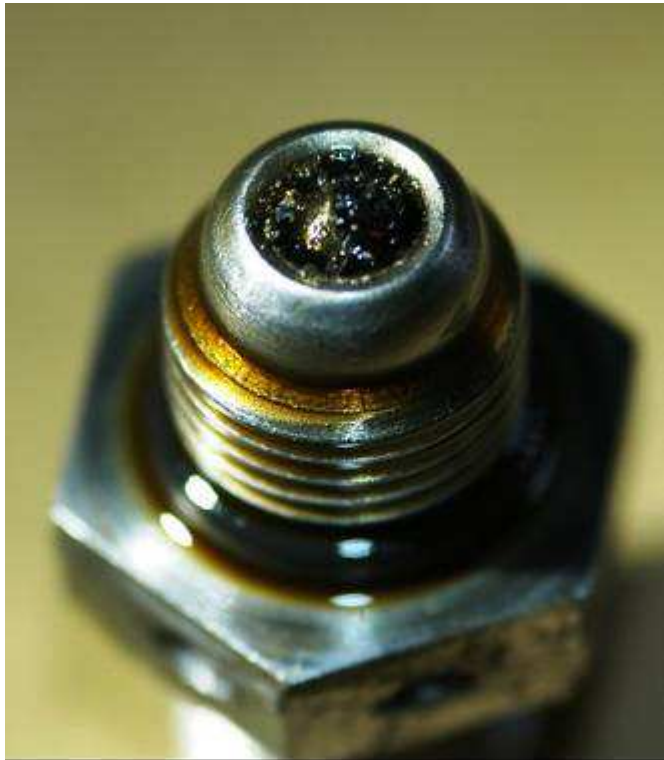
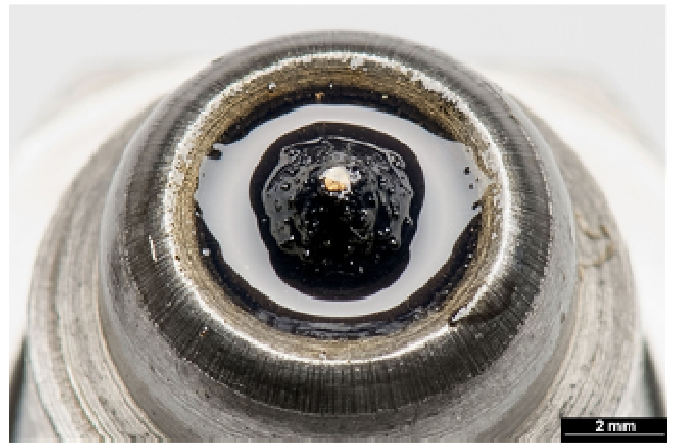
Figure 26. Oil with small amount of metallic chips on the Lower chip detector

Figure 27. Metallic chips on the upper chip detector

- upper metallic chip detector is full with metallic chips;
- it seems that the compressor gear gearwheel some teeth has signs of probable pitting, it was difficult to make any conclusion by visual inspection;
- on the compressor axle the cogwheel surface wear out (not visible cracks);
- the gear box bearings without visible defects and had free rotation without any noise;
- the compressor gear bearing in fastening place had lateral play (5-7mm);
- in the compressor inlet tract has some quantity of oil;
- pieces of metal in the poured oil from engine;
- the warning indication light “Engine chips” on the instrument panel was not damaged.

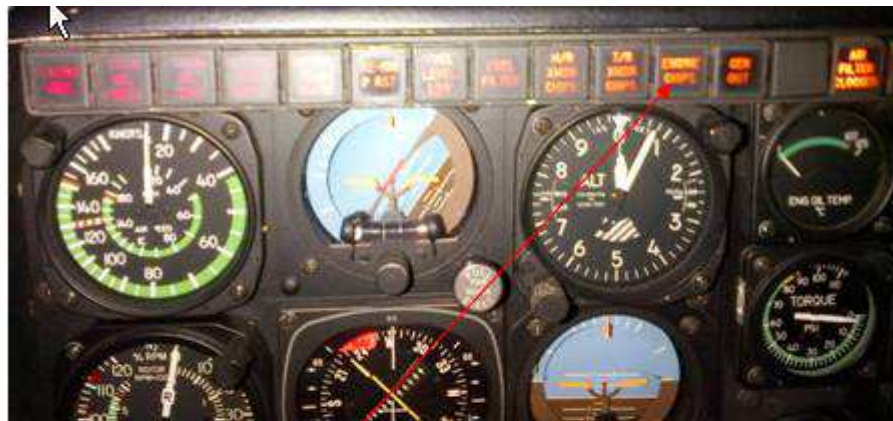
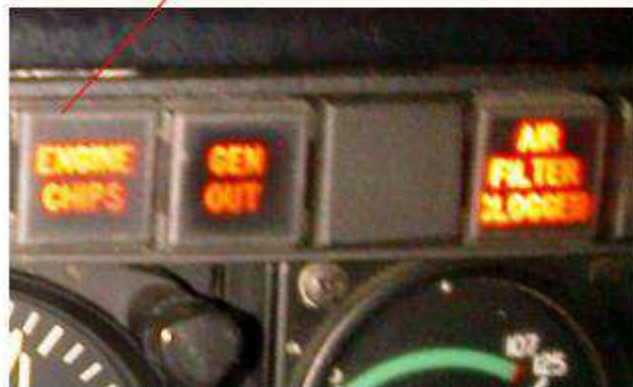
Figure 28. Instrument panel warnings

The warning and caution indication light on the instrument panel were checked by pressing button “Test warning and caution lights”. All warning lights including “Engine chips” were lighting during checking.

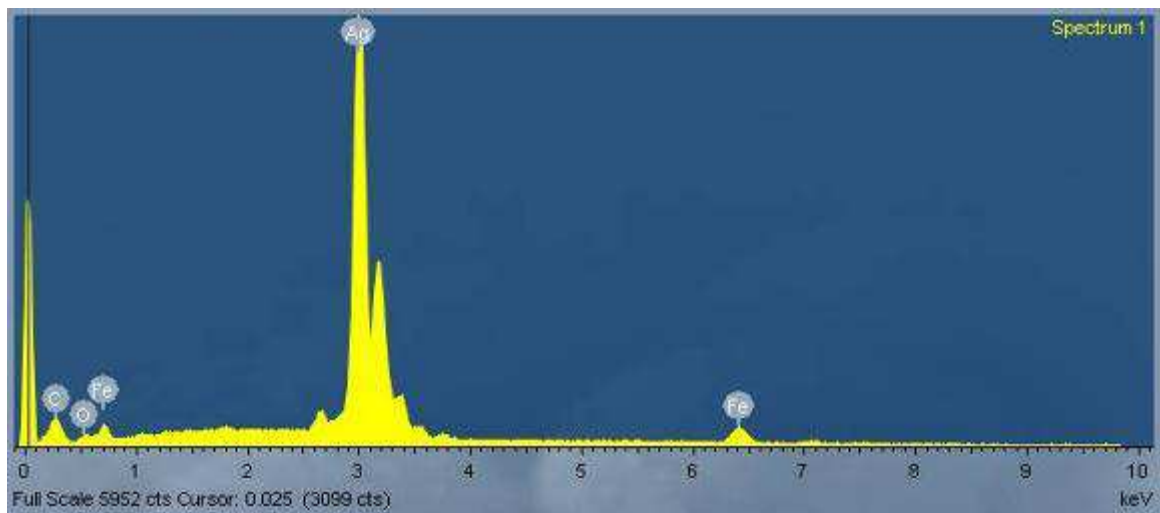
Figure 32 EDX analysis of the white appearing material in Fig. 10. Material mainly consists out of silver

- particles with a composition similar to M50 (3.7Cr, 3.5Mo, 1.2V measured);
- particles with a composition similar to TBA-2e (1.1Cr, 1.6Ni, 0.93Mo and 0.66Mn measured);
- particles with a composition of 0.5V, 2.8Cr (+balance Fe);
- Pure Ag particles attached to Fe particles.

The silver, which is often used as a coating of the cage, and the bearing steels makes investigators believe that the failed component is a bearing, therefore there was necessary to know which bearings contain these alloys and Ag-coatings for more detailed expertise. Such information was only in the disposal of engine manufacturer Rolls-Royce. Taking into account that information about materials data were not in disposal of NLR laboratory but determination of the sources of the chipping was possible only based on manufacturer information, a decision was made to contact with engine Manufacturer Rolls-Royce for getting necessary data of materials. After discussing further possible investigation with Rolls-Royce, company offered assistance with the investigation, subsequent to work conducted at NLR and a decision was made to conduct the further investigation at H+S Aviation AMC in Portsmouth, England. Macro-inspection of the Accessory gearbox section and components that share the same oil system was performed in the NLR;

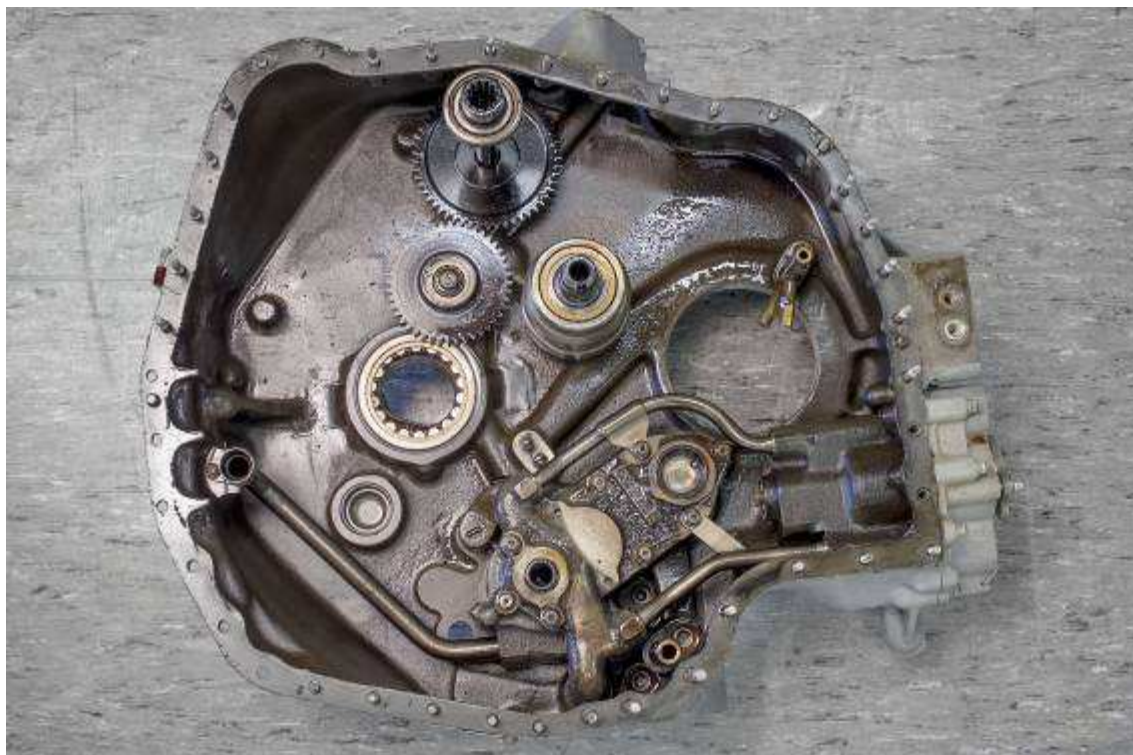
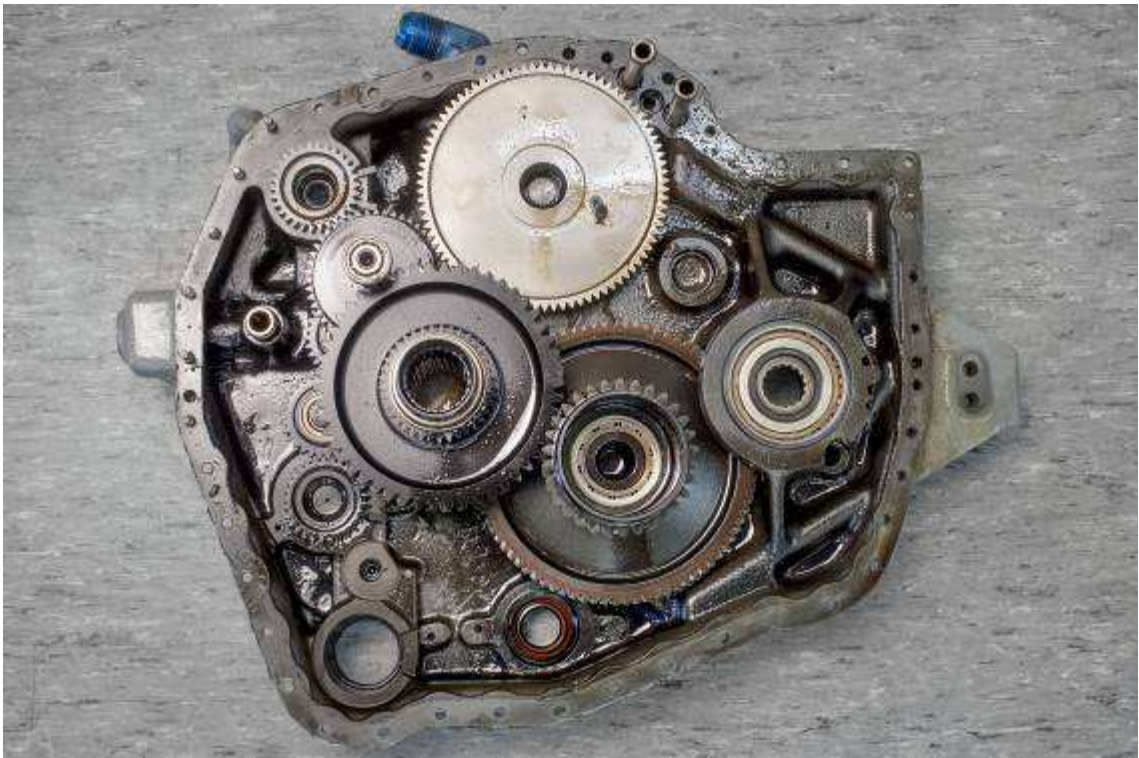
Figure 33A.

Figure 33B. Accessory gearbox section cogwheels

Turning the components of the gearbox does not give an audible sound of bearing problems. Also there was almost no resistance to turn the gears and therefore the bearings.

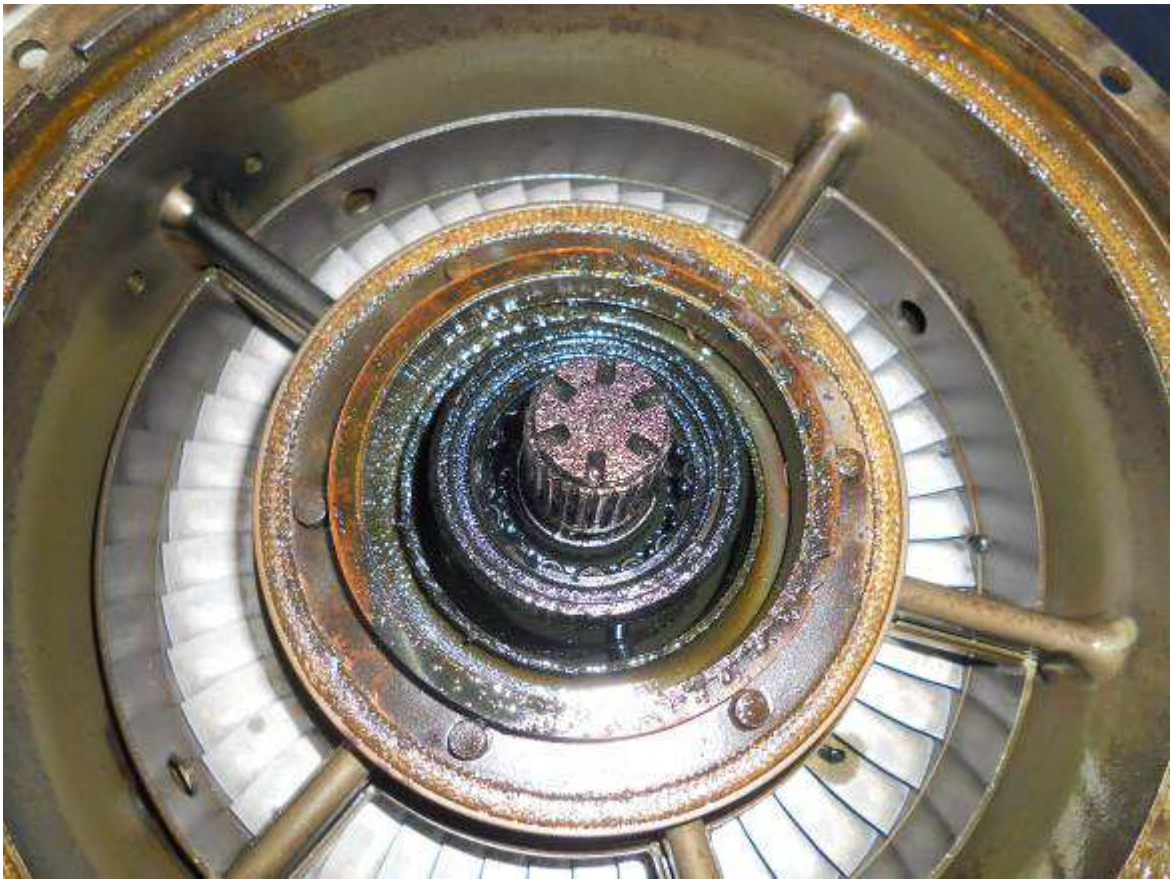
Figure 39. Heavy concentration of diffused material

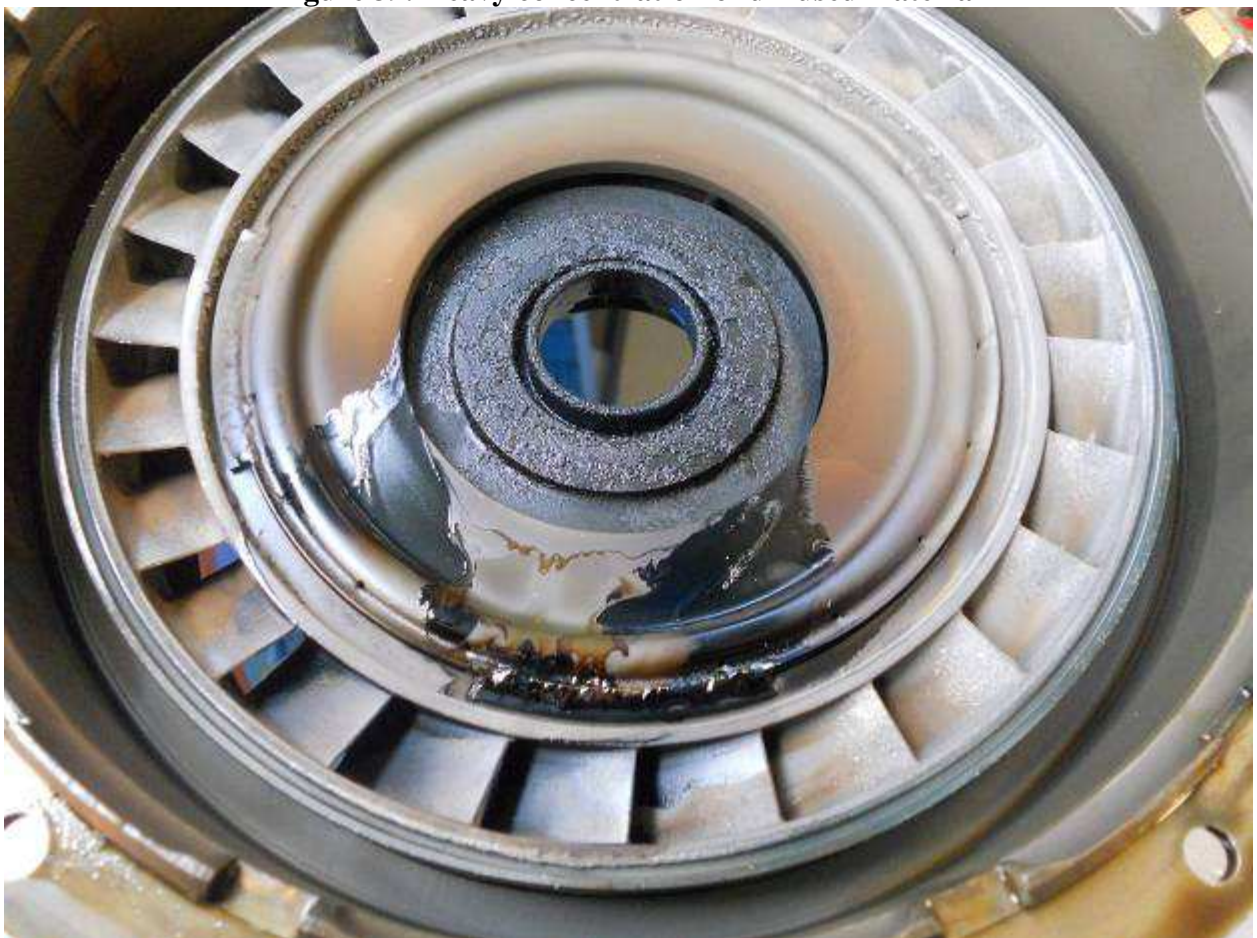
Figure 40. Heavy concentration of diffused material

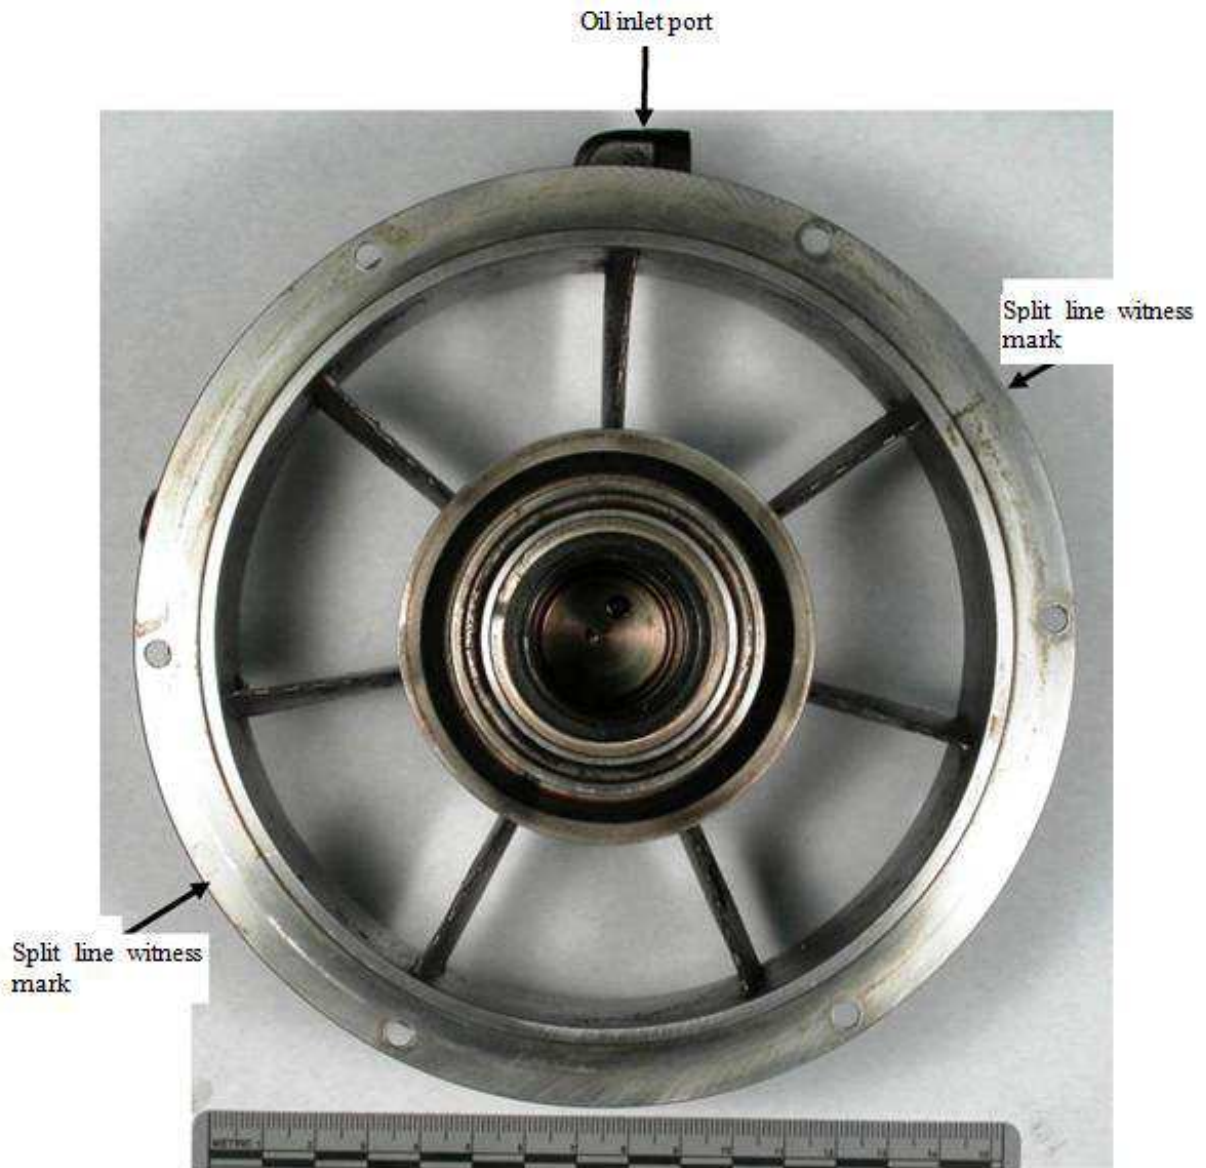
The condition of the front compressor support assembly documented in *Figures 44* and *45*. *Figure 45* shows witness marks on the aft flange indicating the orientation of the compressor case as it was installed. The radial witness marks are from the compressor case split lines. The support assembly was generally oily but exhibited no obvious damage or impact marks on the struts.

Figure 45. The front compressor support assembly viewed from the aft side

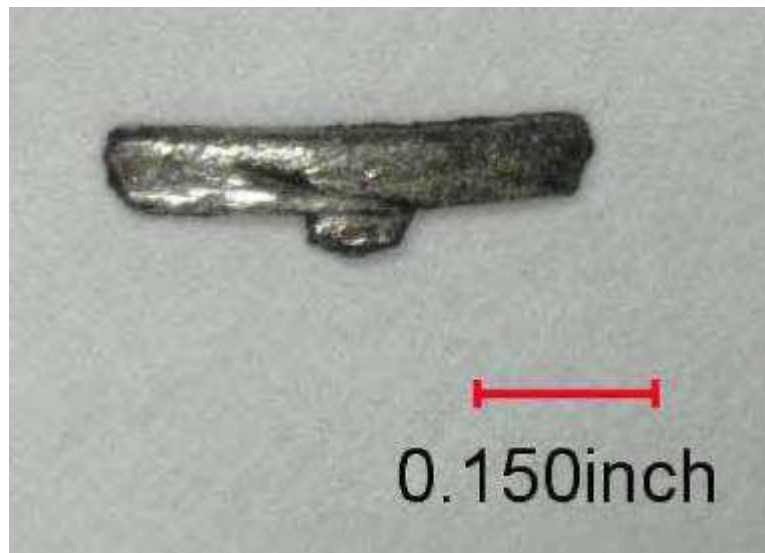
Figure 49. The debris flushed and collected from both the front compressor support and the bearing housing assembly.

Figure 49 shows the debris that was flushed and collected from both the front compressor support assembly and the bearing housing assembly. The bottom image reveals the larger fragment recovered from the bearing housing assembly sump area (see *Figure 46*). Several of these fragments were analyzed using the scanning electron microscope (SEM) x-ray dispersive analysis system revealing most of the fragments were consistent with an AMS6491 (M50) type material used in the outer ring, inner ring and rollers. Other fragments, including the fragment shown at the bottom of *Figure 49*,

was consistent with an AMS6415 (4340) type material with silver plating which is consistent with the materials used in the No 1 bearing separator.

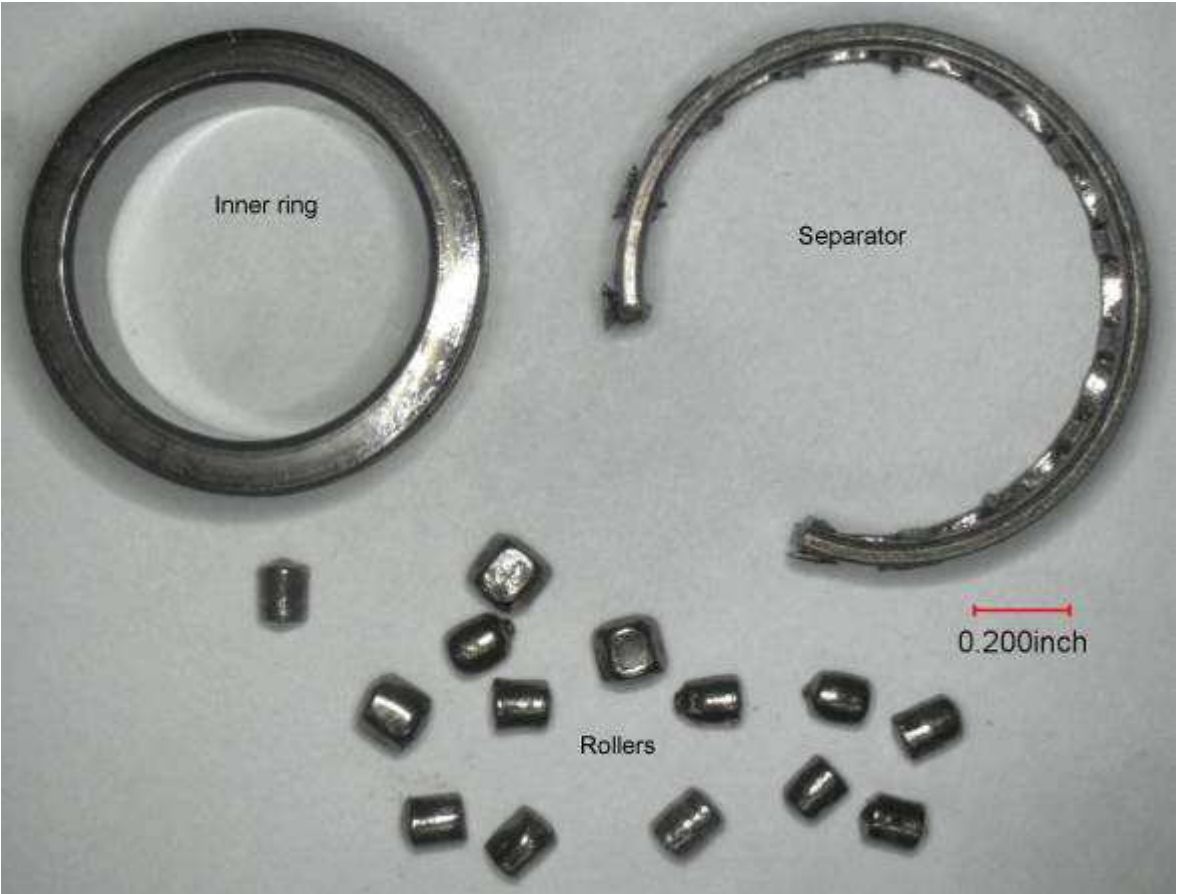
Figure 50. The No.1 bearing (minus the outer race)

Figure 50 shows the components after they were cleaned to remove surface oil. The bearing outer ring was retained in the bearing housing and was photographed separately after it was removed from the housing and therefore is not included in this image.

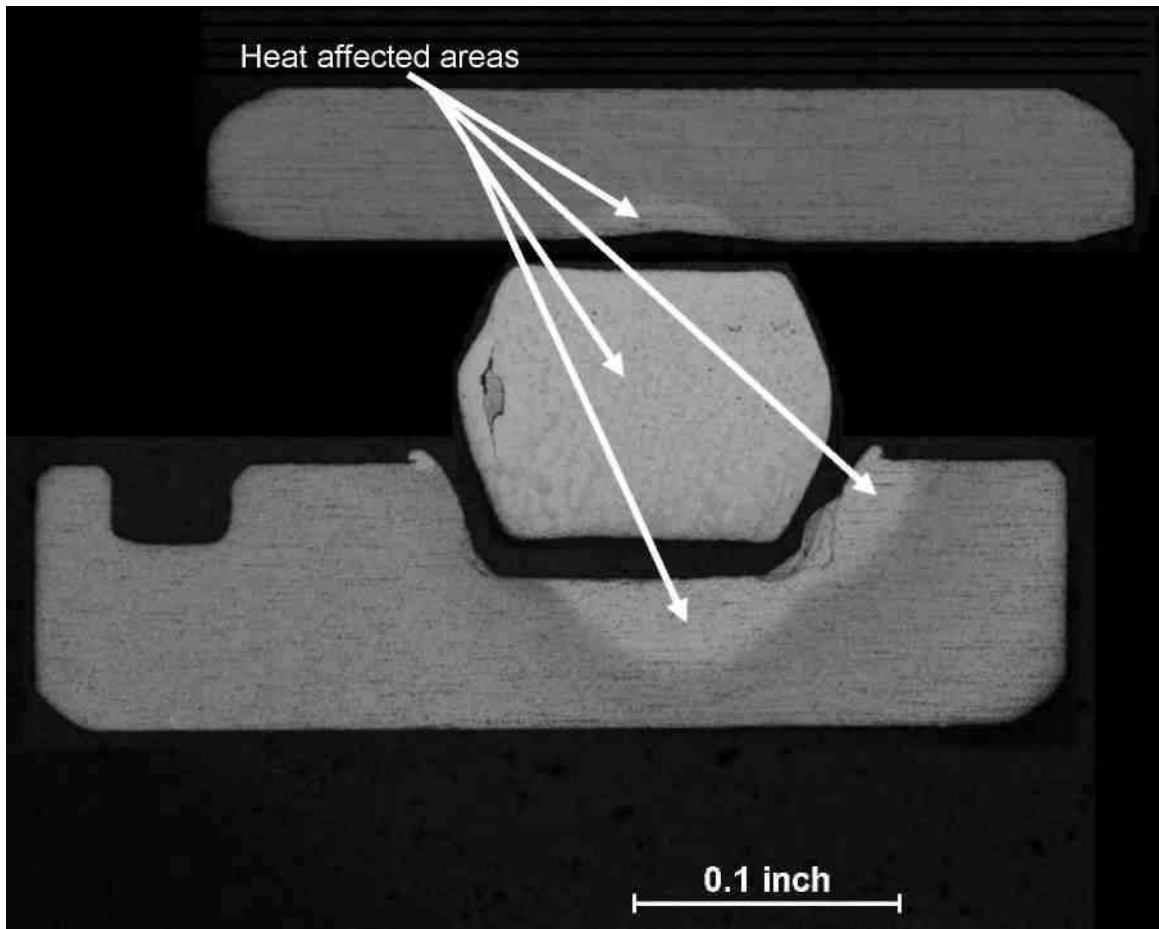
The montage metallographic image of *Figure 59* shows a cross section of the No.1 bearing components (excluding the separator) arranged in a manner to simulate orientation during engine operation. The white areas indicate localized heat distress on each of the components; specifically throughout the roller, the inner raceway and the aft shoulder of the inner raceway, and the outer raceway.

Figure 59 the montage metallographic image a cross section through the No.1 bearing with the separator excluded. Used etchant: Nital 5%

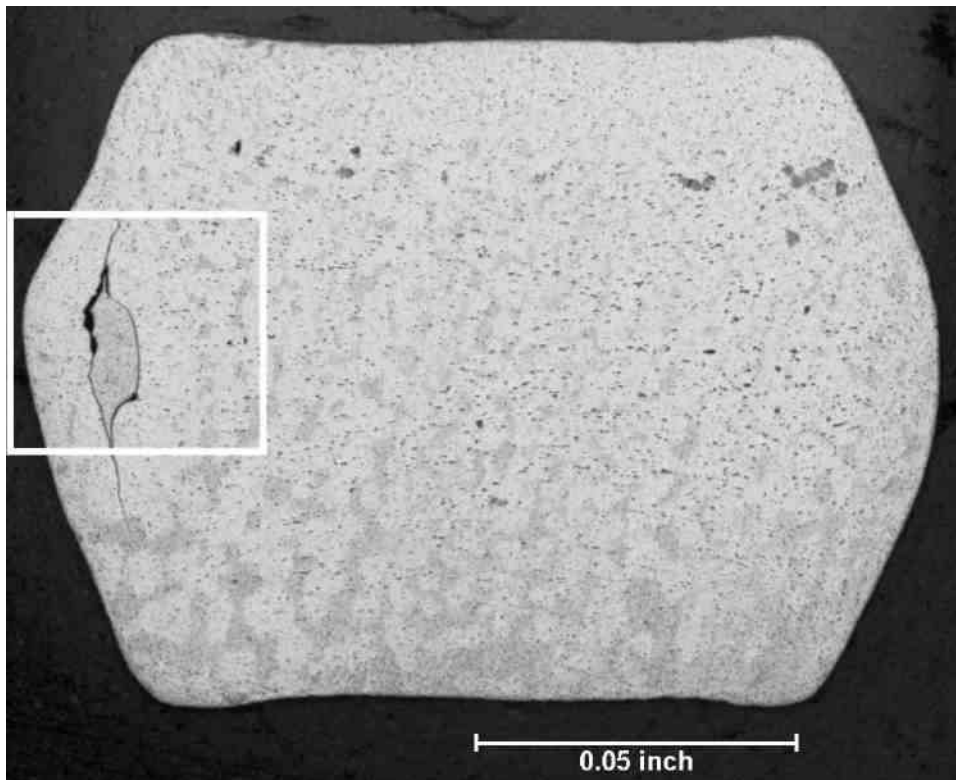
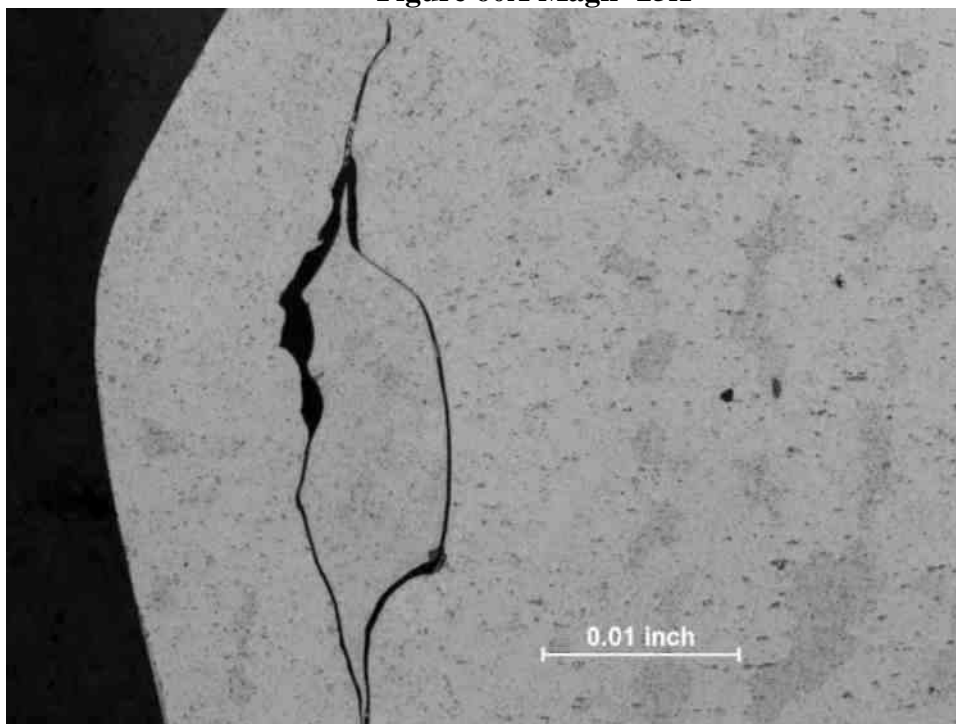
Figure 60A Magn=25X

The metallographic images above show a cross section through a roller from the No.1 bearing. Used etchant: Nital 5%

Figures 60A and 60B show a higher magnification view of a section through a representative roller from the No.1 bearing. The heat affected zone extended throughout the entire roller. The roller had a general barrel shaped appearance and was bowed outward at each of its ends. One end contained a

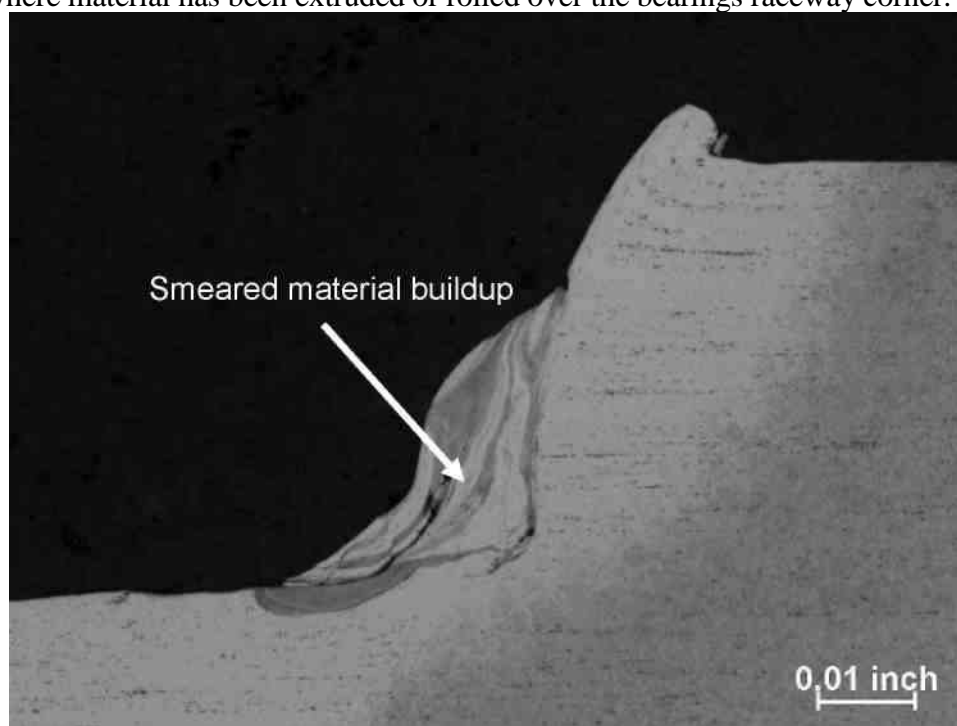
Figure 62 The metallographic image of a portion of the No.1 bearing's inner ring. Used etchant: Nital 5%

Figure 62 contains a detailed view of the smeared material built up and thermal distress in the aft corner of the inner ring's raceway.

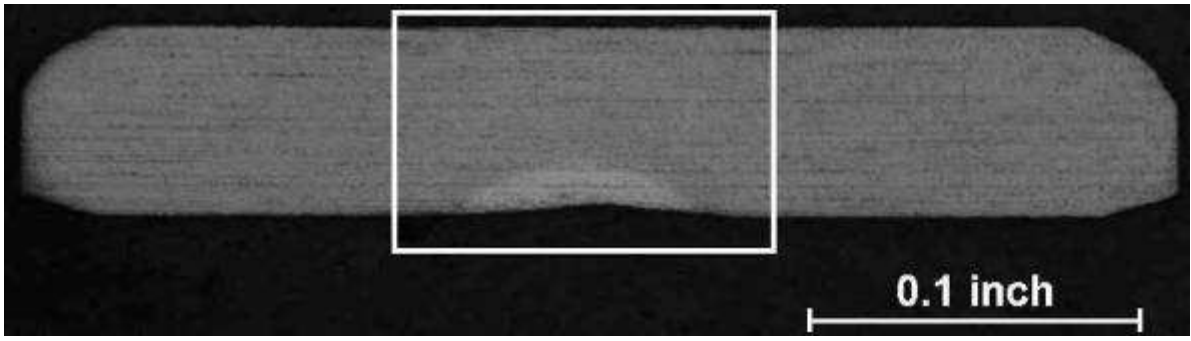
Figure 63. The metallographic image of a cross section through the No.1 bearings outer ring. The white box represents the area shown in *Figure 64*. Used etchant: Nital 5%

Figures 63 and 64A, 64B show a cross section through the outer ring and highlights the thermal distress along the raceway. The detailed views presented in Figure 64 shows the heat affected zone was positioned along the center of the raceway and extended approximately 0.012 inch deep. Some micro spalling was also noted along the raceway surface. Detailed metallographic evaluations of the bearing separator were not conducted.

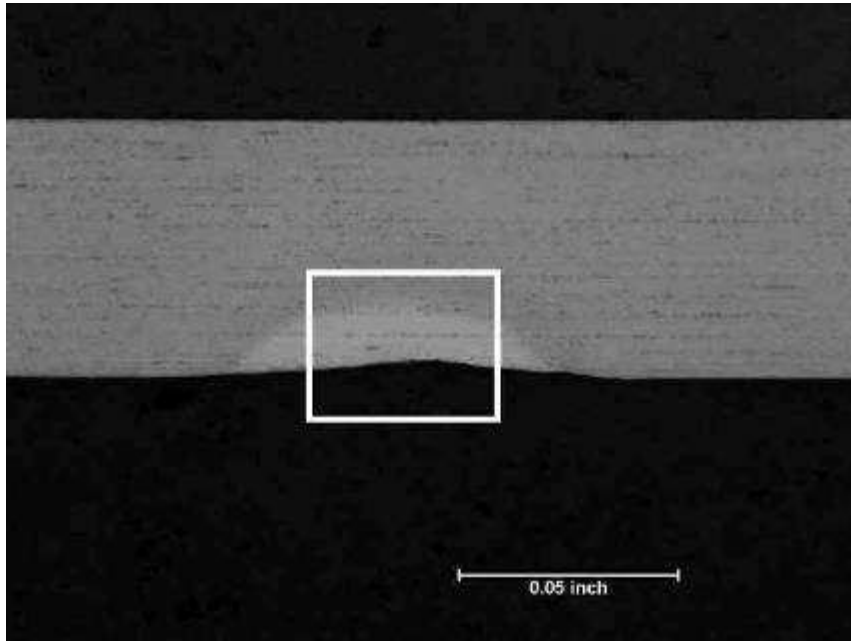
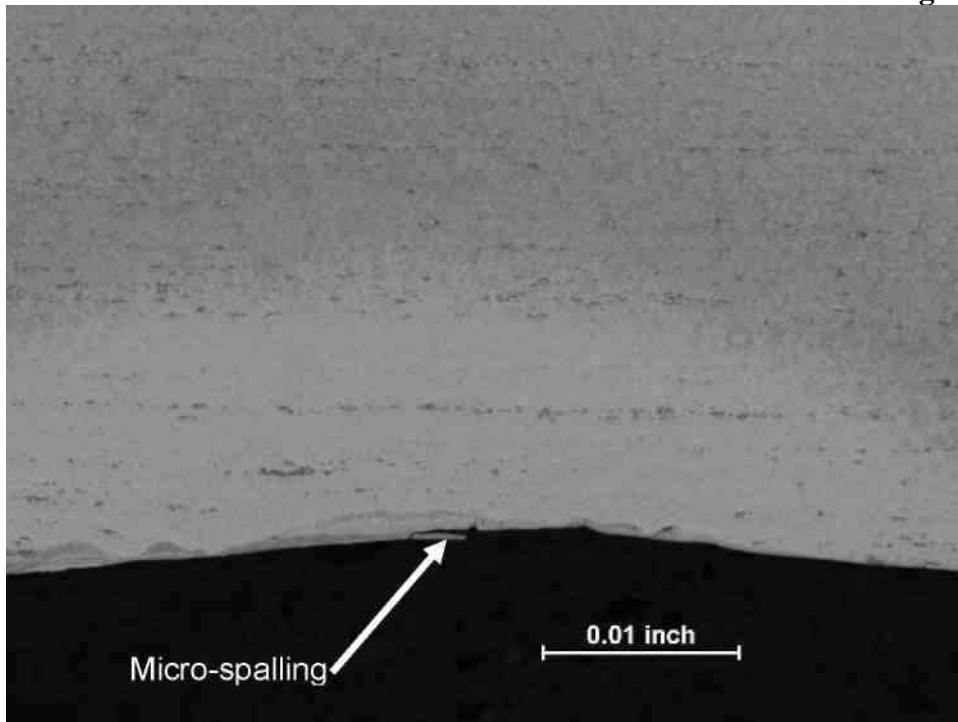
Figure 64A

Figure 64B The metallographic image of a cross section through the No.1 bearings outer ring. Used etchant: Nital 5%

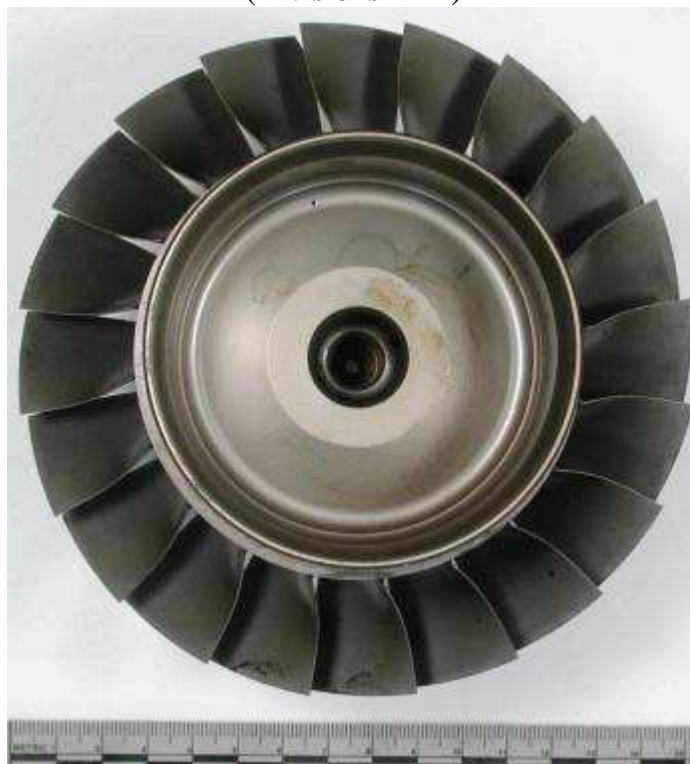
The condition of the stage 1 compressor wheel is shown in *Figures 66* and *67*. There was no obvious damage along the leading edges of the airfoils and no obvious sign of knife seal rub. Blade tip rub was evident around the entire circumference of the wheel and was consistent with damage noted along the blade path in the compressor case. *Figure 68* shows representative example of tip rub damage. No metallurgical, hardness or chemical analyses were conducted on this wheel.

Figure 67 The image of the shows the trailing edge surface of the stage 1 compressor wheel (Divisions=mm)
