TRANSPORT ACCIDENT AND INCIDENT INVESTIGATION BUREAU

FINAL REPORT Nr.5/2012(3-2014)

**of HELICOPTER MD 369E, REGISTRATION OH-HJR ON JULY 12,
2012 AT KASTIRE**

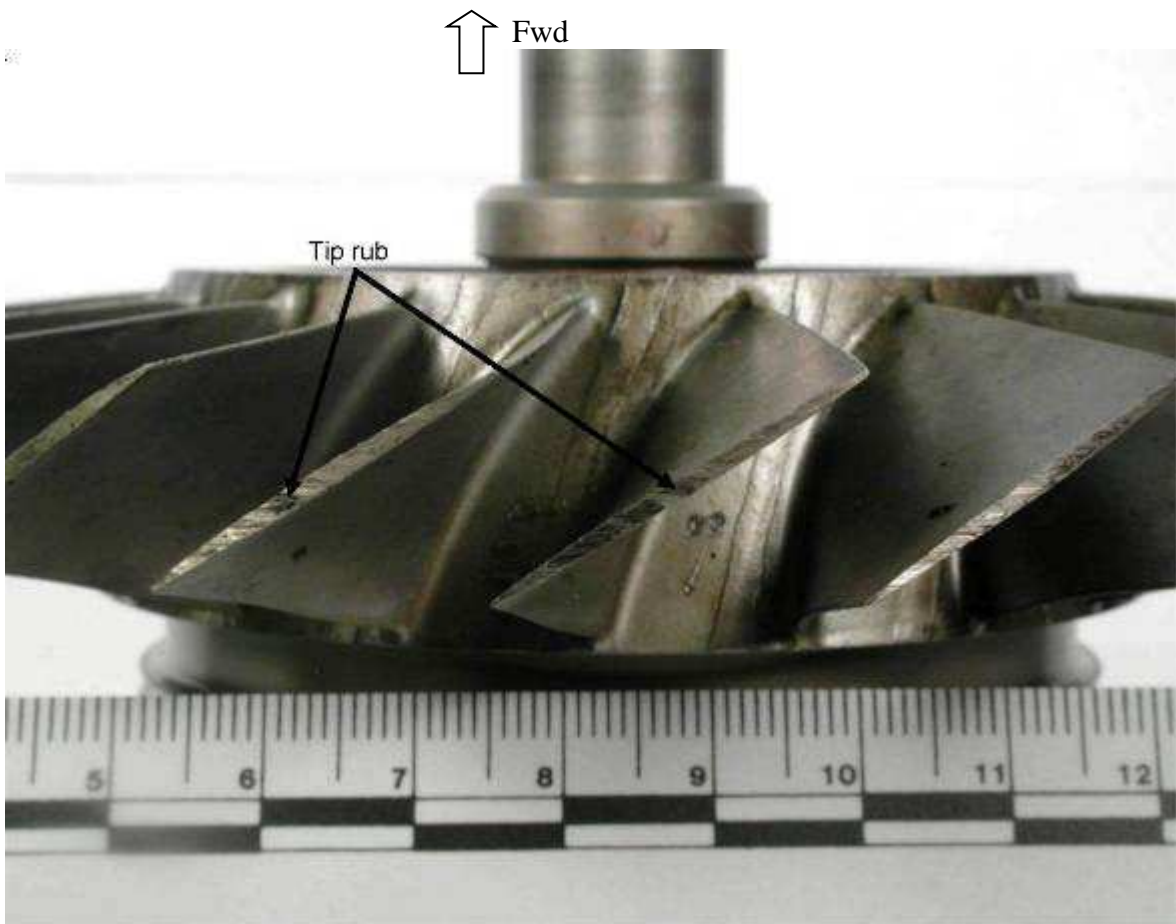
The condition of the stage 1 compressor wheel is shown in *Figures 66* and *67*. There was no obvious damage along the leading edges of the airfoils and no obvious sign of knife seal rub. Blade tip rub was evident around the entire circumference of the wheel and was consistent with damage noted along the blade path in the compressor case. *Figure 68* shows representative example of tip rub damage. No metallurgical, hardness or chemical analyses were conducted on this wheel.

Figure 68.The image of a representative example of tip rub exhibited by the stage 1 compressor wheel. Divisions = mm

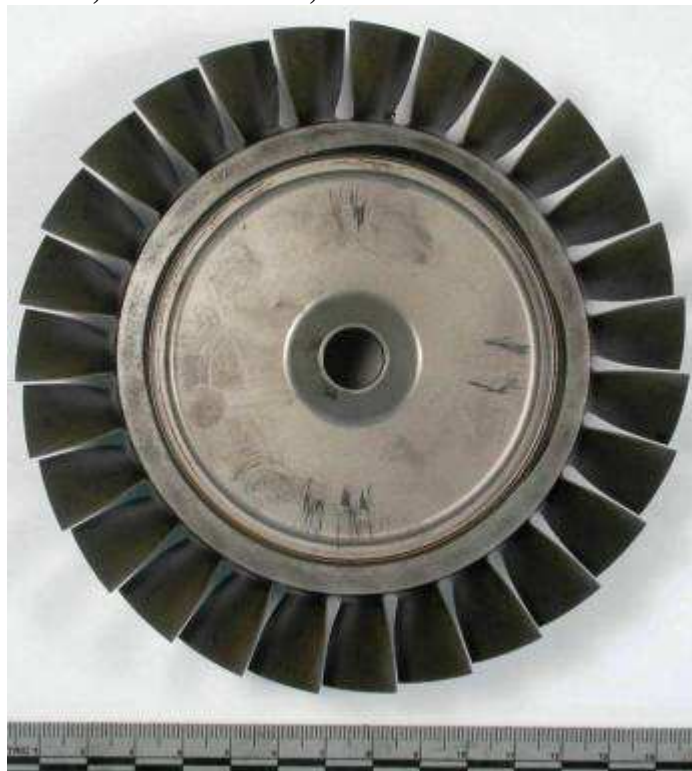
Figure 69. The image of the leading edge surface of the stage 2 compressor wheel (Divisions = mm)

The condition of the stage 2 compressor wheel is shown in *Figures 69 and 70*. There was no obvious damage along the leading edges of the airfoils and no obvious sign of knife seal rub.

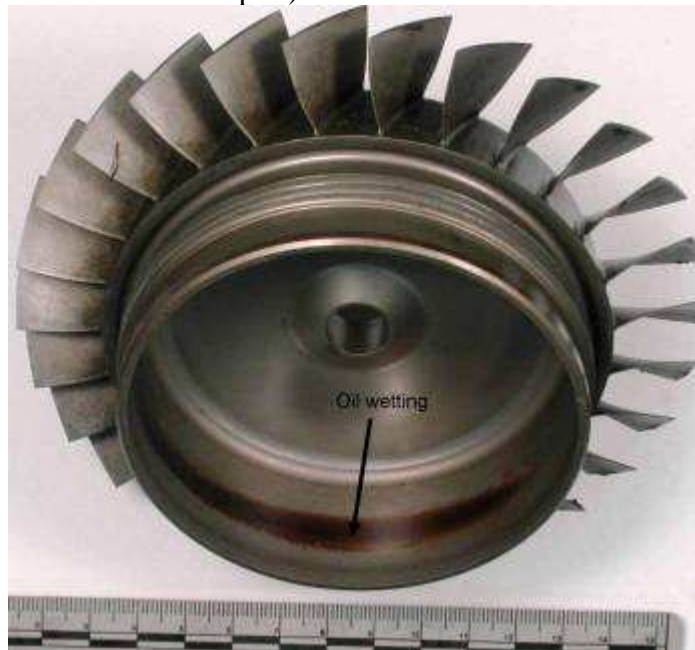
Oil staining and/or coke deposits were evident along the inner surface of the aft spacer arm as shown in *Figure 71* and spanned an arc of approximately 180 degrees. Blade tip rub was evident around the entire circumference of the wheel and was consistent with damage noted along the blade path in the compressor case (discussed later in this report).

Figure 71. The image of the oil wetting within the aft inner diameter of the stage 2 compressor wheel. Divisions = mm

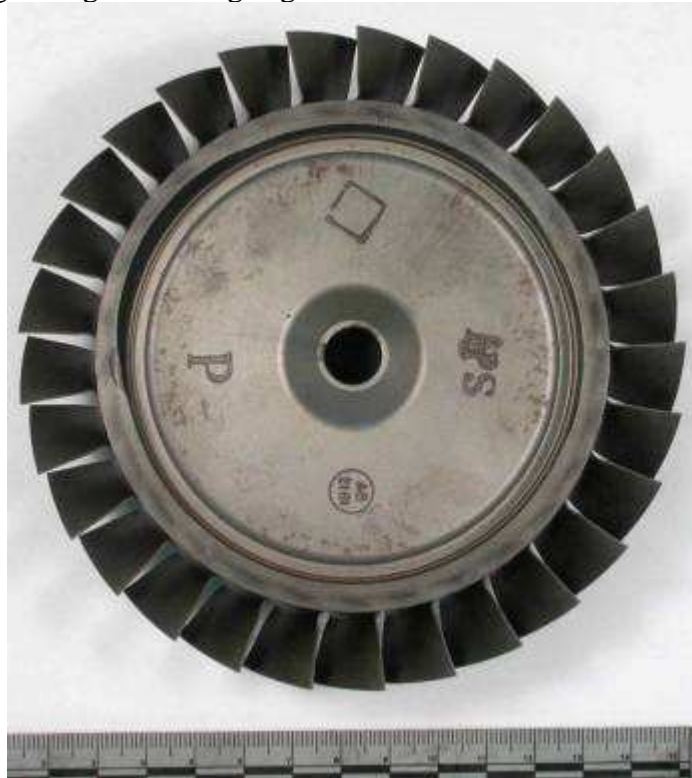
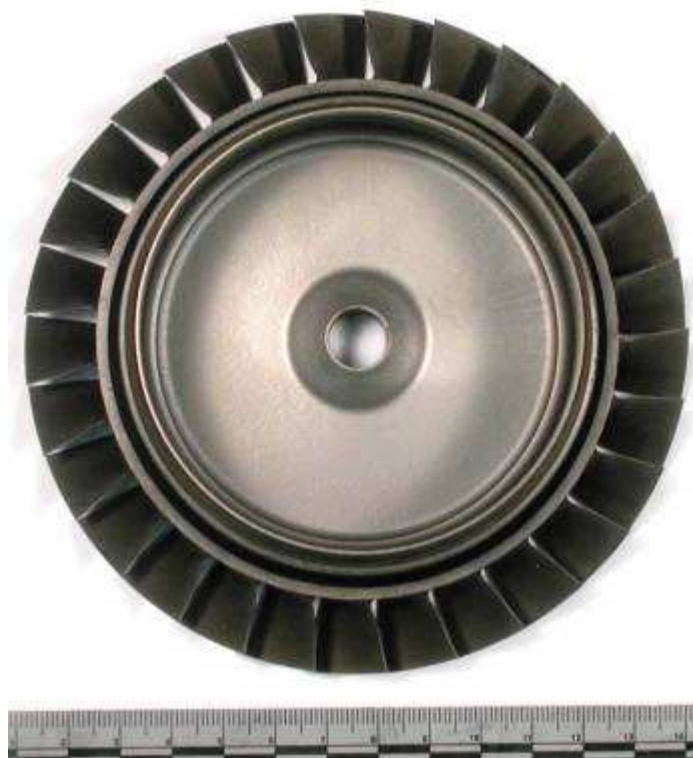
The as-received condition of the stage 3 compressor wheel is shown in *Figures 73* and *74*. There was no obvious damage along the leading edges of the airfoils and no obvious sign of knife seal rub.

Figure 73. The image of the leading edge surface of the stage 3 compressor wheel (Divisions = mm)

Figure 74. The image of the trailing edge surface of the stage 3 compressor wheel (Divisions = mm)

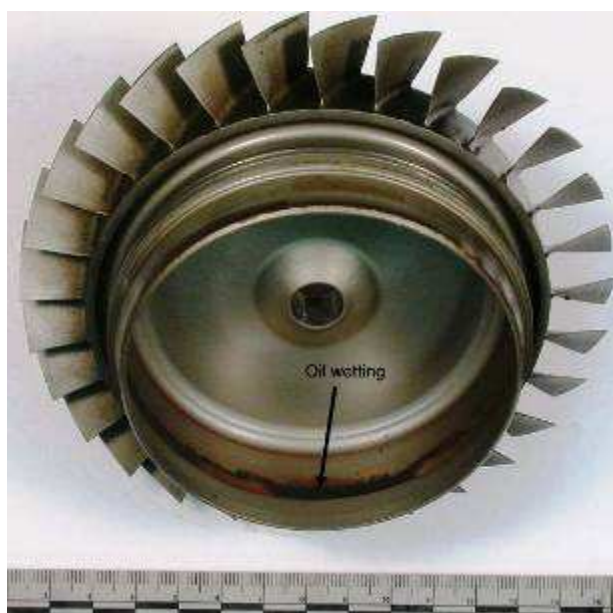
Oil staining and/or coke deposits similar to those noted on the stage 2 compressor wheel were evident along the inner surface of the aft spacer arm as shown in *Figure 75*. This condition spanned an arc of approximately 180 degrees. Blade tip rub was evident around the entire circumference of the wheel similar to that found in the first two compressor stages and was consistent with damage noted along the blade path in the compressor case.

Figure 75. The image of the oil wetting within the aft inner diameter of the stage 3 compressor wheel. (Divisions = mm)

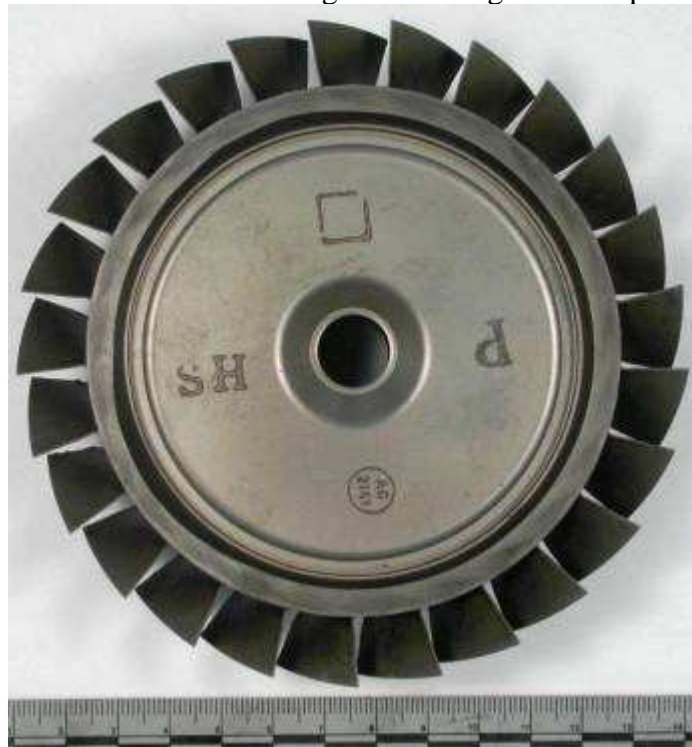
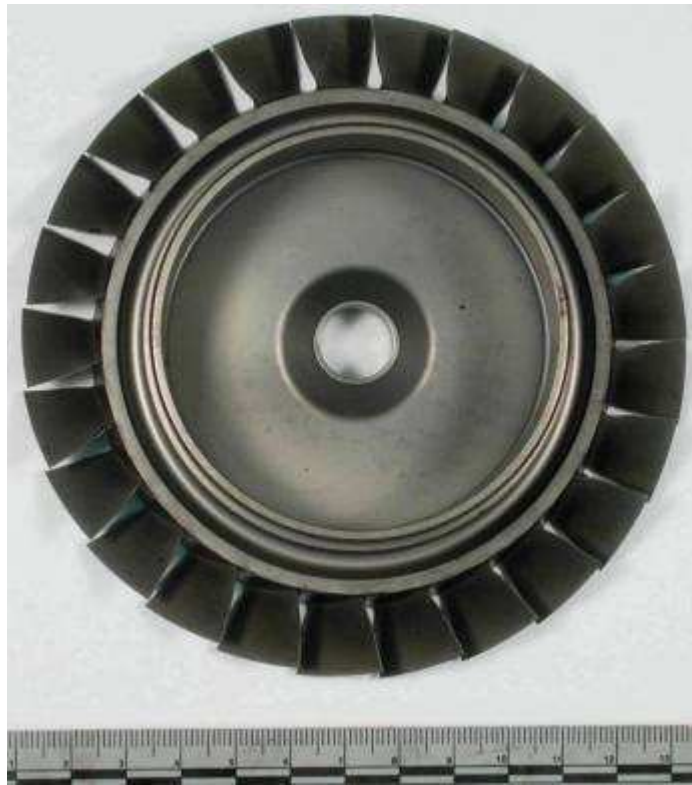
The condition of the stage 4 compressor wheel is shown in *Figures 77 and 78*. There was no obvious damage along the leading edges of the airfoils and no obvious sign of knife seal rub. Blade tip rub was evident around the entire circumference of the wheel as was noted in the previous compressor stages and was consistent with damage noted along the blade path in the compressor case.

Figure 77. The image of the leading edge surface of the stage 4 compressor wheel. Divisions = mm

**Figure 78. The image of the leading edge surface of the stage 4 compressor wheel.
Divisions = mm**

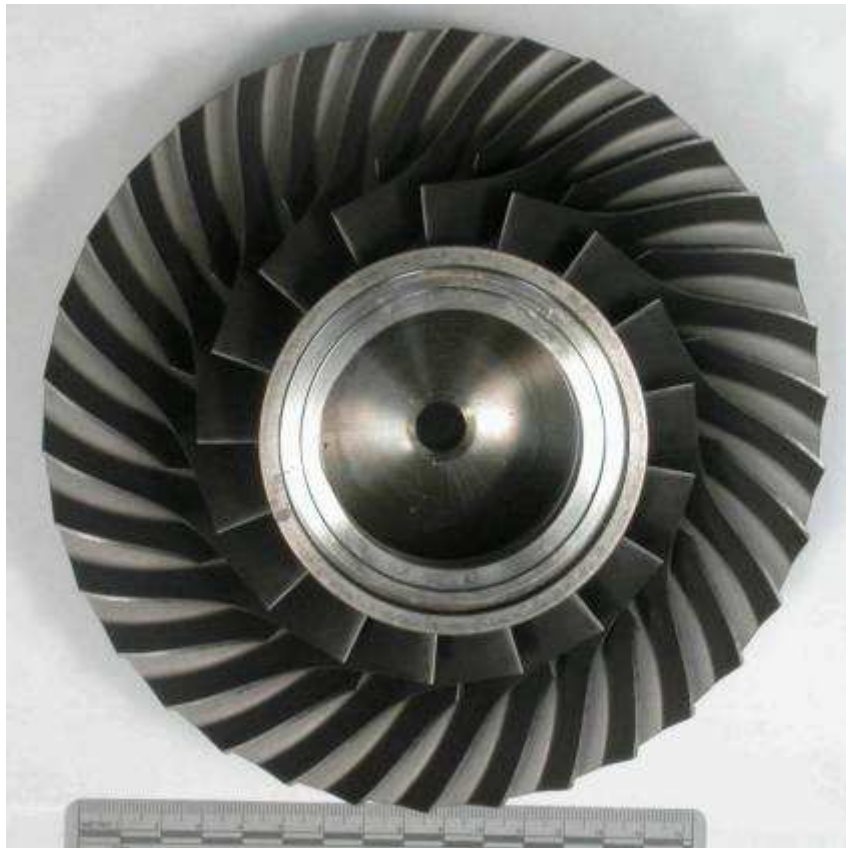
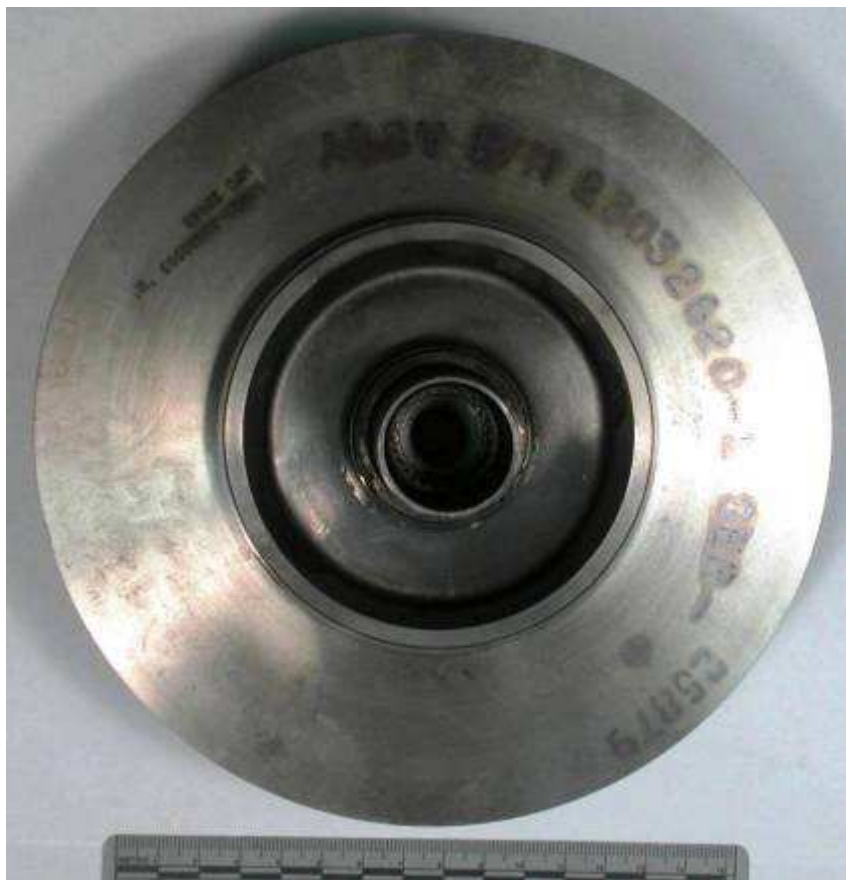
The condition of the compressor impeller wheel is shown in *Figures 80 and 81*. Blade tip rub was evident around the entire circumference. *Figure 82* shows an image exhibiting representative damage. No metallurgical, hardness or chemical analyses were conducted on this wheel.

Figure 80. The image of the condition of the impeller as viewed from the forward face. Divisions = mm

Figure 81. The image of the condition of the impeller as viewed from the aft face. (Divisions = mm)

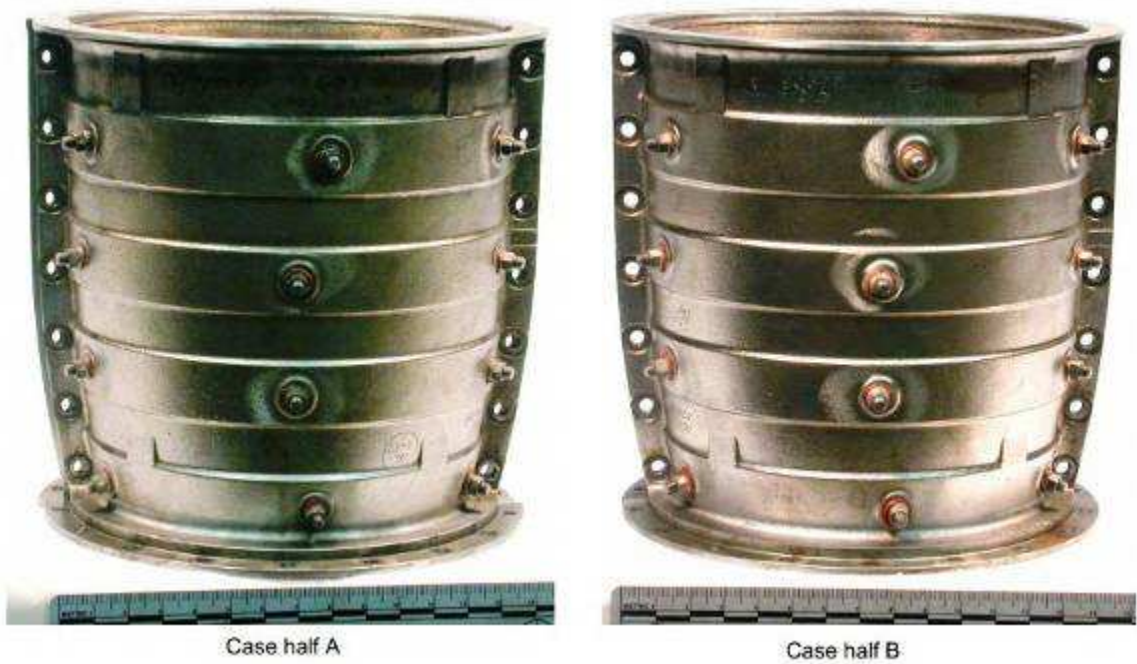
Figure 83. The image of the outer surfaces of the compressor case halves. (Divisions = mm)

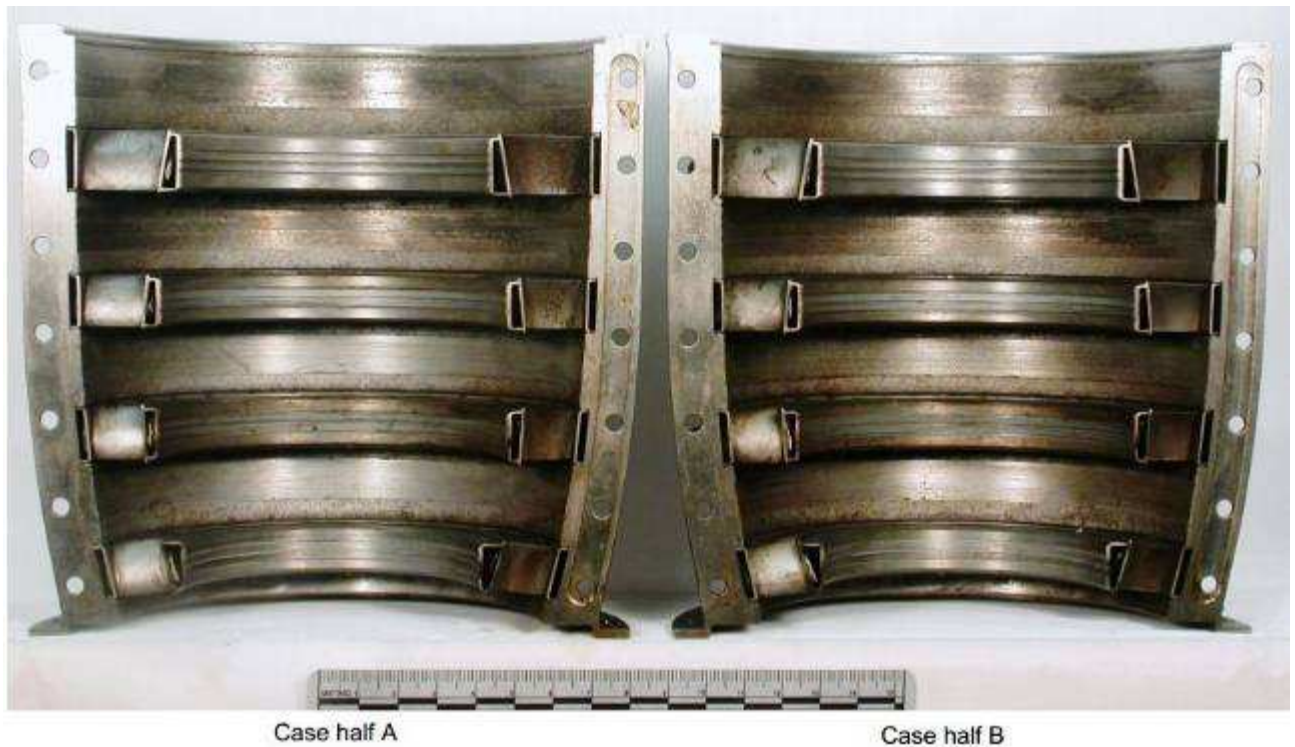
Figure 84. The image of the inner surfaces of the compressor case halves after light cleaning with soap and water. (Divisions = mm)

It was unable to distinguish which was the upper and lower units so for the purposes of identification they were labeled A and B. No obvious damage from heat distress was observed on the outer surface. *Figure 84* shows the inner surfaces after a light cleaning with soap and water to remove surface debris. Rub damage was evident along all four blade paths and was consistent with the tip rub damage noted on the compressor wheels. The grooves in the stationary seals appeared fairly uniform with evidence to suggest axial shift of the compressor rotor assembly. There is no evidence of impact damage to any of the compressor vanes. No metallurgical, hardness or chemical analyses were conducted on this part.

On the outer surface no obvious damage from heat distress was observed. Rub damage was evident inside along all four blade paths and was consistent with the tip rub damage noted on the compressor wheels. The grooves in the stationary seals appeared fairly uniform with evidence to suggest axial shift of the compressor rotor assembly. There was **no evidence of impact damage** to any of the compressor vanes.

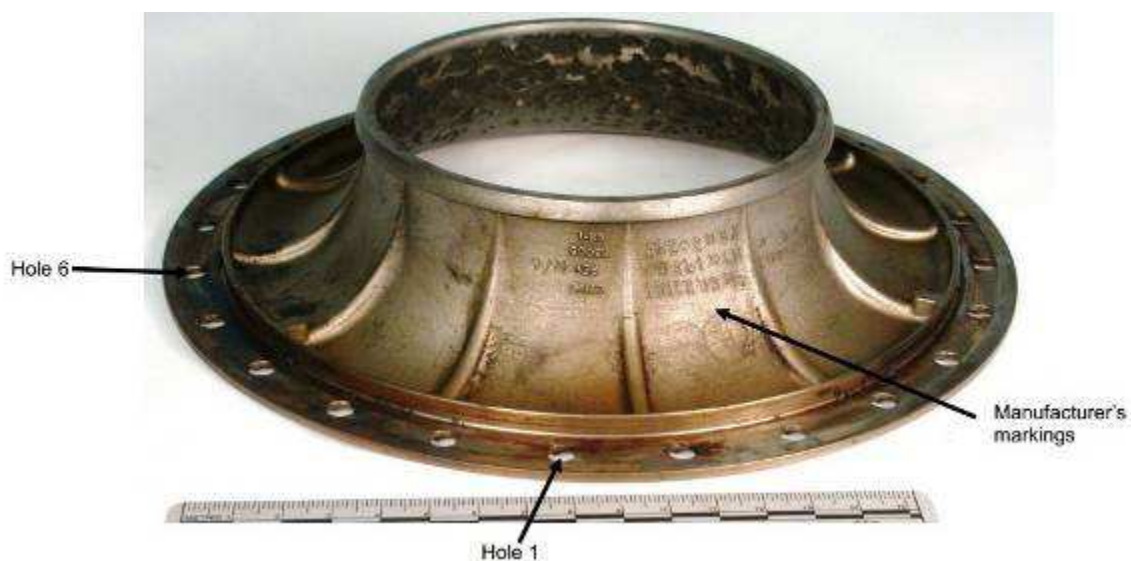
Figure 85. The image of the impeller shroud as viewed from an oblique view to the forward face. Divisions = mm

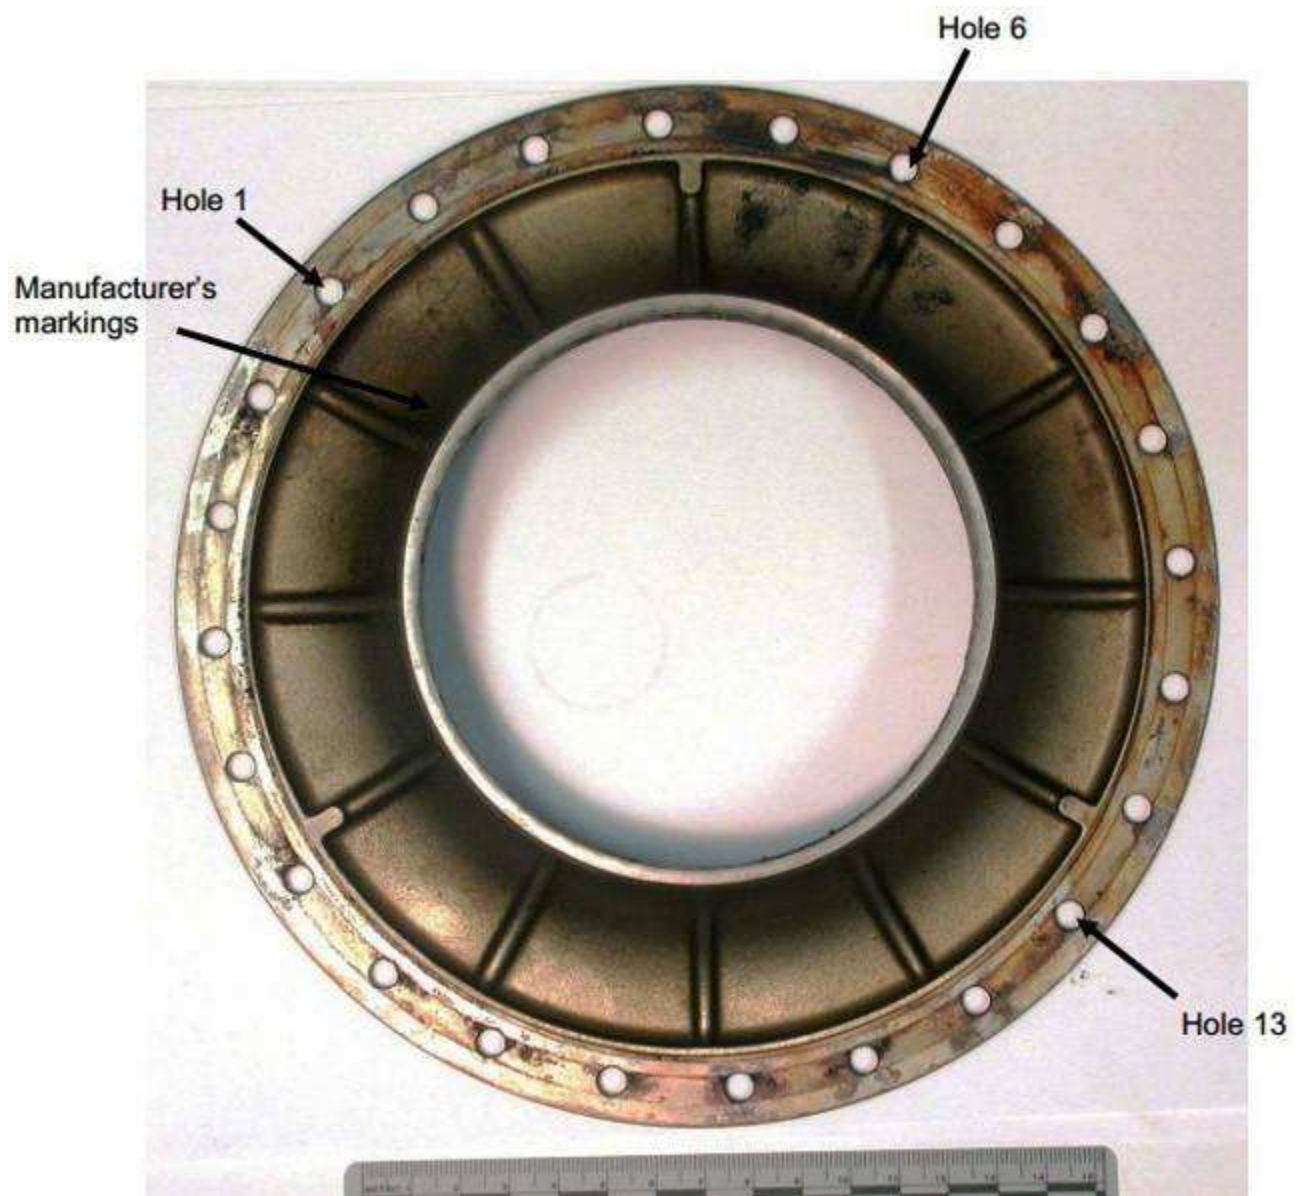
Figure 86. The image of the impeller shroud as viewed from the forward face. Divisions = mm

The forward surface was generally oil stained and dirty, but no obvious damage or heat distress was noted. Pitting was evident on the inner aft surface of the shroud as shown in *Figures 86 and 87*. No obvious patterns were noted, but the pitting appeared most severe near the forward portion of the shroud. A radial cross section was made through the shroud (see red dashed lines in *Figure 87*) and detailed views of the pitting damage is shown in *Figure 89A and 89B*.

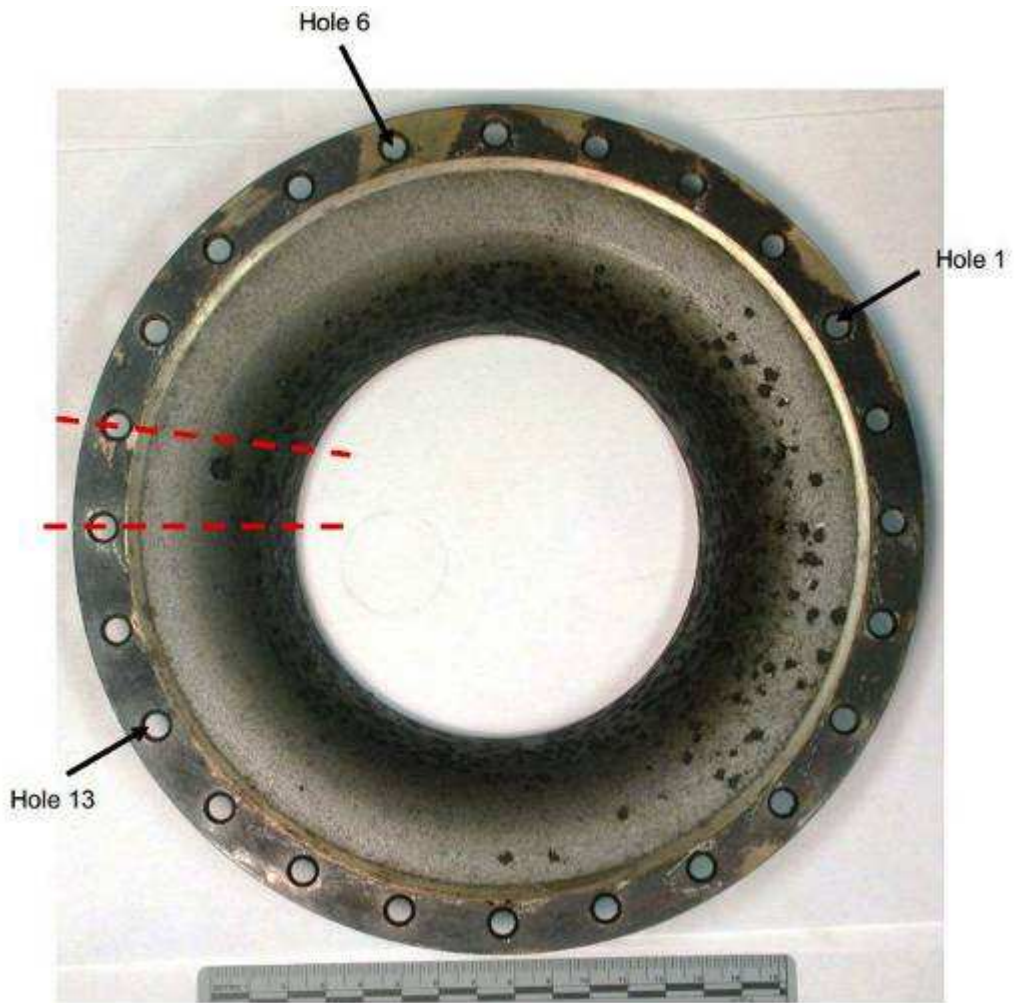
Figure 87. The image of the impeller shroud from the aft face. The red dashed lines represent the plane of metallurgical sectioning. (Divisions = mm)

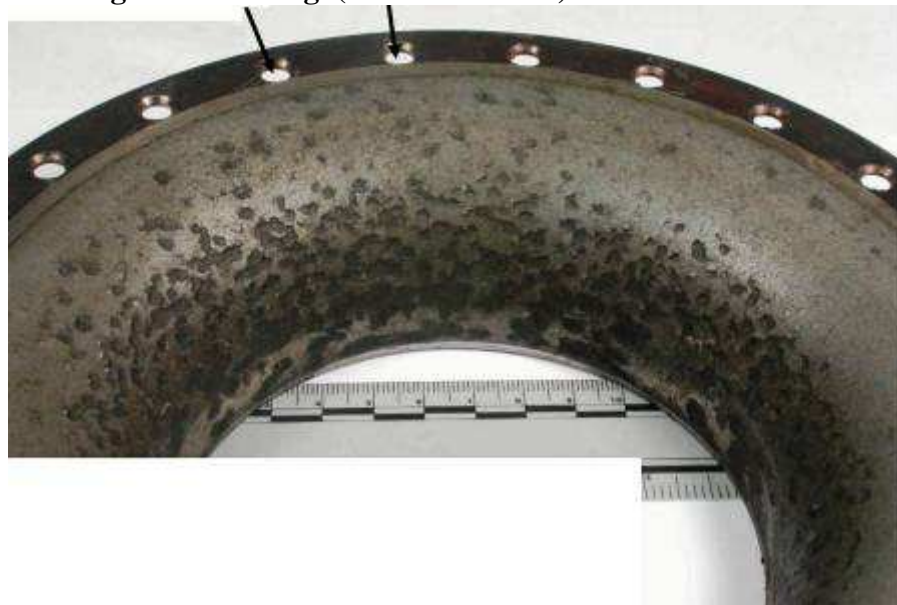
Figure 88. The image of a detailed view of the inner surface of the impeller shroud. (Divisions = mm)

The pitting damage was consistent with spalled areas of the coating applied to the shroud surface. The pitting appeared to be within the coating because no areas of the base metal were evident. Other areas appeared to be blistered, but not yet spalled off. This pitted area did not show evidence of heavy rub scars, but the blistered areas did appear to be rubbed.

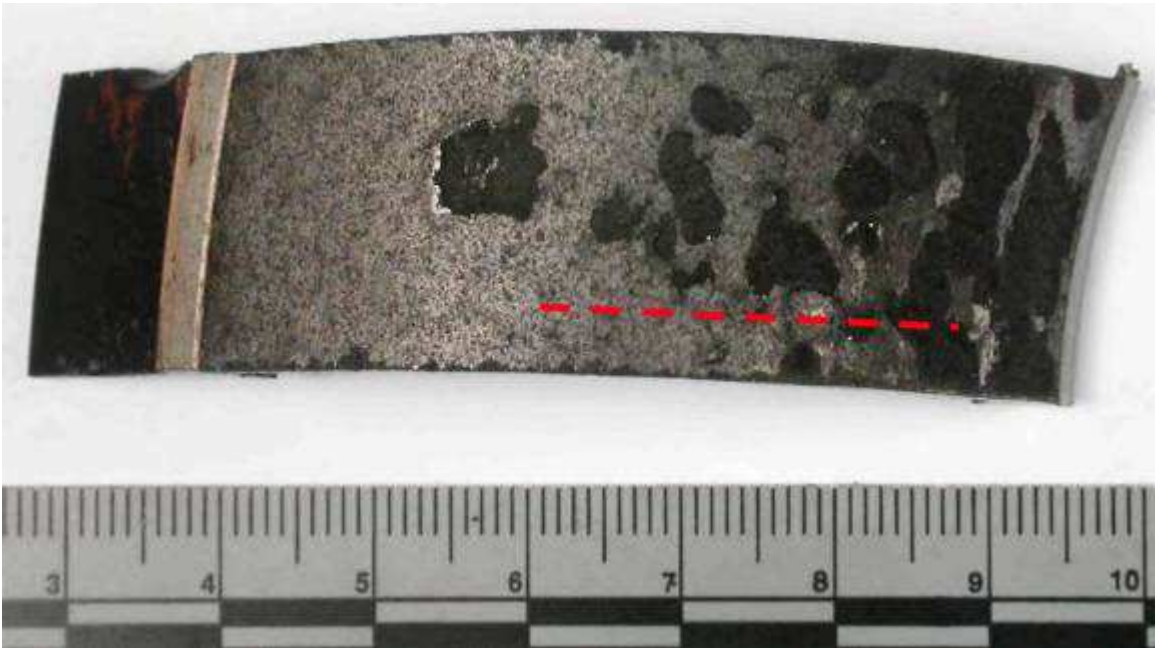
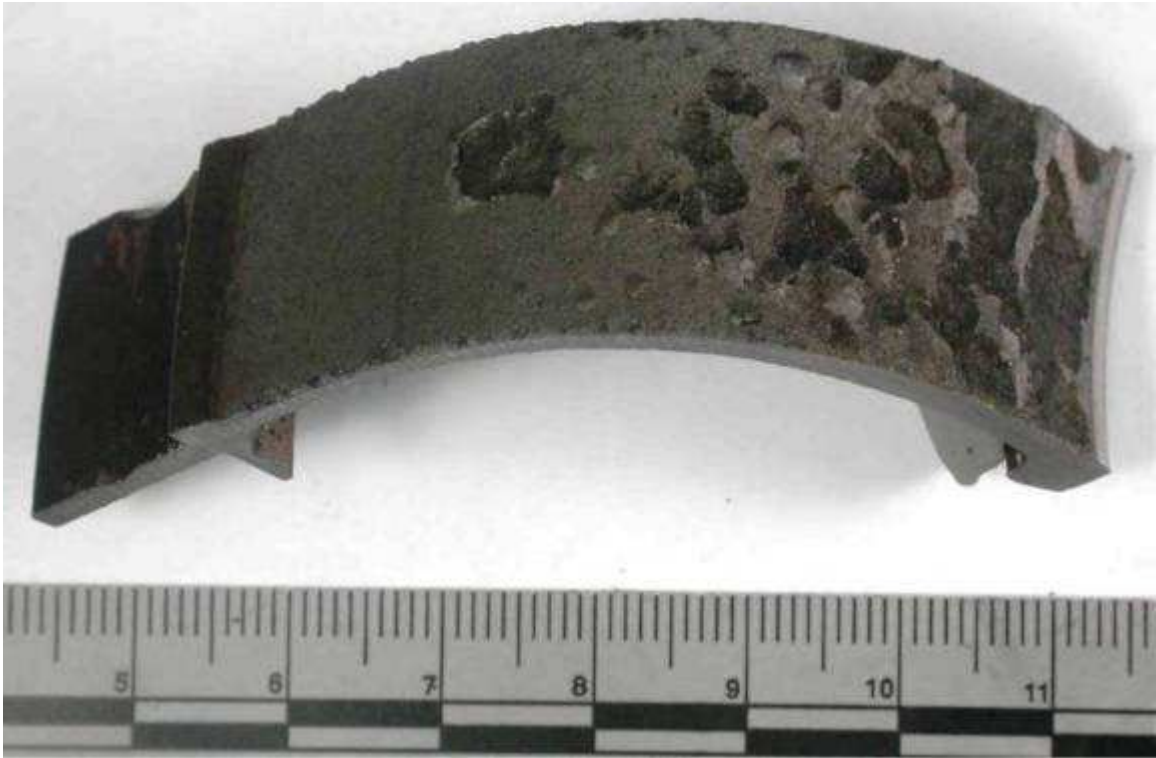
Figure 89 A

Figure 89 B. The image of a detailed view of the section removed from the impeller shroud. (see red dashed lines in *Figure 89A*). The red dashed line represents the plane for metallurgical sectioning. (Divisions = mm)

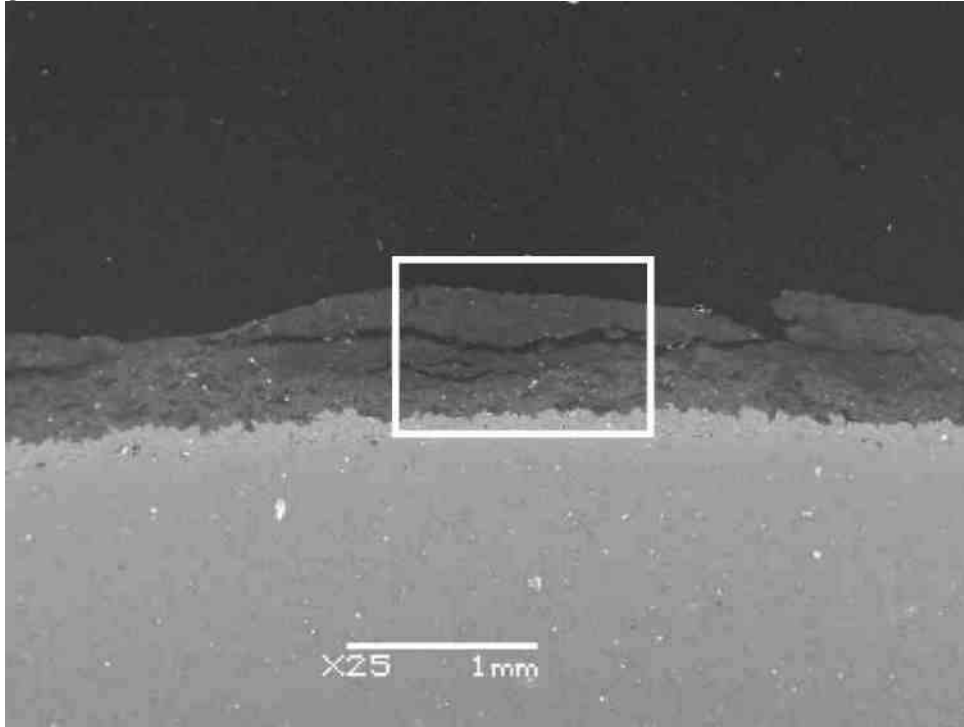
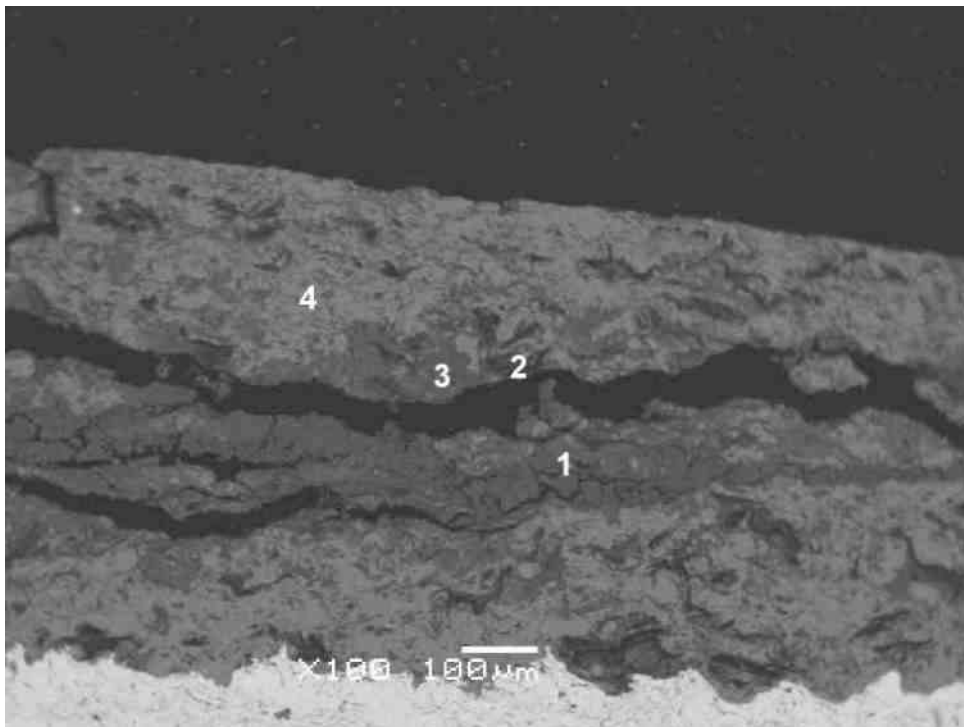
Figure 90A

The scanning electron microscope (SEM) images in *Figure 90* show a cross section through one of the blistered areas on the impeller shroud. The coating had delaminated and localized portions of the coating had liberated. Several areas of the coating exhibited different morphologies. Four of these areas of differing morphologies were analyzed by semi-quantitative dispersive spectroscopy (EDS) analysis to determine their compositions. The locations analyzed are marked on the bottom image of *Figure 90A* and *90B*.

Figure 90B. The SEM images above show a portion of the cross section taken from the impeller shroud (see red dashed line in *Figure 46*).

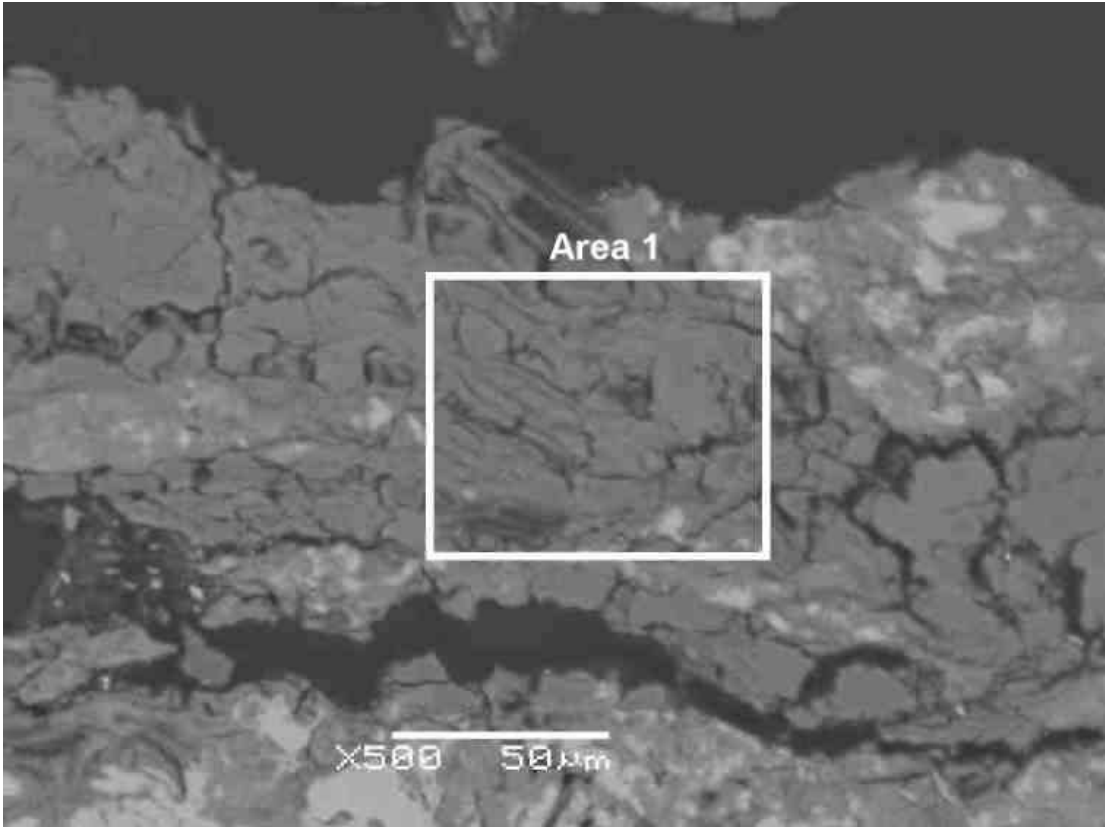
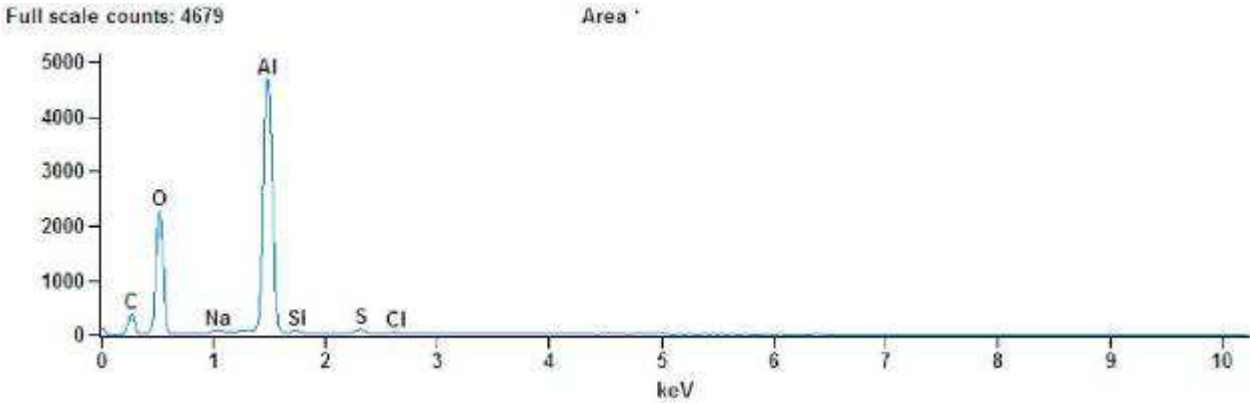
The SEM image at the top of *Figure 91* shows a portion of the cross section of the impeller shroud and the area referred to as “area 1” and was prevalent along the crack. The resultant spectra at the bottom of the page revealed that it was primarily comprised of aluminum and oxygen with trace elements of carbon, sodium, silicon, sulfur and chlorine. This is consistent with aluminum oxides that are produced during the coating process, but are typically uniformly dispersed throughout the coating.

Figure 91. The SEM image at the top of the page shows area 1 that was analyzed by EDS and the resultant spectra is shown at the bottom of the page.

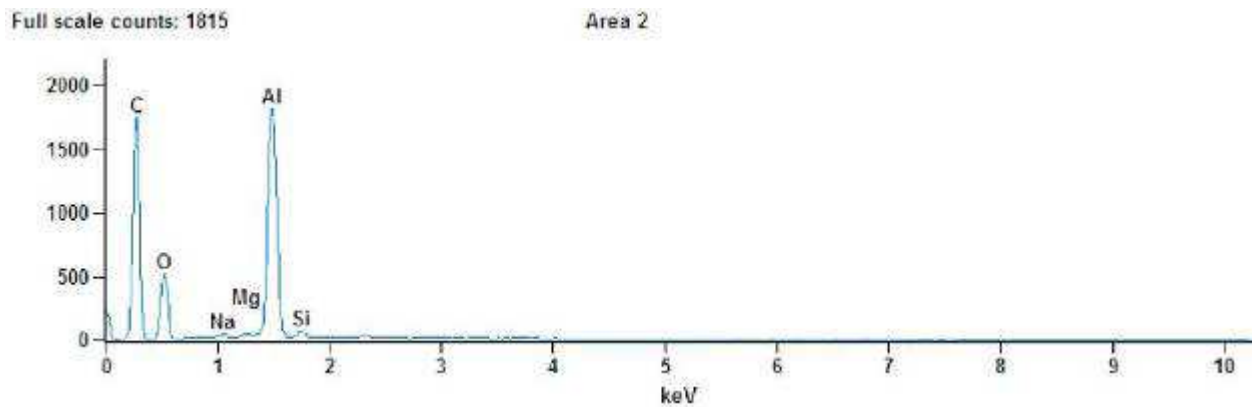
Figure 92 The SEM image at the top of the page shows area 2 that was analyzed by EDS and the resultant spectra is shown at the bottom of the page.

The SEM image at the top of *Figure 92* shows the area referred to as “area 2”. The resultant spectra at the bottom of the page reveal that it is primarily comprised of carbon, aluminum and oxygen with trace elements of sodium, magnesium and silicon. This area is consistent with the milled graphite particles that are intentionally included as part of the coating to improve the friability or abrasability of the coating.

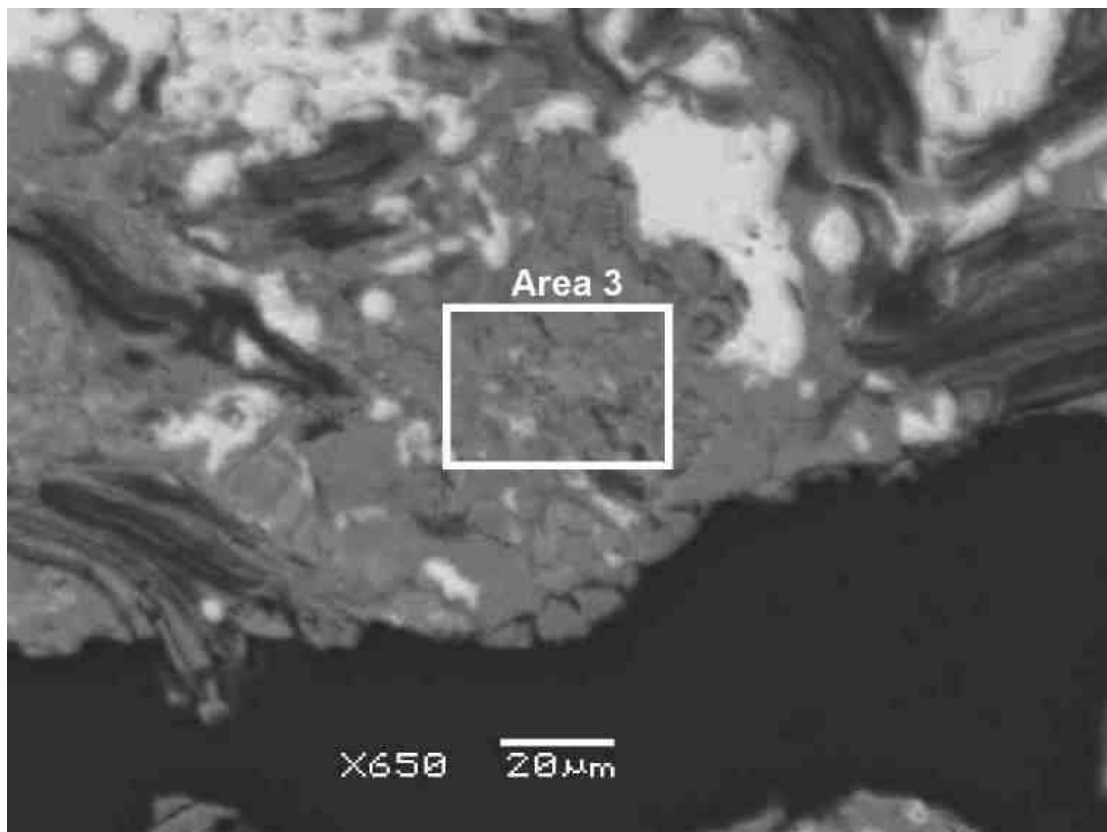
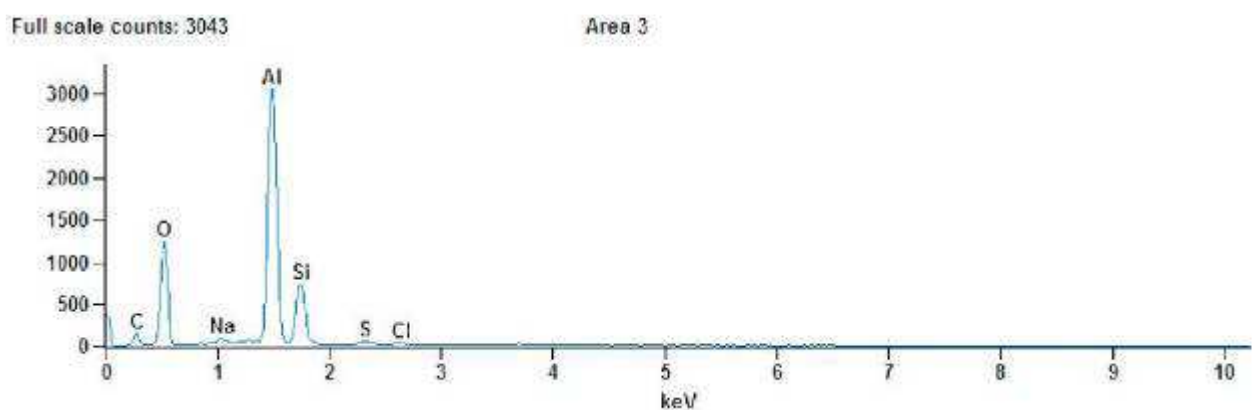
Figure 93. The SEM image at the top of the page shows area 3 that was analyzed by EDS and the resultant spectra is shown at the bottom of the page.

The SEM image at the top of *Figure 93* shows the area referred to as “area 3”. The resultant spectra at the bottom of the page reveal that it is primarily comprised of aluminum, oxygen and silicon with trace amounts of carbon, sodium, sulfur and chlorine. These areas appear to be more uniformly dispersed throughout the coating, but were also evident along the crack.

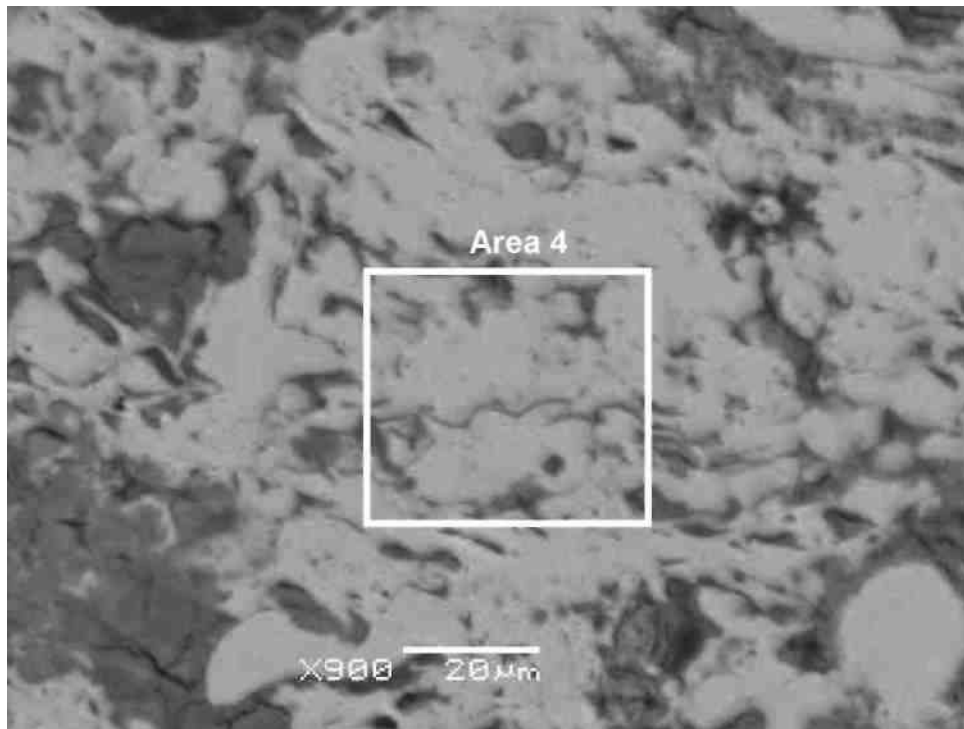
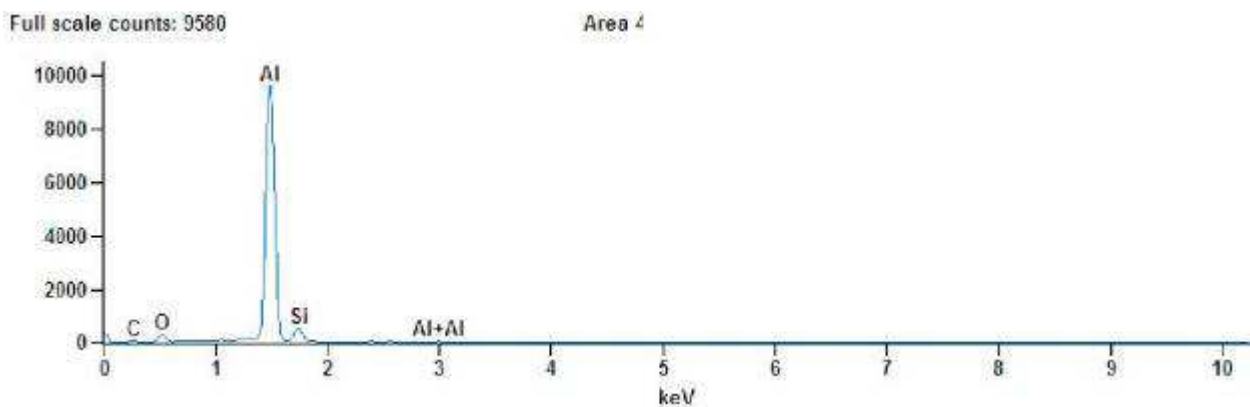
Figure 94 The SEM image at the top of the page shows area 4 that was analyzed by EDS and the resultant spectra is shown at the bottom of the page.

The SEM image at the top of *Figure 94* shows the area referred to as “area 4” and is representative of the aluminum portions of this coating system. The resultant spectra at the bottom of the page reveal that it is primarily comprised of aluminum with only trace amounts of carbon, oxygen and silicon.

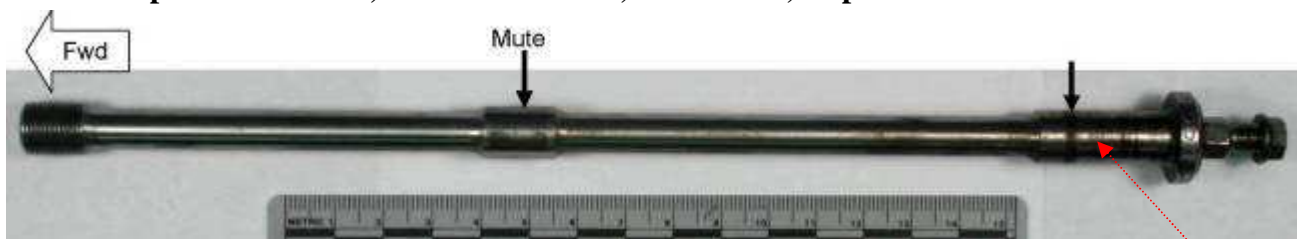
Figure 95. Compressor tie bolt

The condition of the compressor tie bolt is shown in *Figure 95 and 96*. There was slight discoloration on the mute area and coke deposits on the aft end as shown in *Figure 97*. No metallurgical, hardness or chemical analyses were conducted on this component.

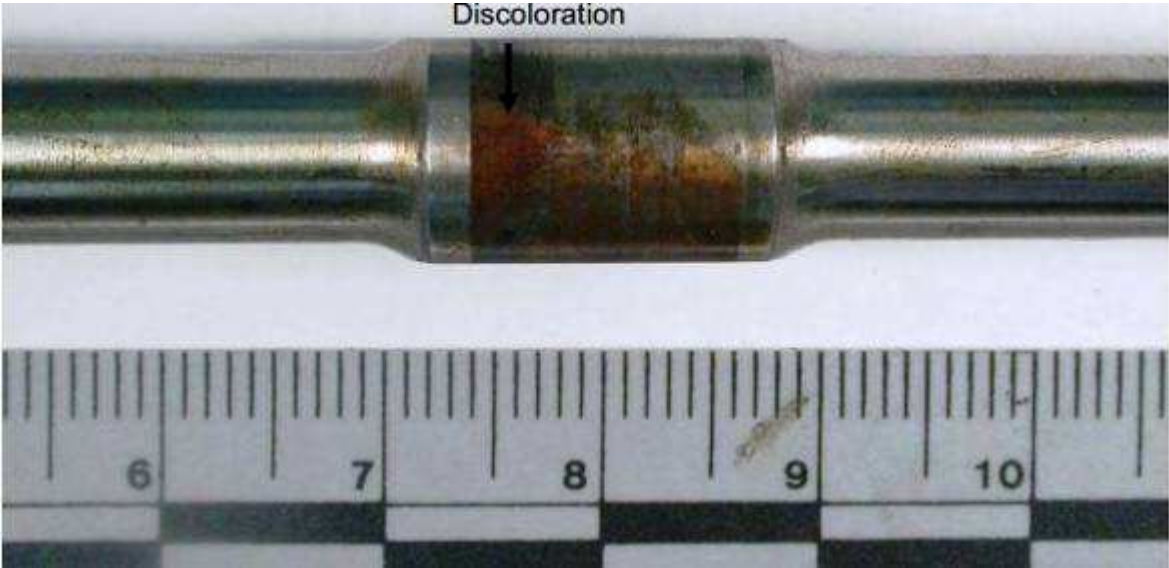
Figure 96. The image of the compressor tie bolt (top) and localized discoloration on the mute area (bottom), Divisions = mm.
