TRANSPORT ACCIDENT AND INCIDENT INVESTIGATION BUREAU

FINAL REPORT Nr.5/2012(3-2014)

**of HELICOPTER MD 369E, REGISTRATION OH-HJR ON JULY 12,
2012 AT KASTIRE**

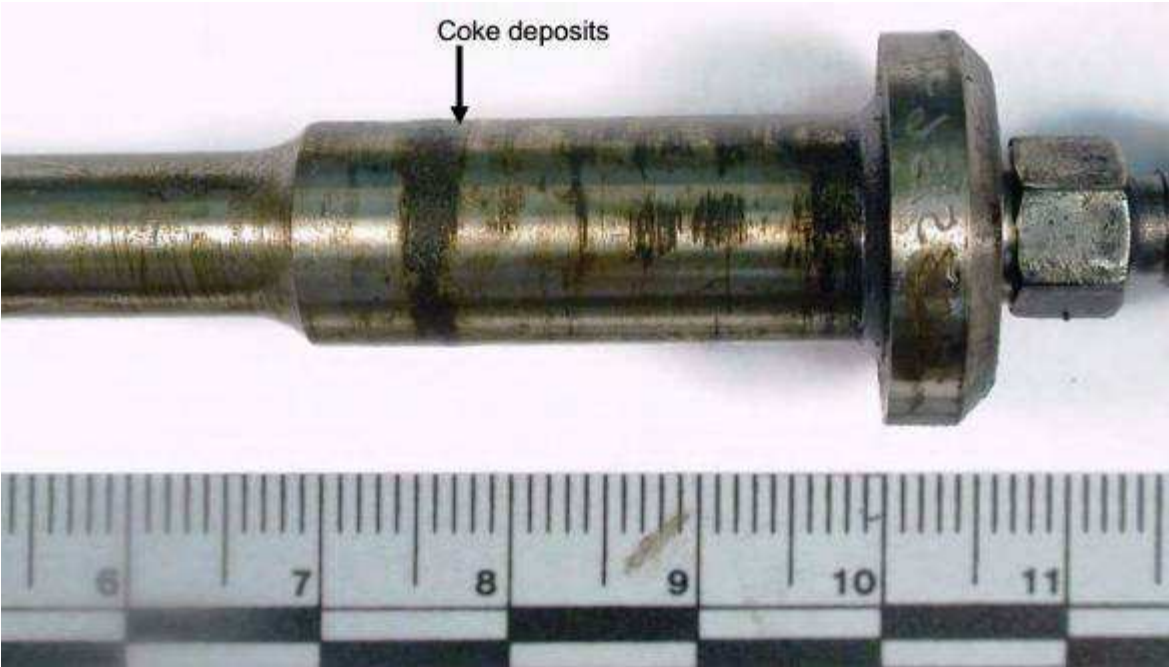
Figure 97. The image of the coke deposits on the end of the compressor tie bolt. (Divisions – mm)

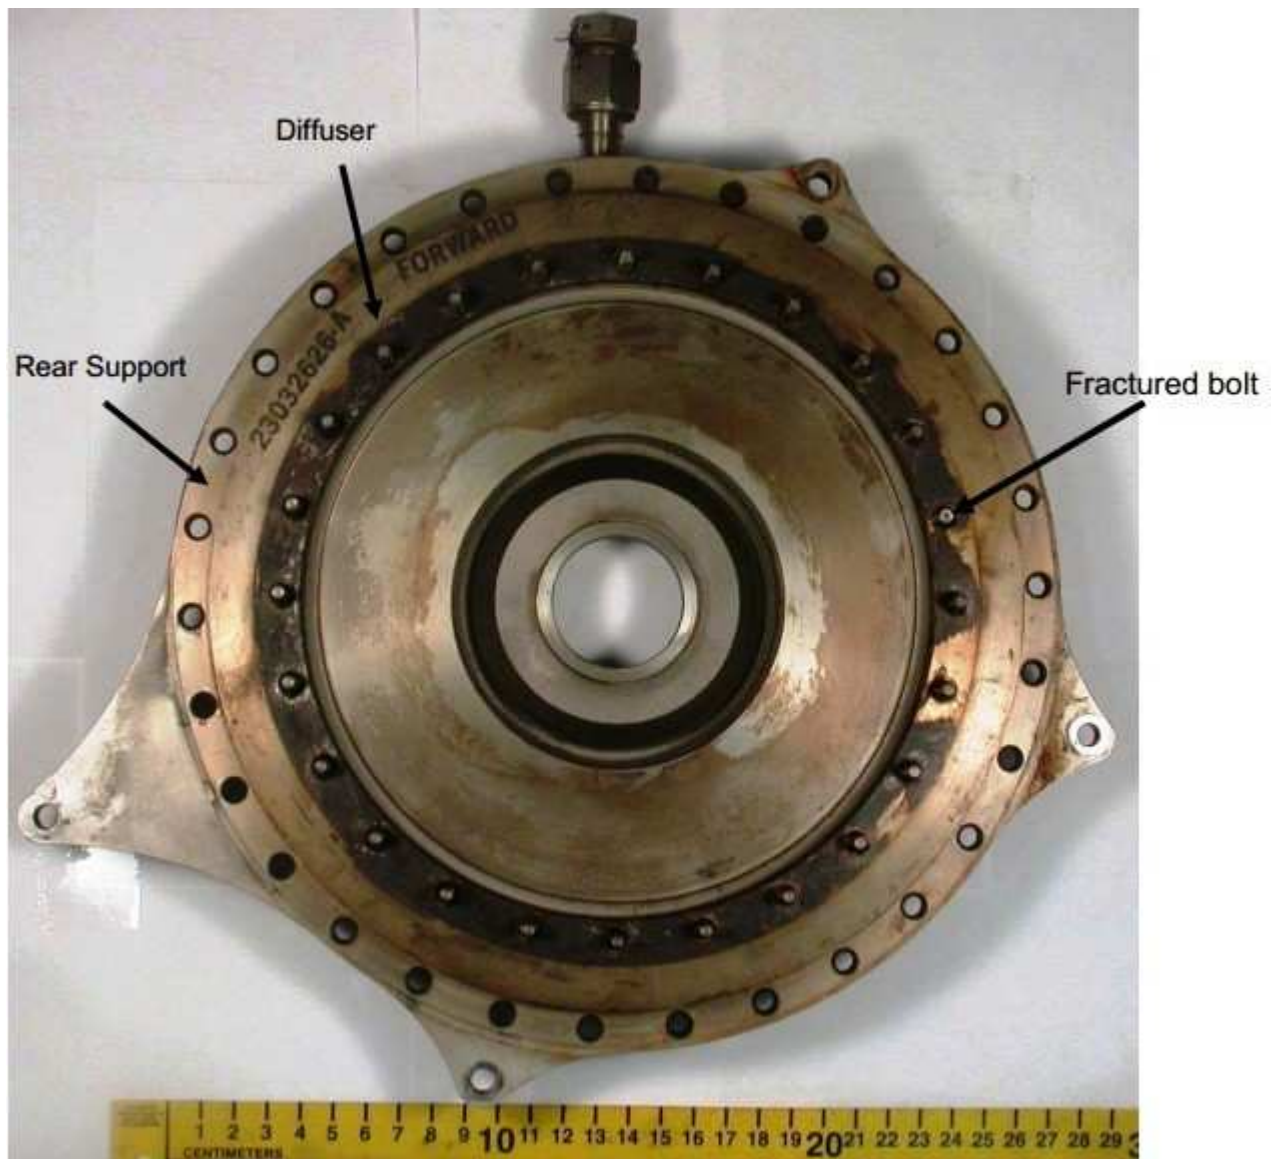
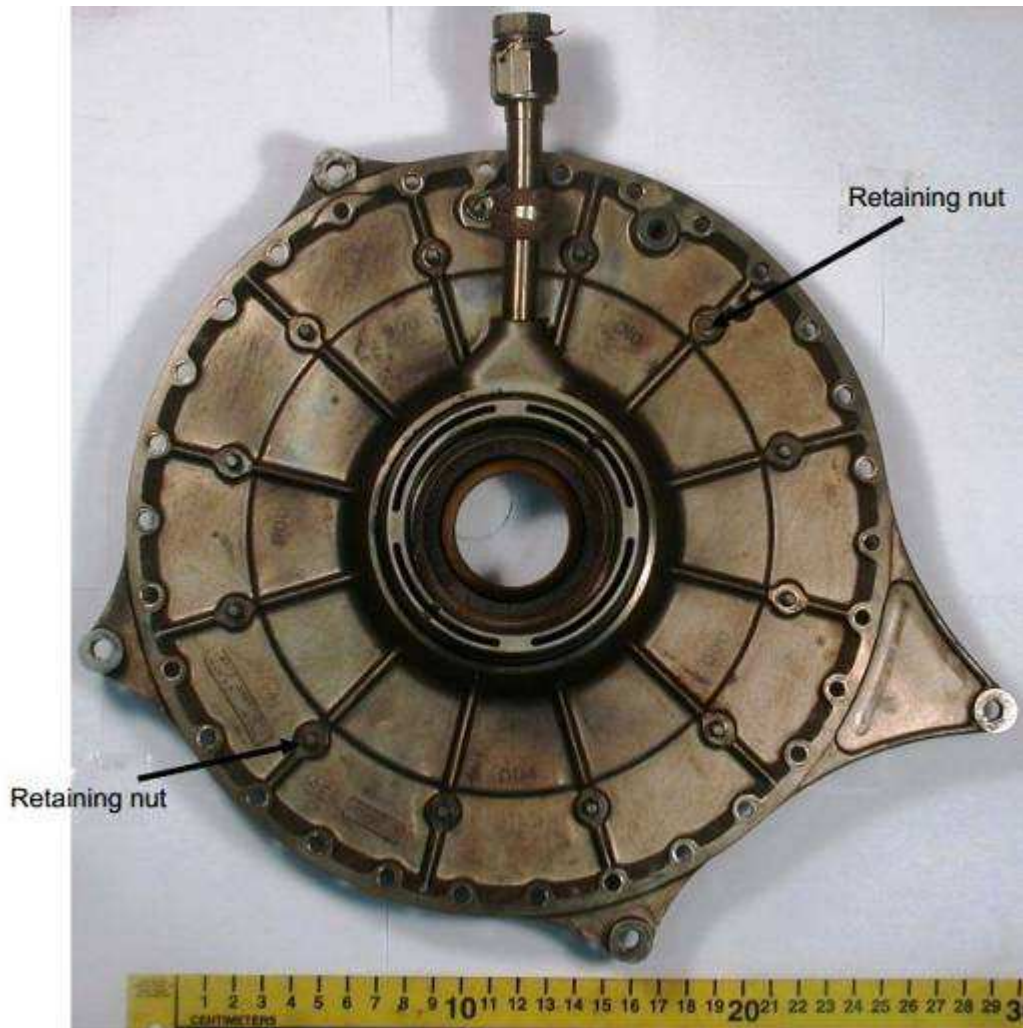
Figure 98 The image of the condition of the compressor rear support and diffuser as viewed from the forward face. Divisions=cm

The condition of the compressor rear support and diffuser assembly is shown in *Figures 98 and 99*. The general condition was dirty with local areas of oil staining and/or surface corrosion. One mounting bolt on the forward side had fractured. The fracture appeared bright and shiny and the macroscopic fracture features were consistent with overload indicating the bolt most likely fractured during disassembly. Detailed fractographic evaluations were not conducted. Both static seals exhibited uniform grooves. All but two of the nuts holding the diffuser assembly to the rear support had been removed.

Figure 99 The image of the condition of the compressor rear support and diffuser as viewed from the aft face. Divisions=cm

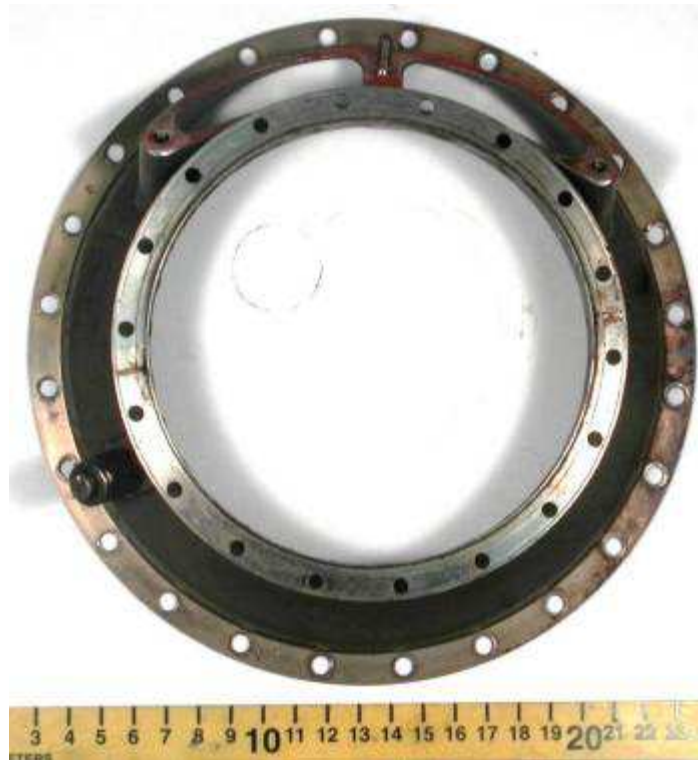
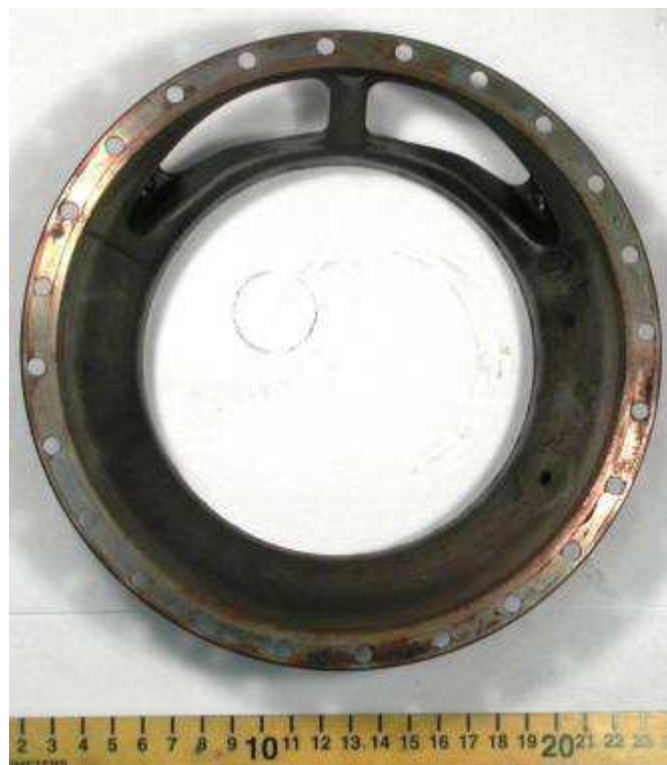
The as-received condition of the bleed manifold is shown in *Figures 101* and *102*. No obvious damage was noted to this component but red colored RTV gasket type material was evident on the bolt ring and the triangular shaped ports. No metallurgical, hardness or chemical analyses were conducted.

Figure 101. The image of the condition of the bleed manifold as viewed from the forward face. Divisions = cm

Figure 102. The image of the condition of the bleed manifold as viewed from the aft face. Divisions = cm

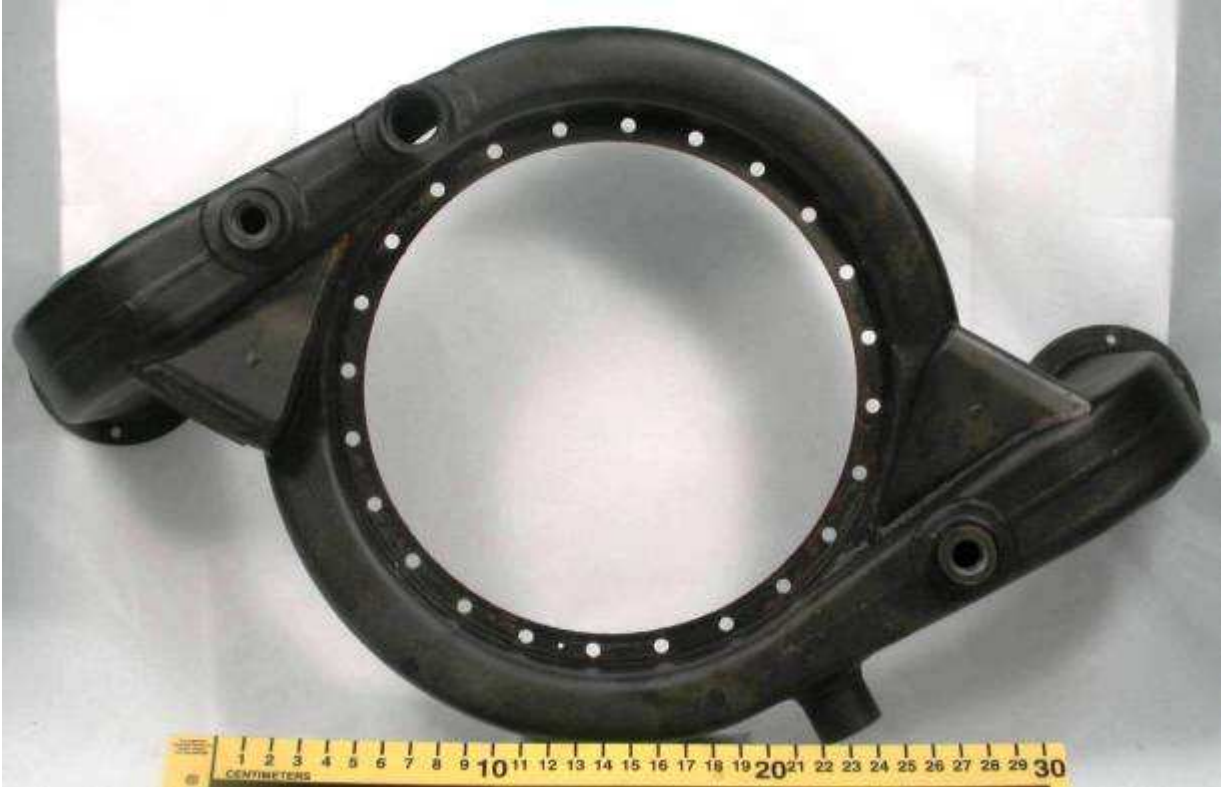
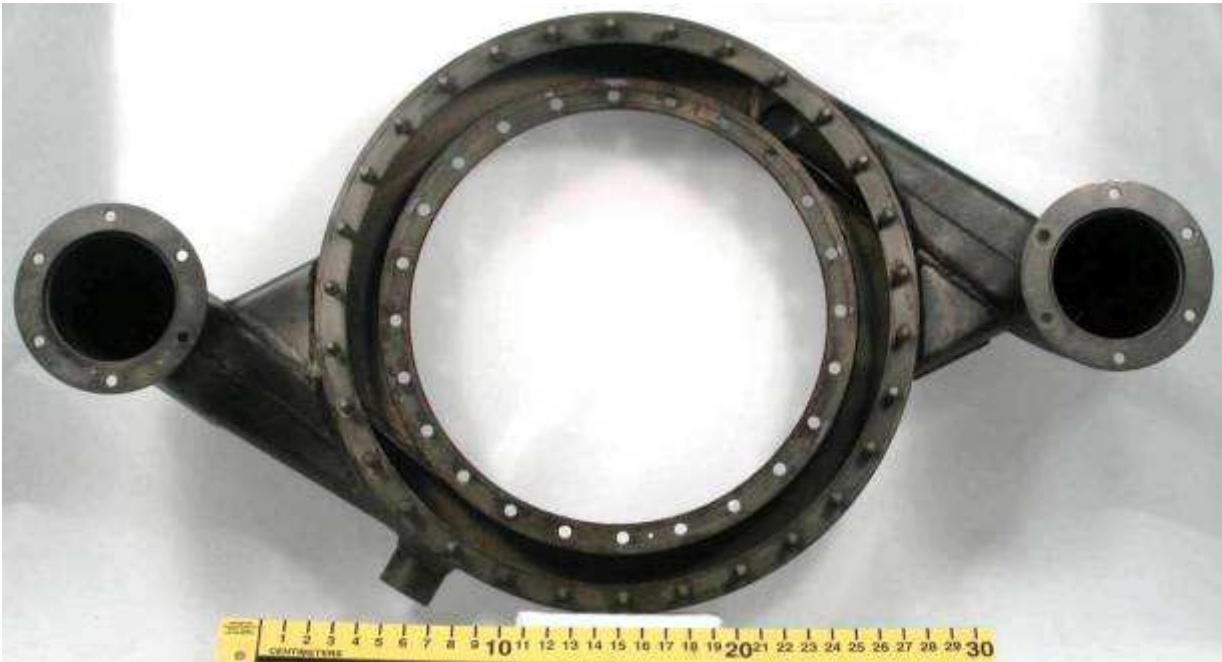
The as-received condition of the scroll is shown in *Figures 103* and *104*. The scroll surfaces were dark, but no obvious damage was noted on this component. No metallurgical, hardness or chemical analyses were conducted.

Figure 102. The image of the conditions of the scroll assembly from the forward face. Divisions = cm

Figure 102. The image of the conditions of the scroll assembly from the aft face. Divisions = cm

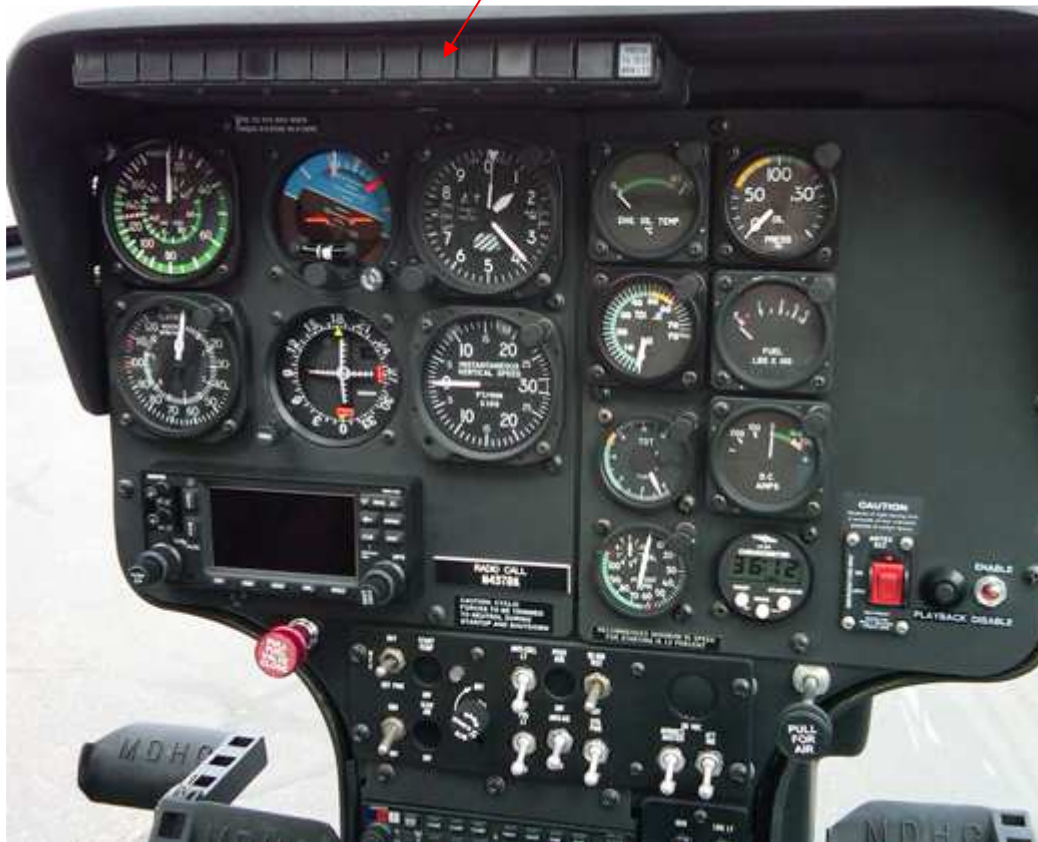
Figure 105. Instrument panel

The helicopter is equipped with warning and caution indicators located at the top of the instrument panel, including Engine Chip Detector

According to pilot's testimony there were not chip lights or abnormal instrument indications prior to the engine power loss. At that moment when the pilot heard engine noise reducing he was observing the saw through helicopter's window, therefore he can not to see caution indicator's indications. The pilot assured that during preflight check as well as during performing cutting work was not any abnormalities with engine operation as well as engine chip warning.

During investigation it was found on the chip plugs overdose of the metal particles matched the bearing outer ring, inner ring, rollers material and separator silver material. Such quantity of accumulated metallic debris could be enough for chip detectors to illuminate a cockpit warning light.

During investigation it was found that the chip detection system has been functional, therefore it is possible to conclude that during flight chip indication warning appeared, at least chip light to be forced flicker on.
