FINAL REPORT No. 4-02/ 3-18 (3-2019)

On THE ACCIDENT of AIRCRAFT BUCKER Bu 133C JUNGMEISTER, REGISTRATION SE-AJA ON JULY 8, 2018 AT BAUSKA DISTRICT

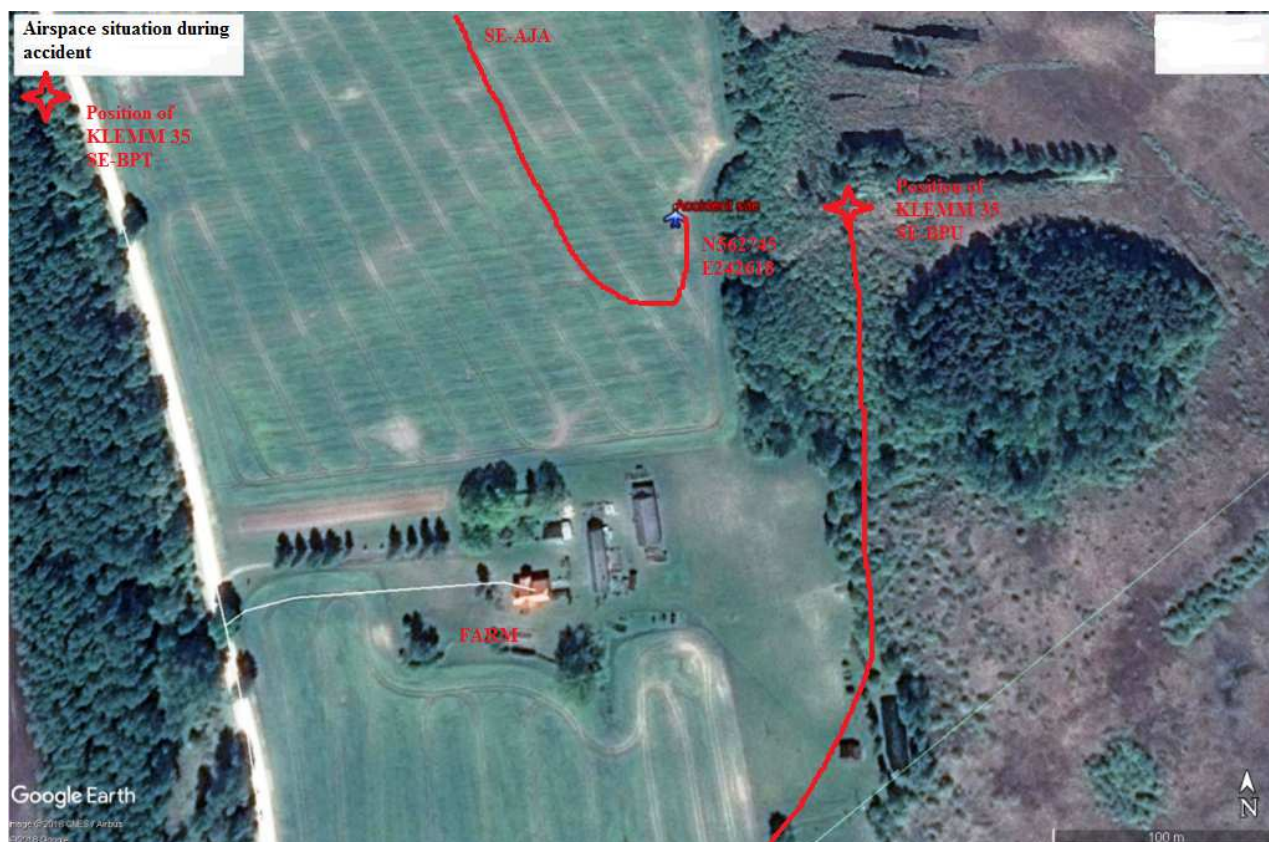
Picture 3 Area of accident site

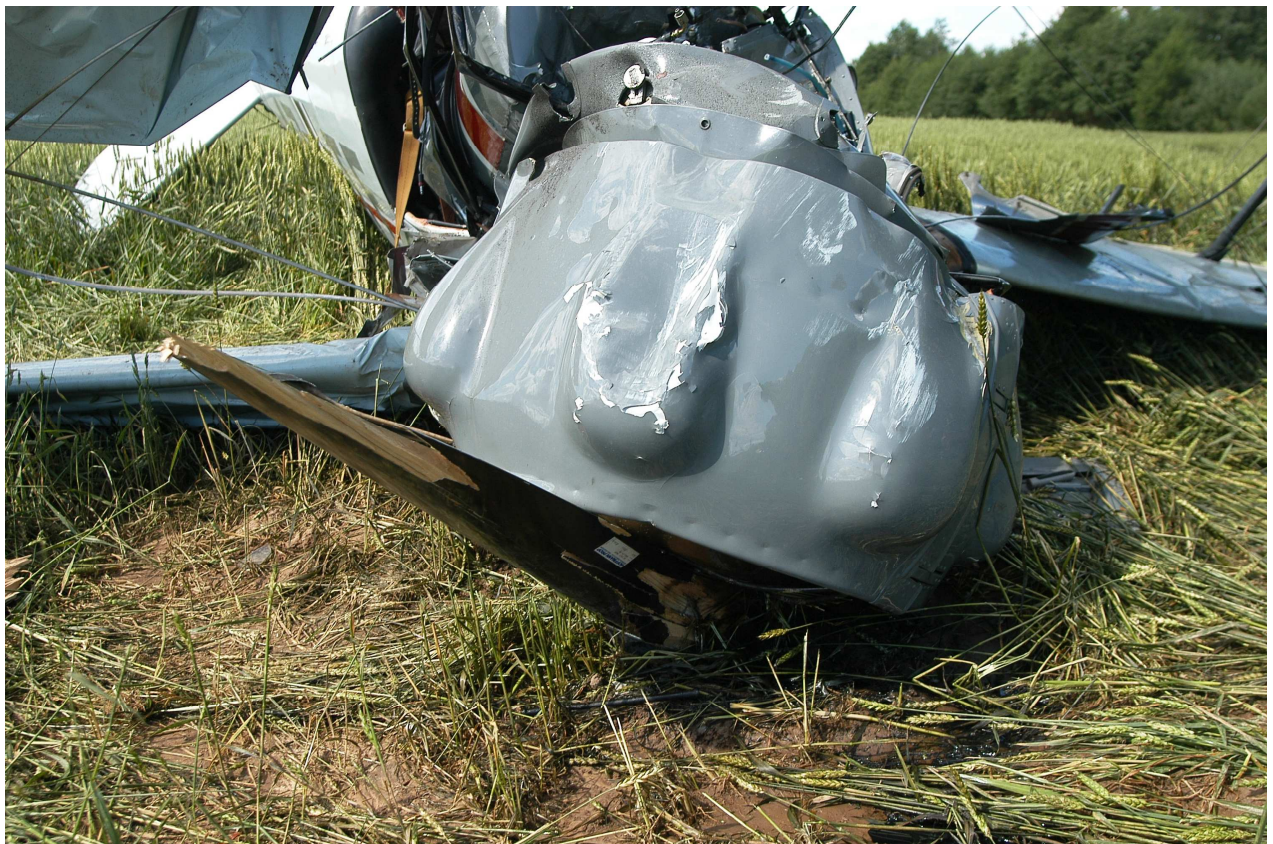
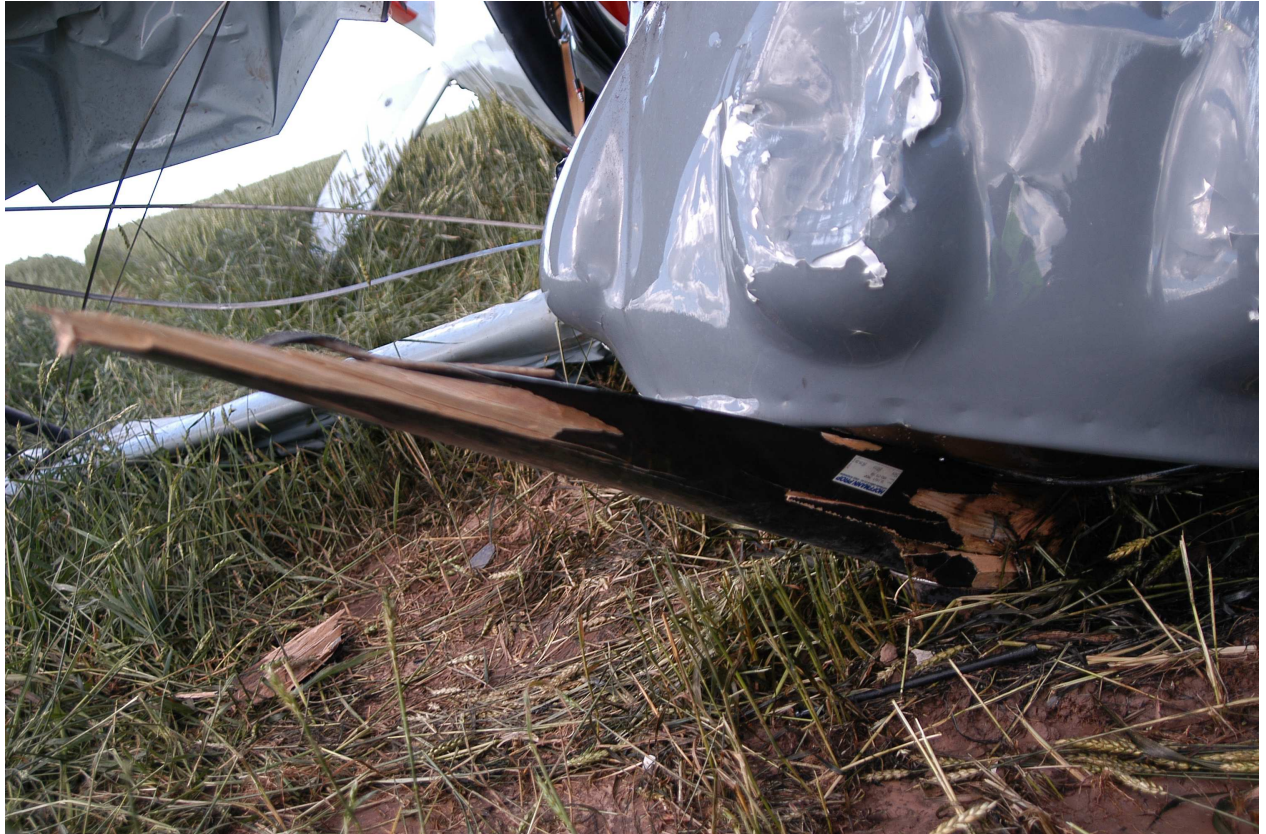
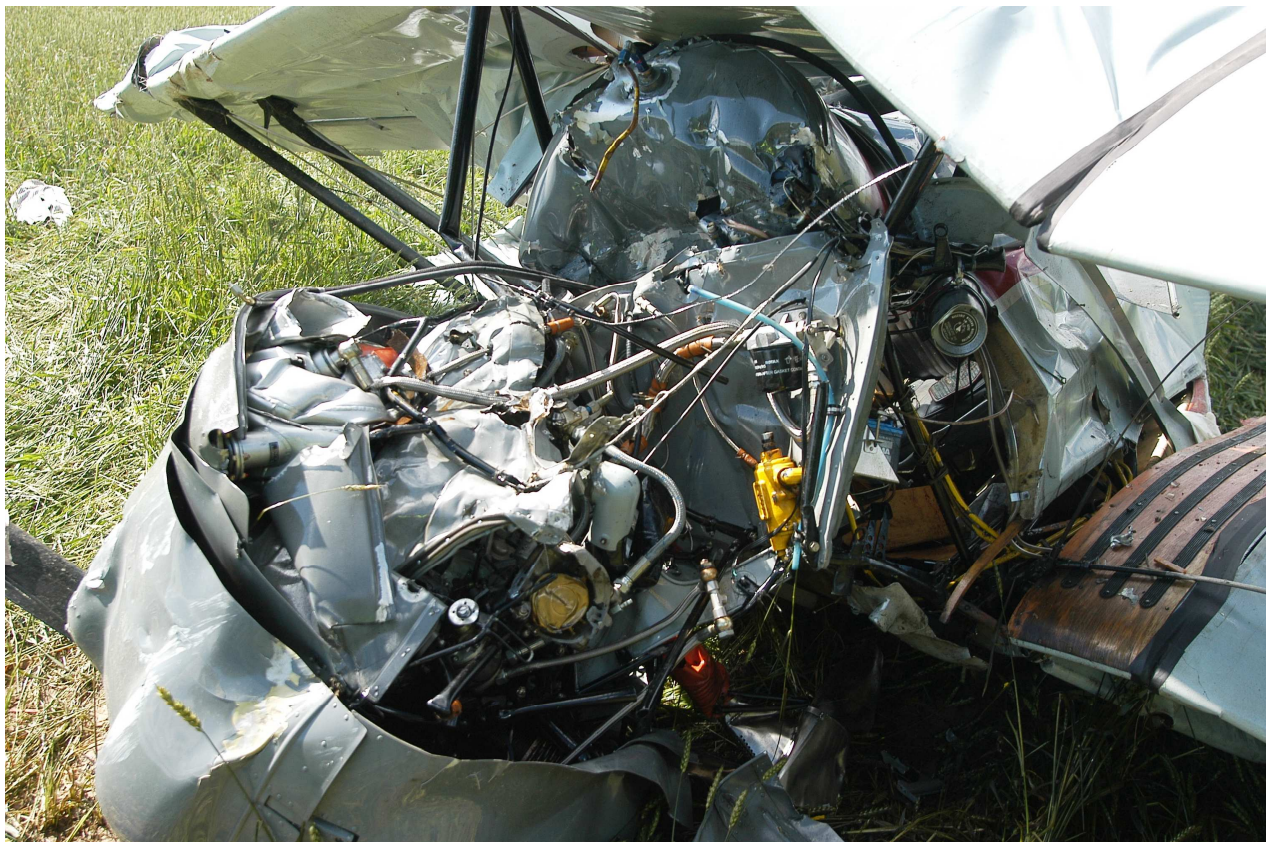
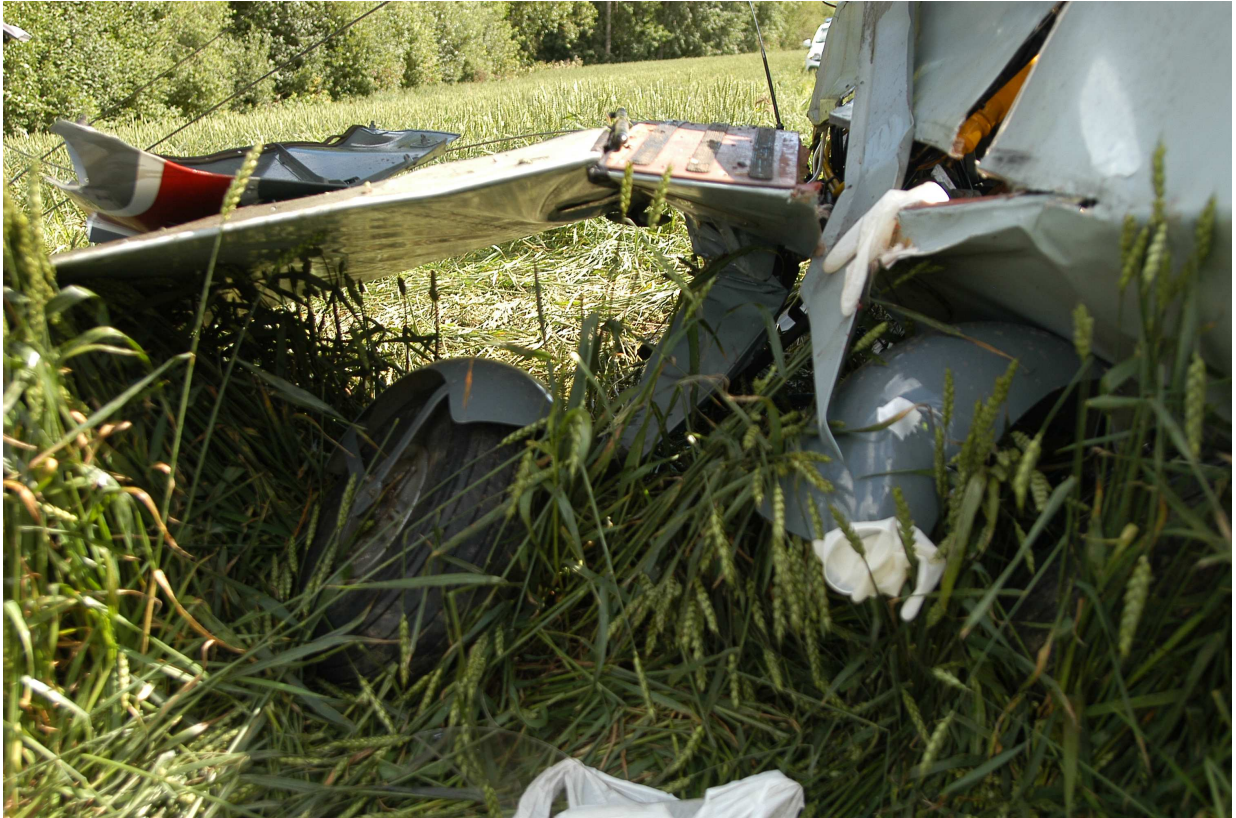
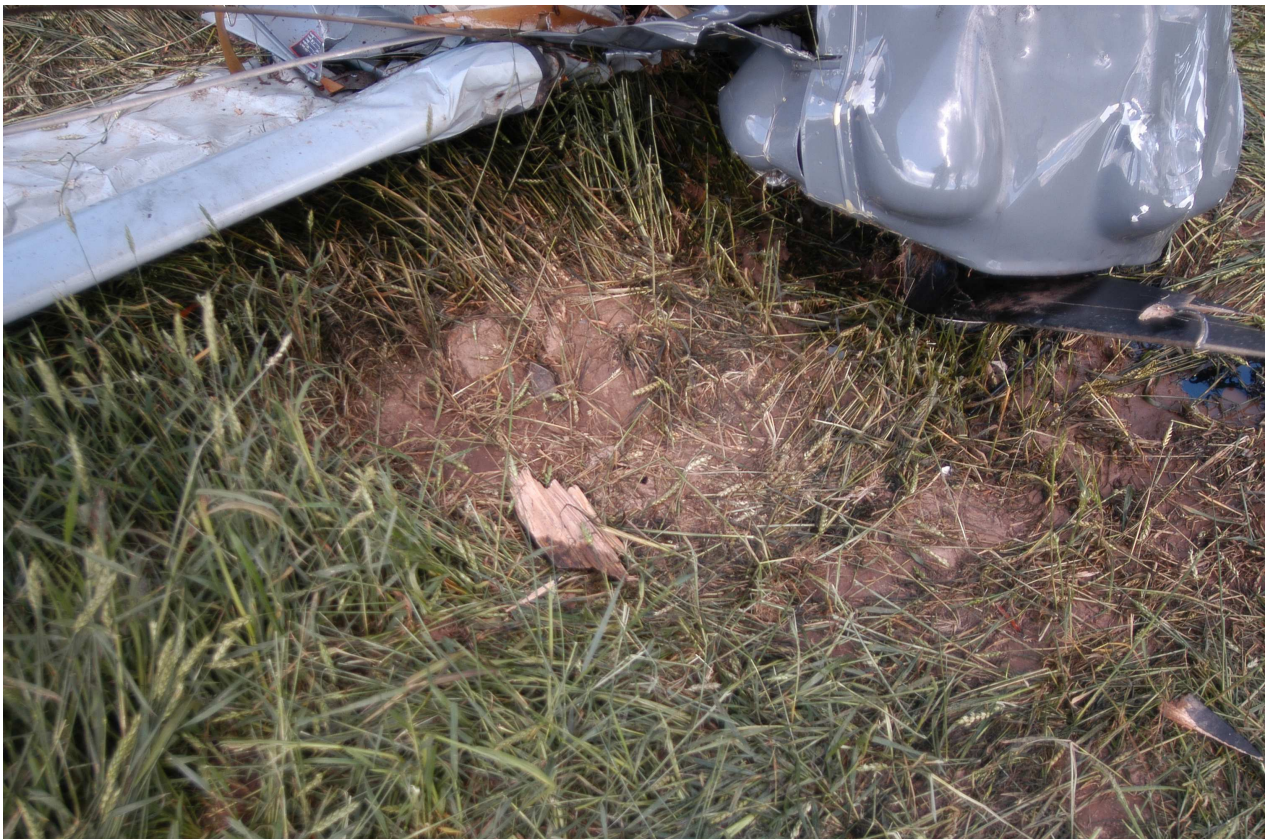
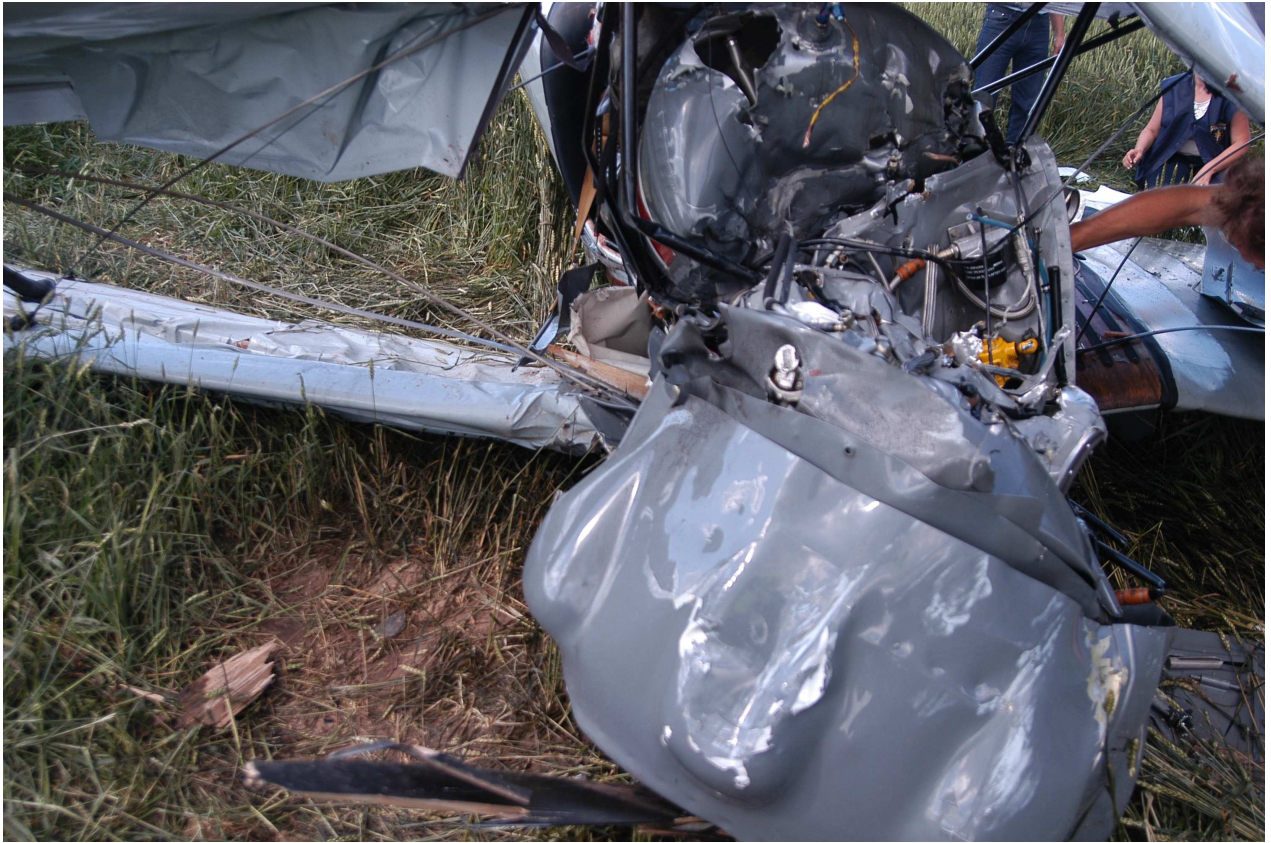
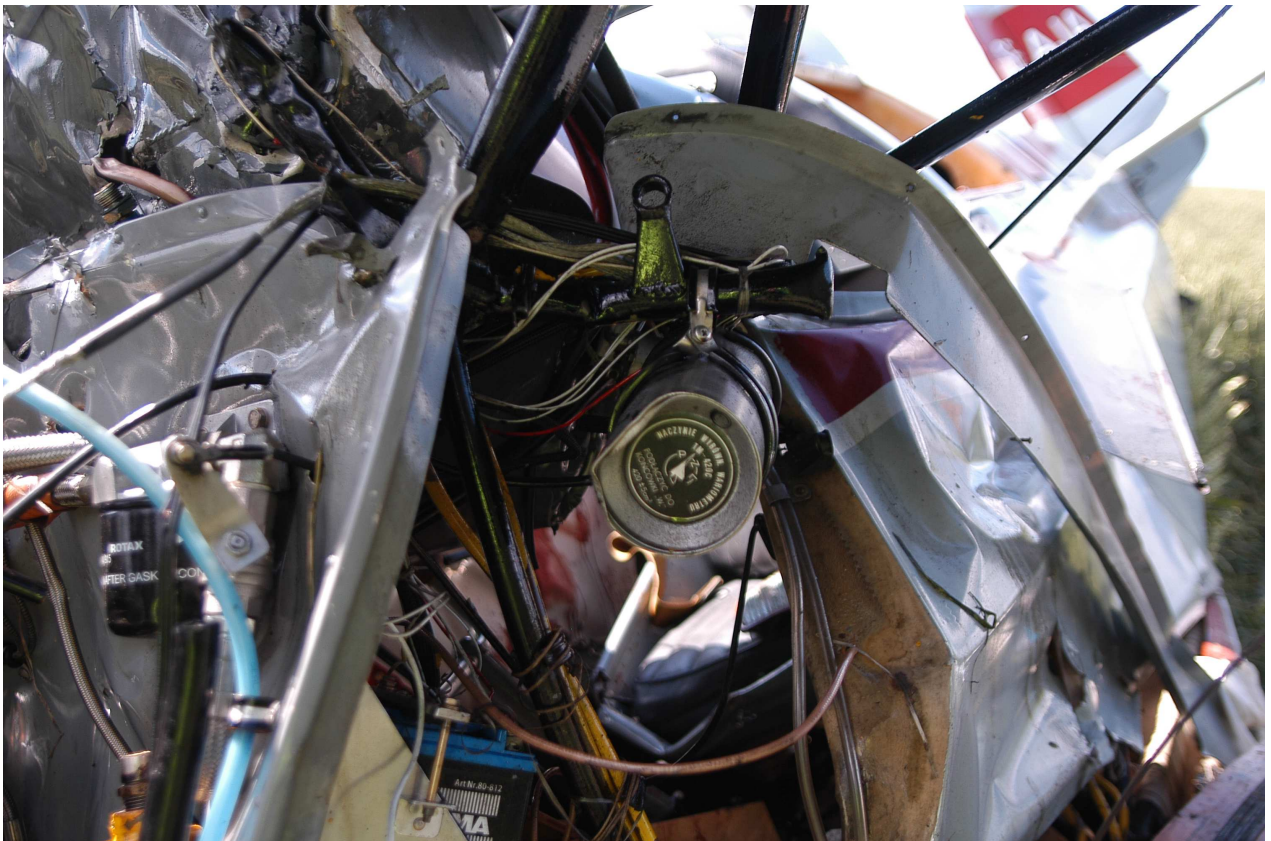
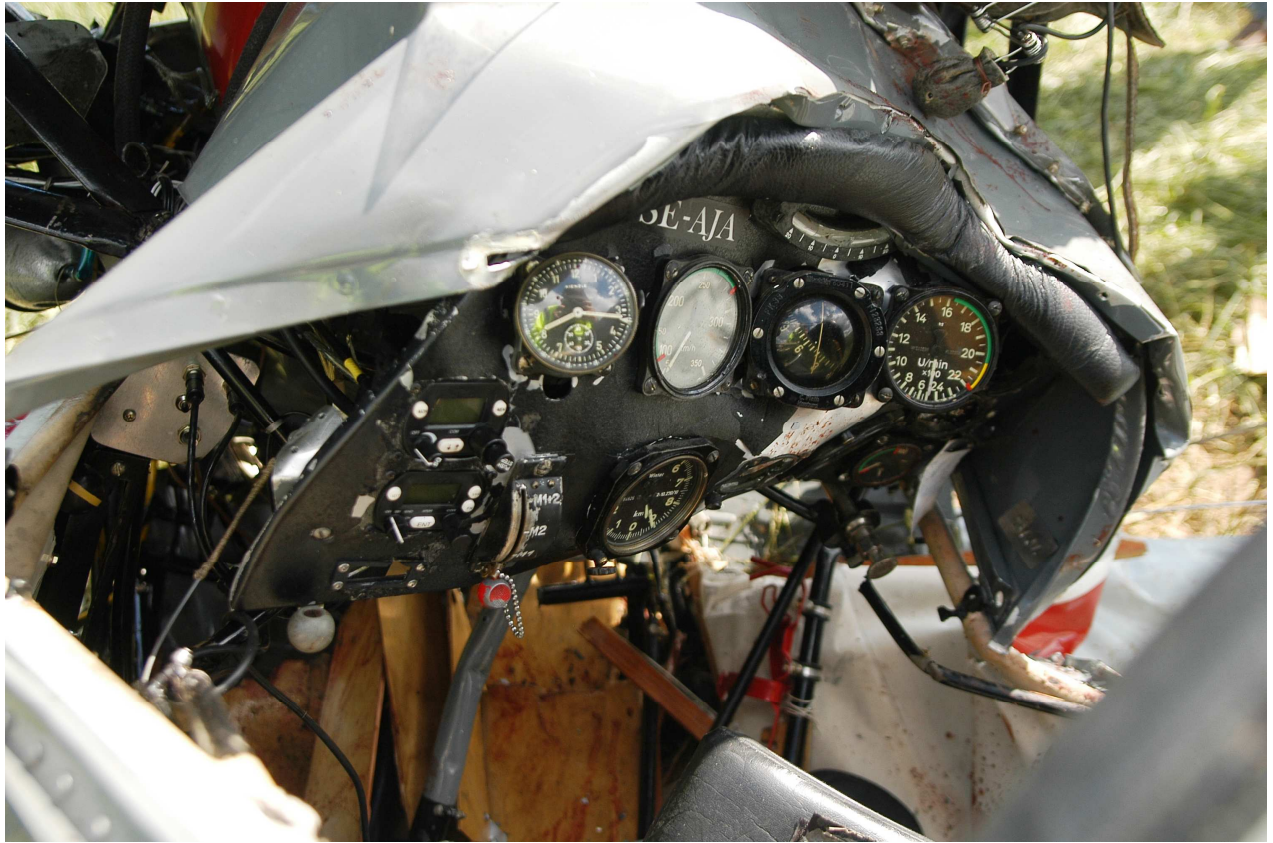
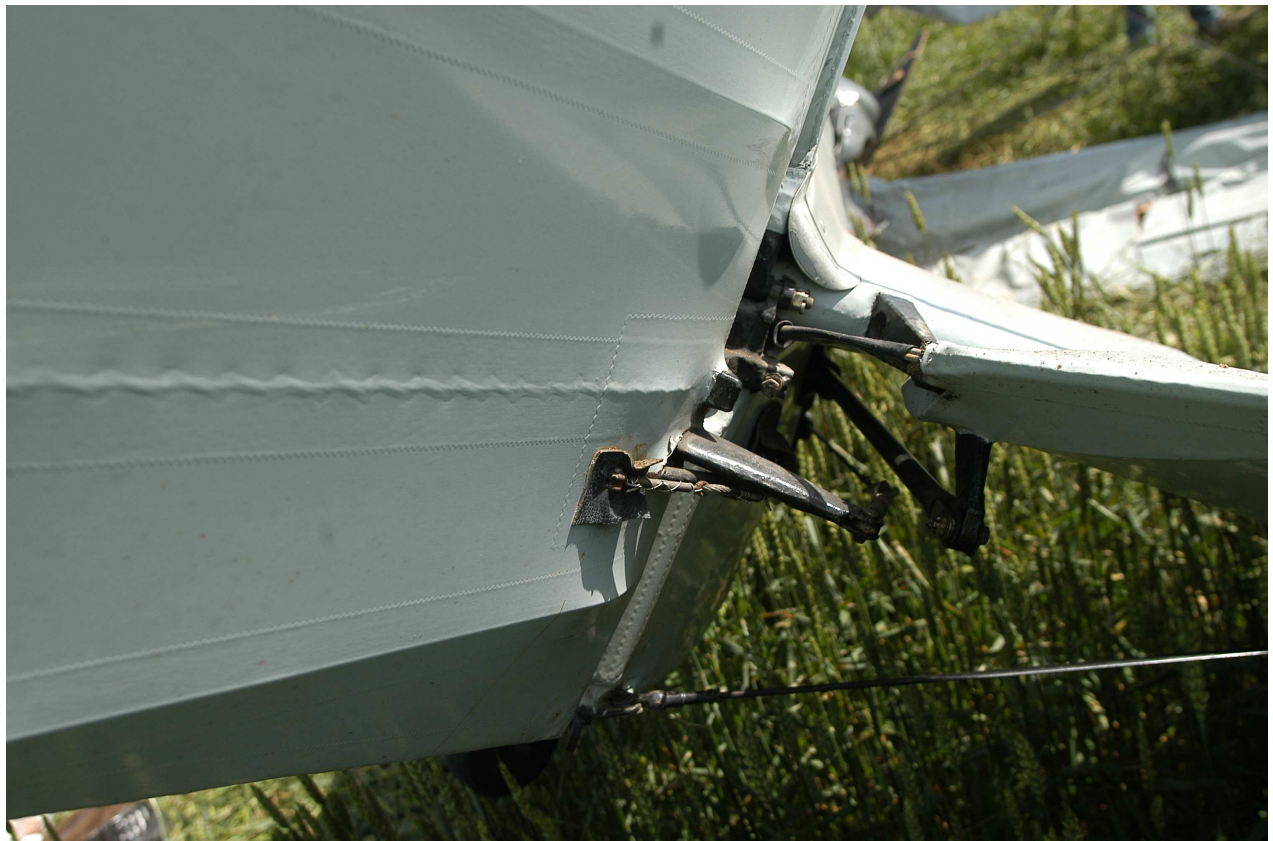
Inspection of the wreckage at the accident site revealed that that the aircraft suffered substantial damage of engine and fuselage.

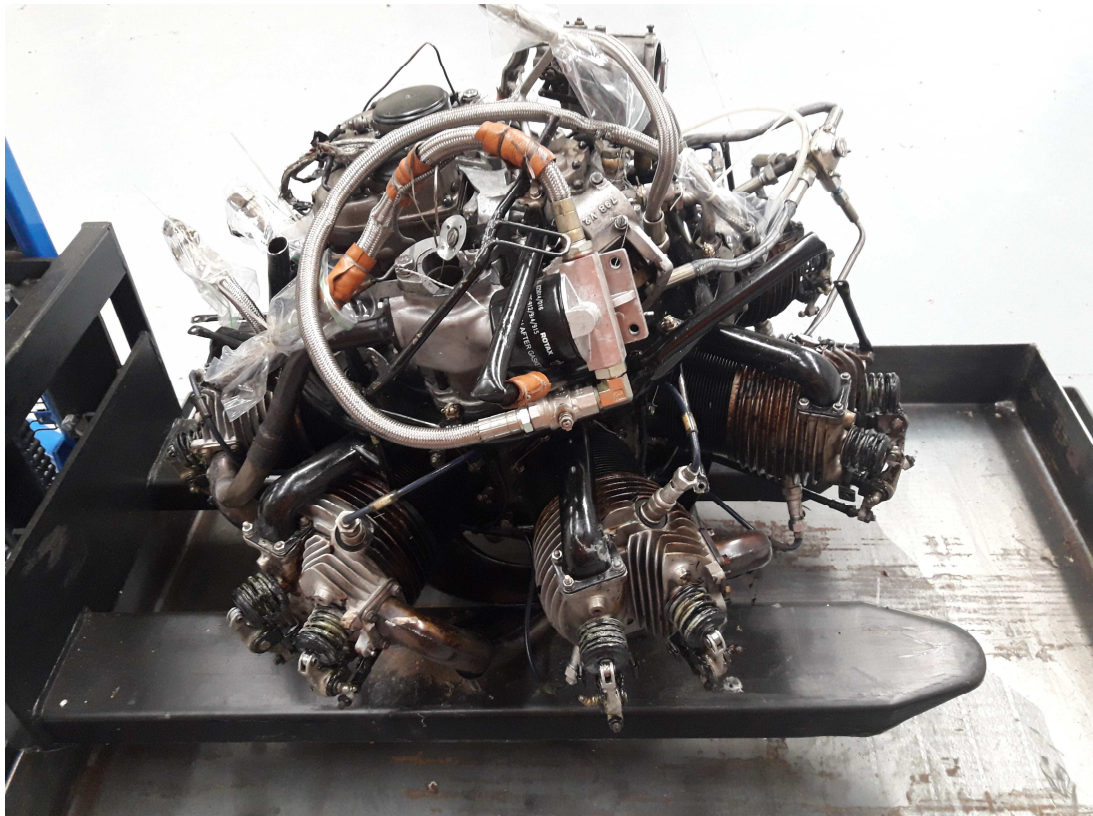
Picture 14 Dismounted engine

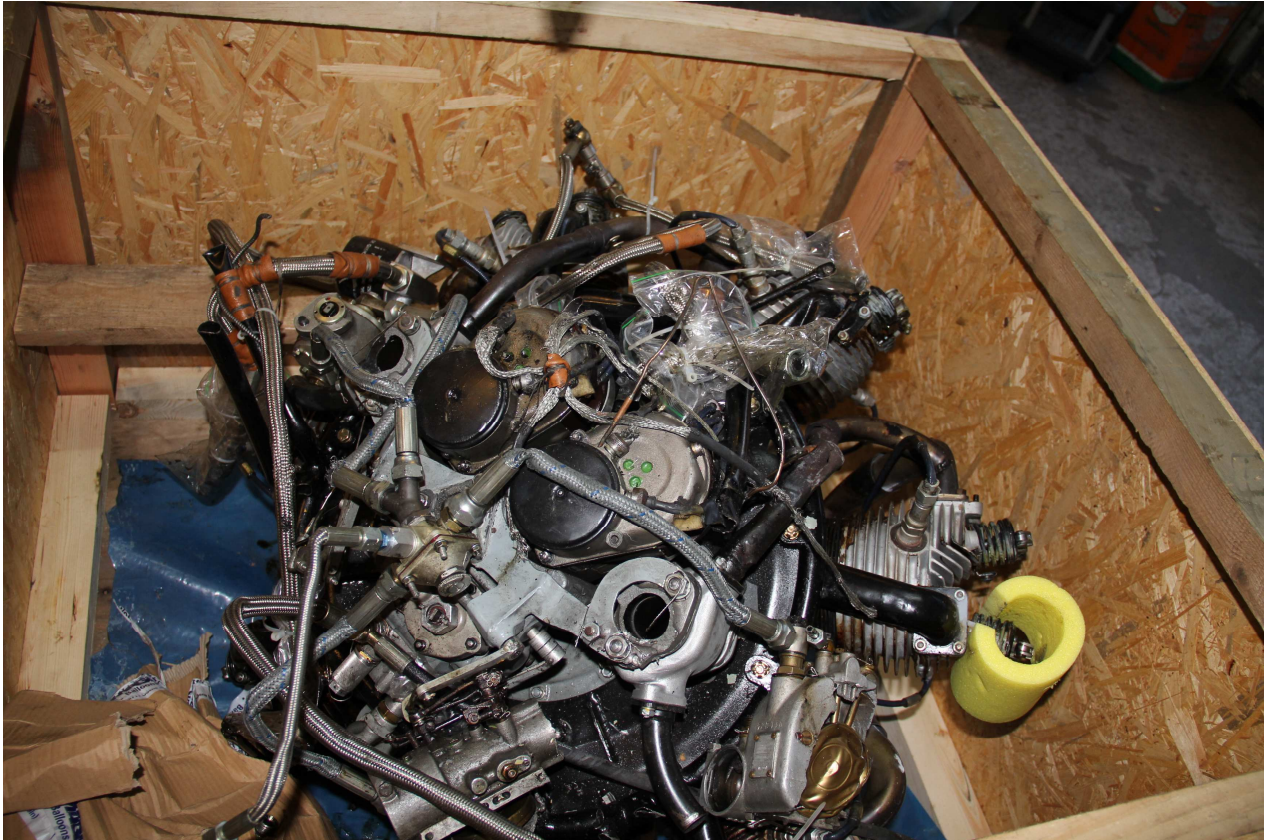
The following damage to engine equipment was detected:

- Both carburetors destroyed;
- Gearbox cracked;
- Engine was not blocked, but rotation of only approximately 20° was possible;
- On several stages of the investigation water was found in the engine;

Checking of ignition point not performed due to engine elements damage, all valve rockers were rotatable, no signs of damage. LH Magnet free rotatable, no visible damage, RH Magnet jamming, cover broken.

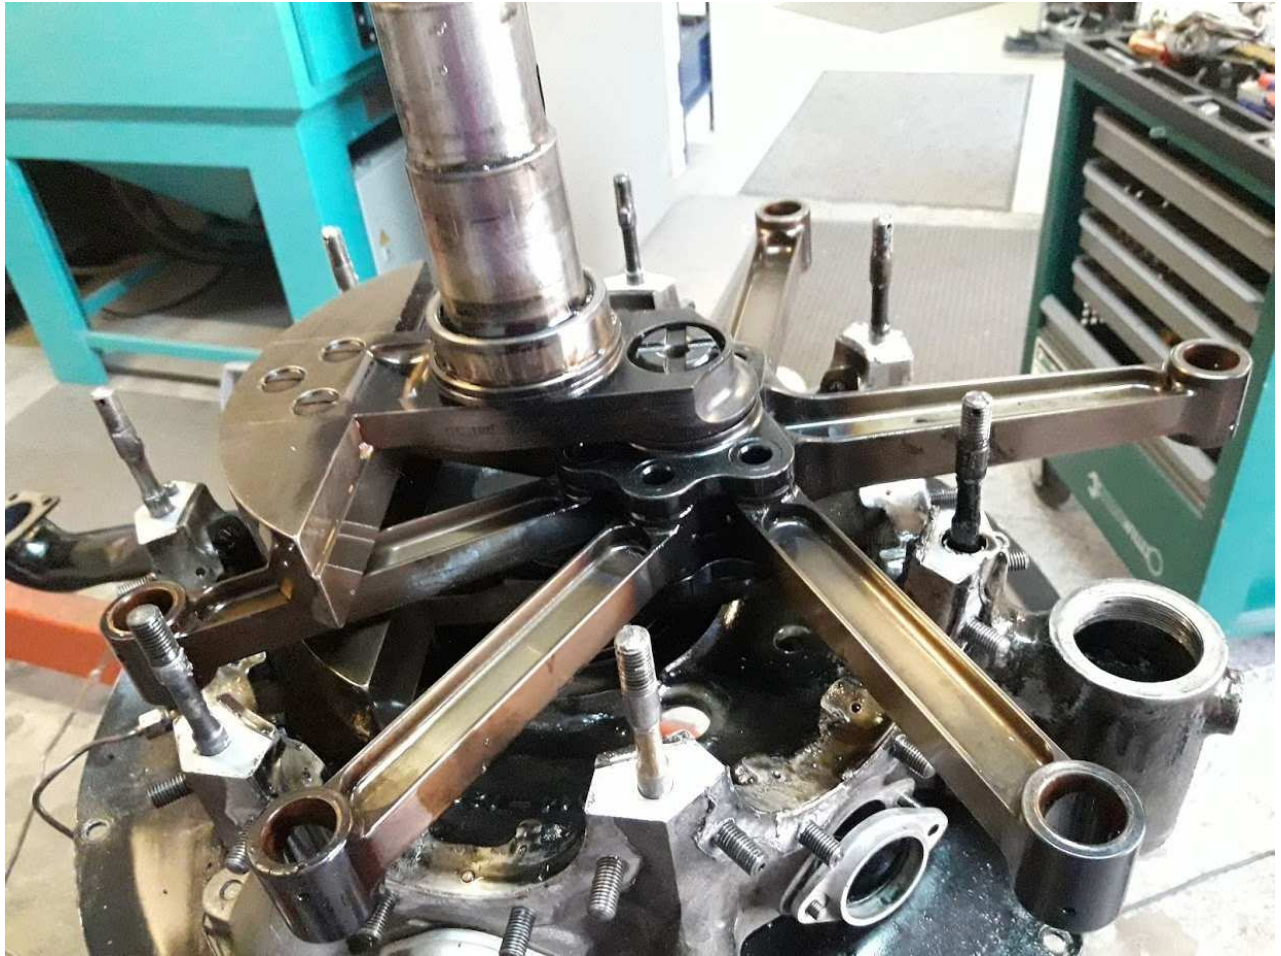
Piston rod assembly disassembling

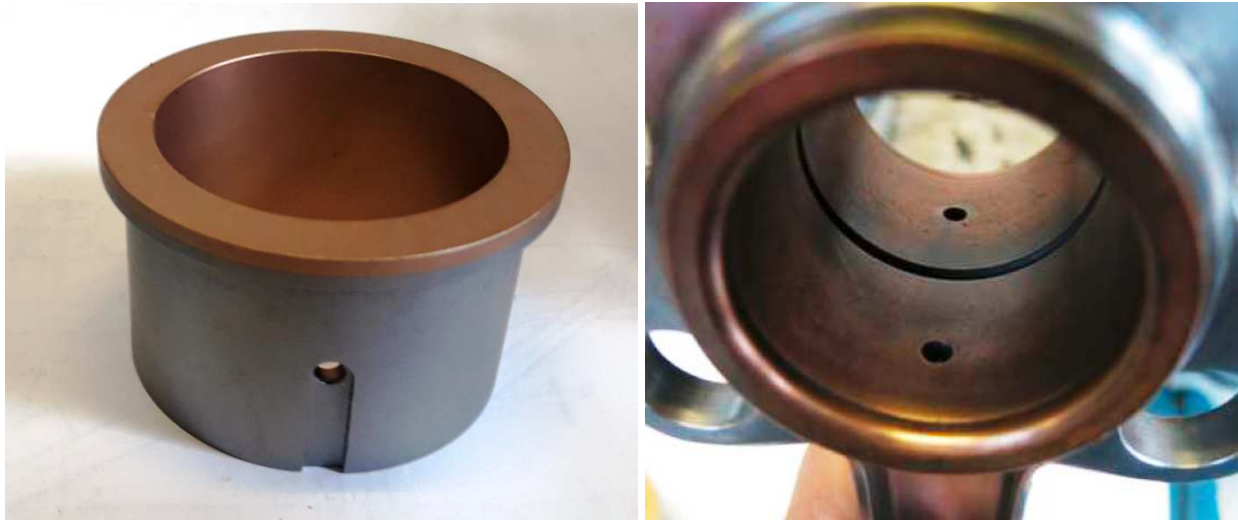
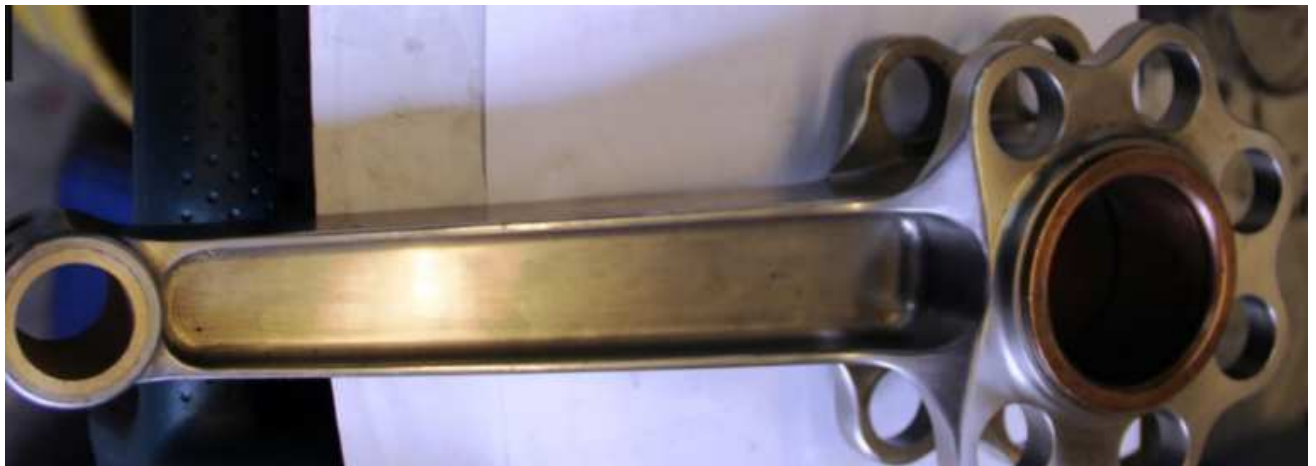
Crankshaft pin and loose / front bushing of the big end bearing of the main piston rod. The front bushing of the big end bearing of the main piston rod was loose but fixed with the crankshaft. It showed severe wear. The rear bushing was fixed to the main piston rod but in a deflected (turned)

position (approximately 30°). Thus, the lubrication orifices (holes) were also shifted about 30 degrees respectively.

Due to the deflected (turned) position of the bushings the lubrication of the big end bearing (crankshaft) and small end bearing (piston) was interrupted as a result the engine had failed due to reduced lubricant (oil) supply.

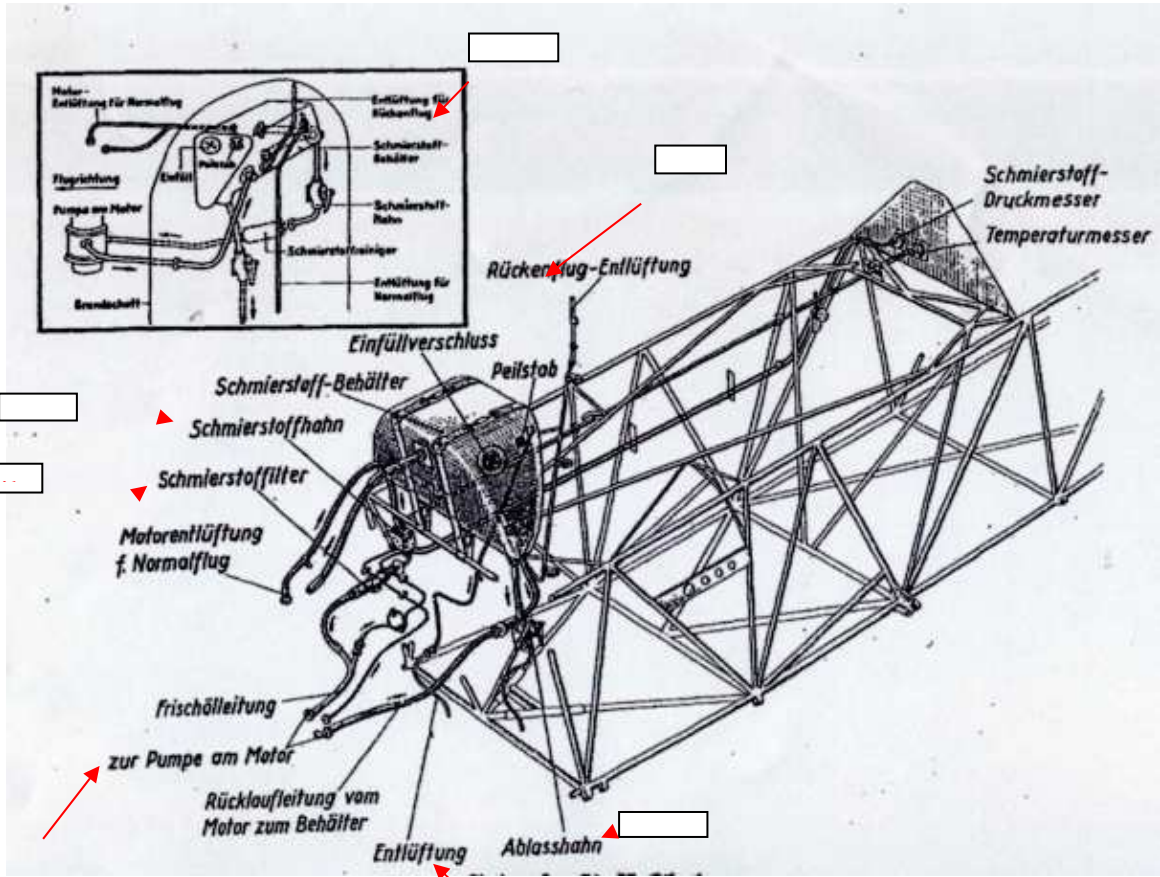
Actual oil system was different to the drawing - additional installation of an oil temp sensor and of a drain valve on the oil tank. Installation of a non-standard oil filter (ROTAX, Part No: 825014/016) (see drawing - parts in red). Connecting hoses were non-standard. Oil tank was seriously damaged.

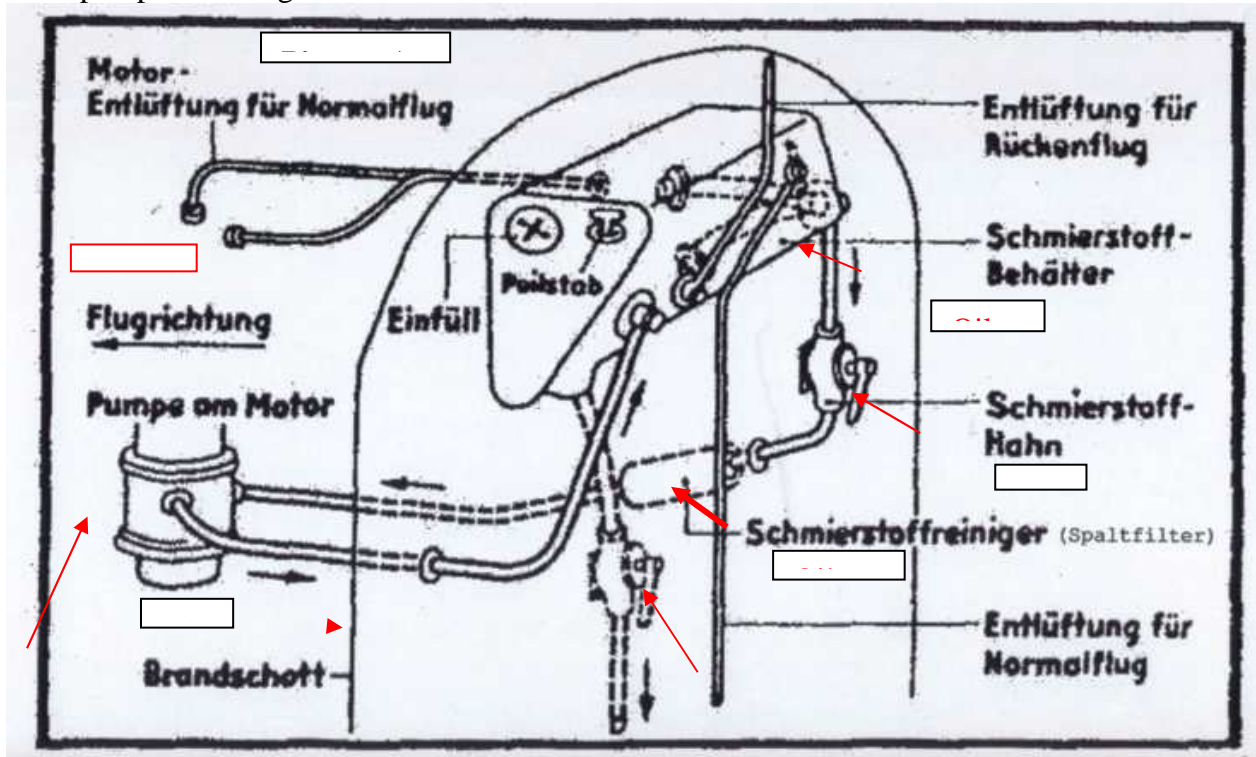
Pump to engine

Drain cock

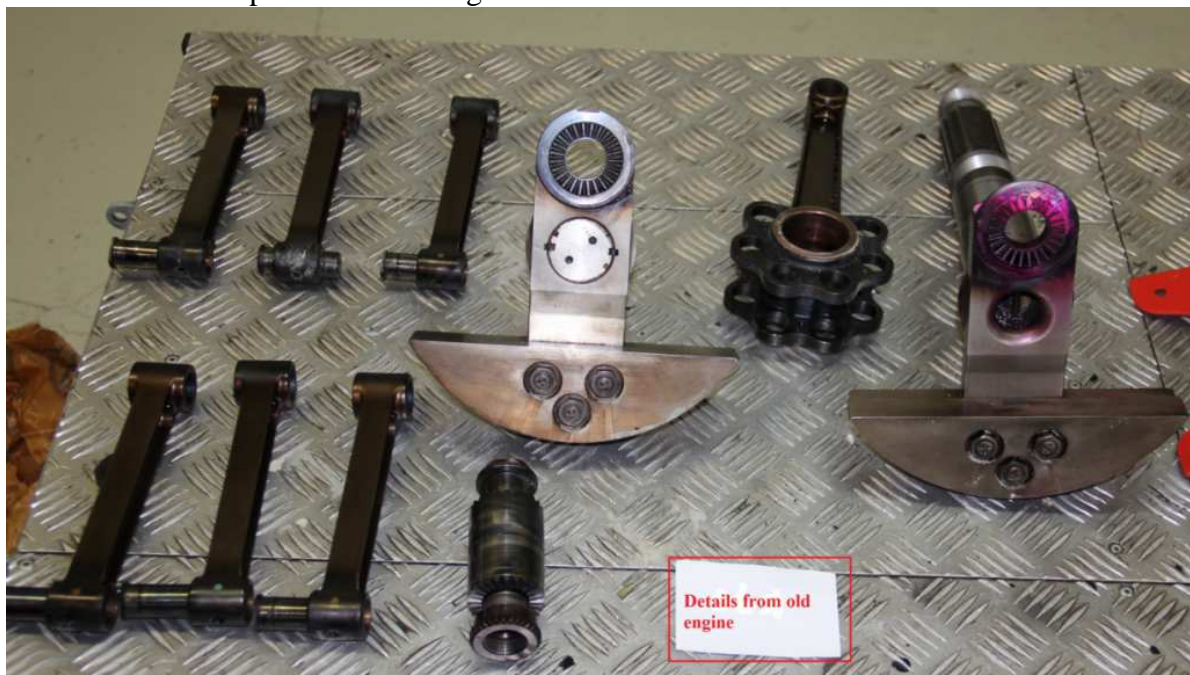
LTB Bende have a crankshaft and piston rods in stock which showed the same colour marks, wear and rotation of the piston rod bearing.
