FINAL REPORT No. 4-02/1-16(1/2017)

INVESTIGATION SEPARATION MINIMA INFRINGEMENT BETWEEN THE AIRCRAFT LANCAIR EVOLUTION, REGISTRATION N503AL and AIRCRAFT Boeing B738, flight RYR-55RM IN RIGA FIR (56°45'09"N 023°08'43"E) ON APRIL 21, 2016.

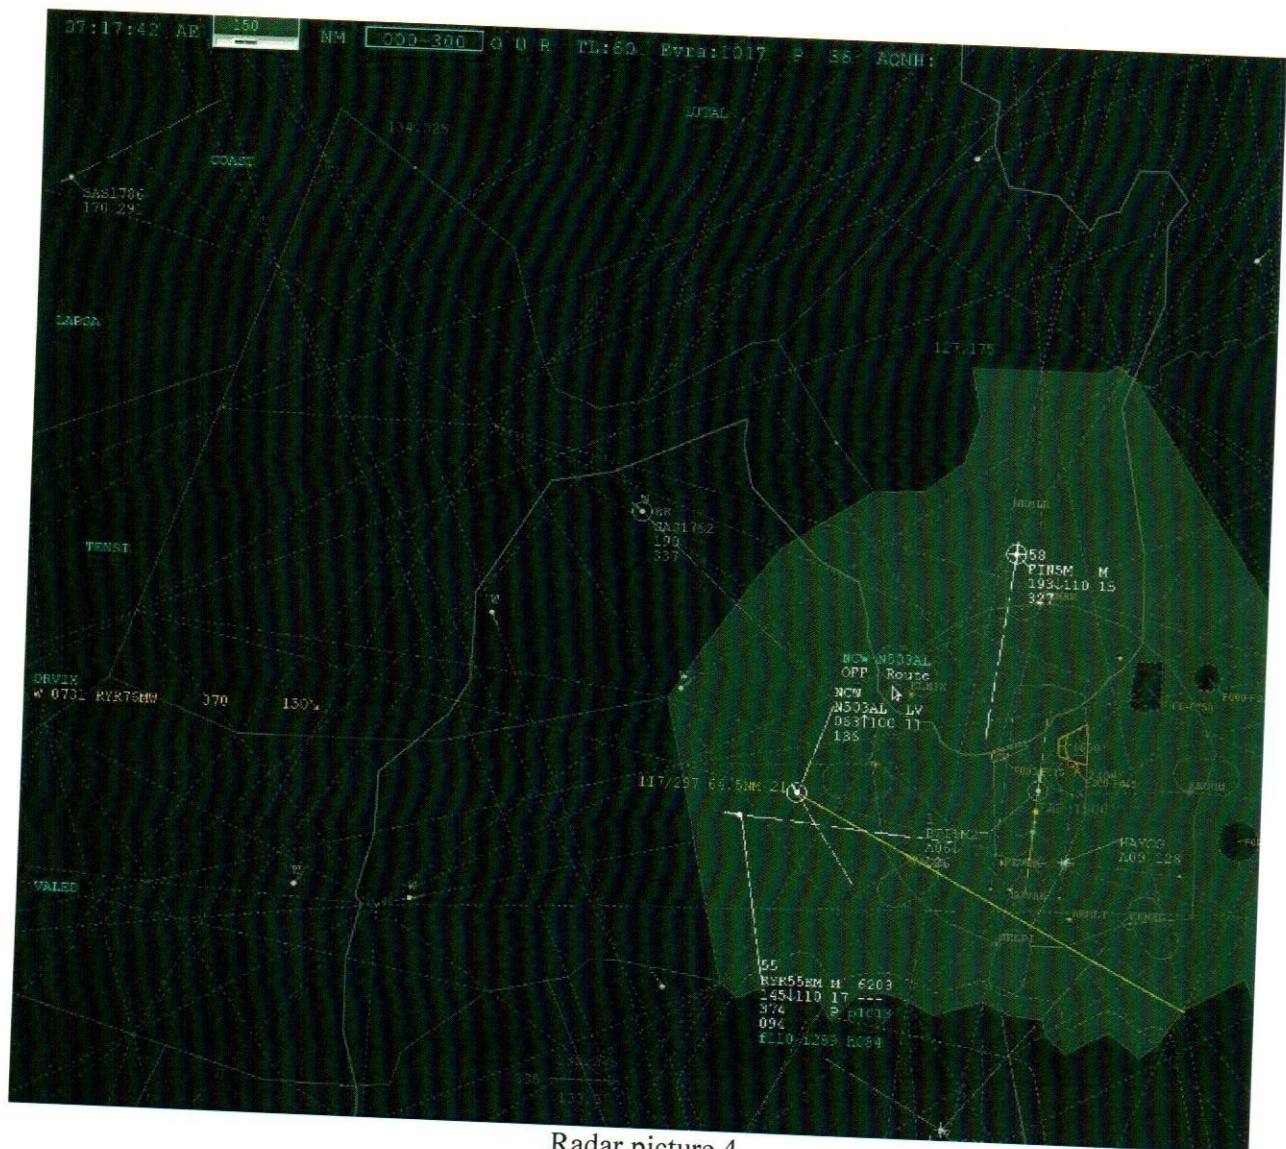
Radar picture 4.

At 07:17:42 the controller gave instruction to crew of N503AL: “N503AL re-cleared direct to ERIVA from present position”

At 07:17:51 the crew of N503AL answered: “Direct to RIA from this position, please give the heading”

At 07:17:54 the controller repeated clearance again: “NAL direct point ERIVA”

At 07:17:58 the crew confirmed clearance:” Direct point ERIVA, N503AL”

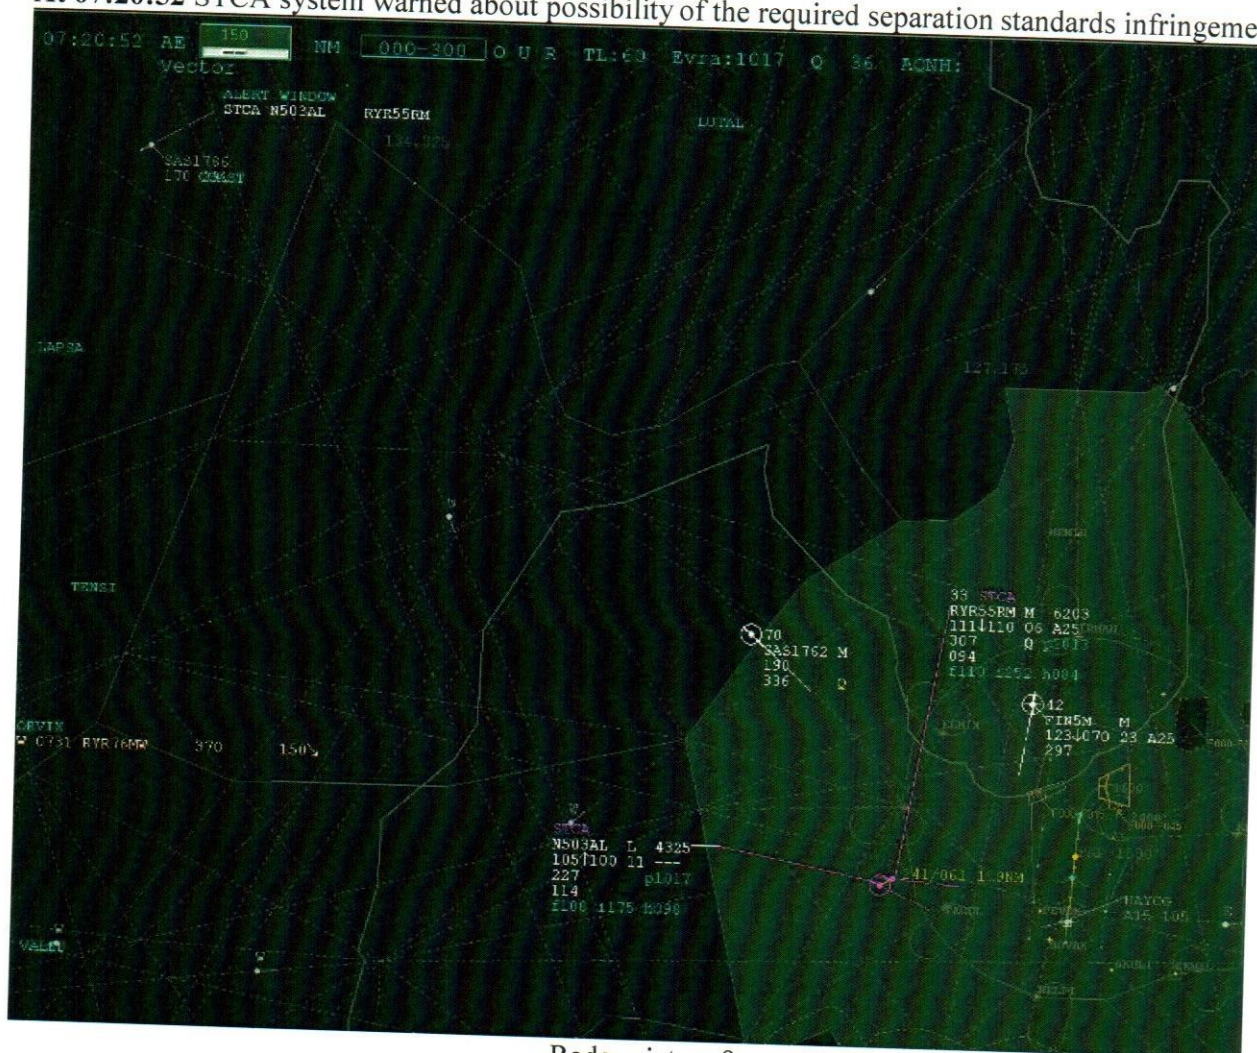
Radar picture 9.

At 07:20:52 STCA system warned about possibility of the required separation standards infringement.

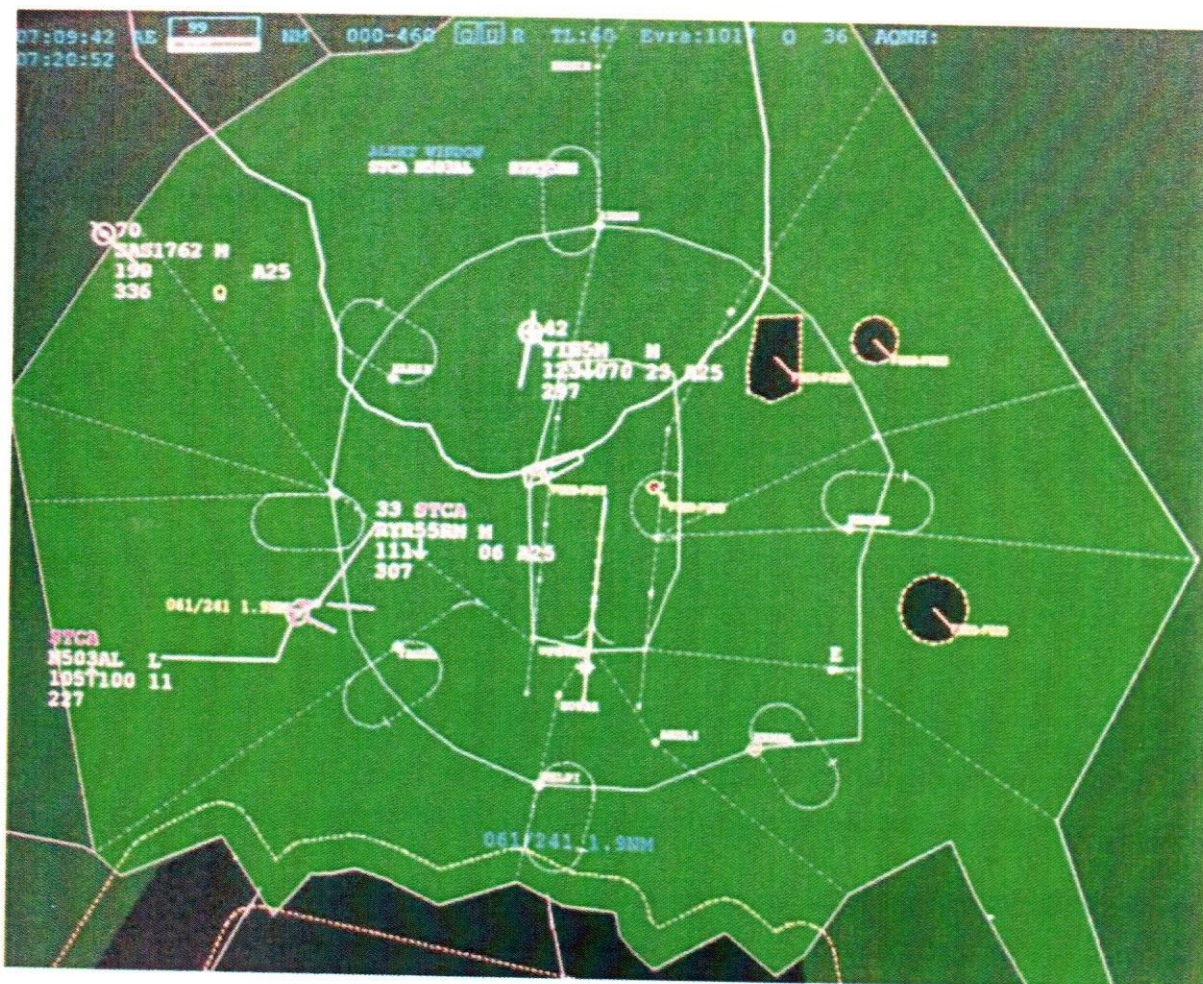
Radar picture 11.

Radar separation between identified, controlled aircraft at the same flight level (altitude) when double SSR coverage is provided the radar separation **not less than 3 NM** shall be applied;

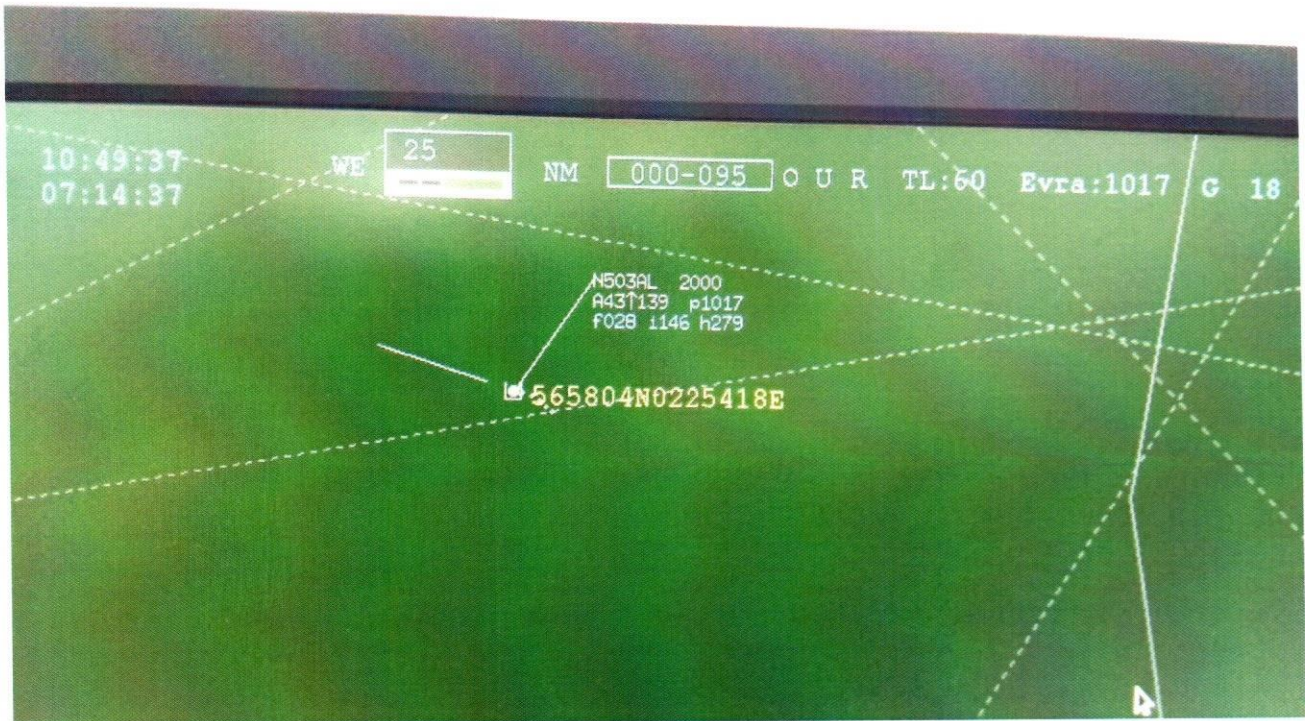
Radar picture 14.

At 07:12:50 N503AL still was flying in the controlled airspace without APP controller permission

Only at 07:14:37 crossing altitude 4300 feet the pilot of N503AL established first radio contact with the APP Controller and declared "*N503AL proceed via flight plan to point ERIVA*".

The APP controller for identification instructed pilot of N503AL to set SQUAWK 4325 and requested to confirm about altitude what he is flying. Pilot said that FL 240 and APP controller cleared initial climb FL100 which was confirmed by N503AL pilot.
